## **Conner Recovery Site Field Trip**

## October 6, 2010

The purpose of this field trip was to:

- 1. Observe whether People's 100 accurately represents the Conner Recovery site at high tide.
- 2. Observe what happens to debris as the tide recedes.

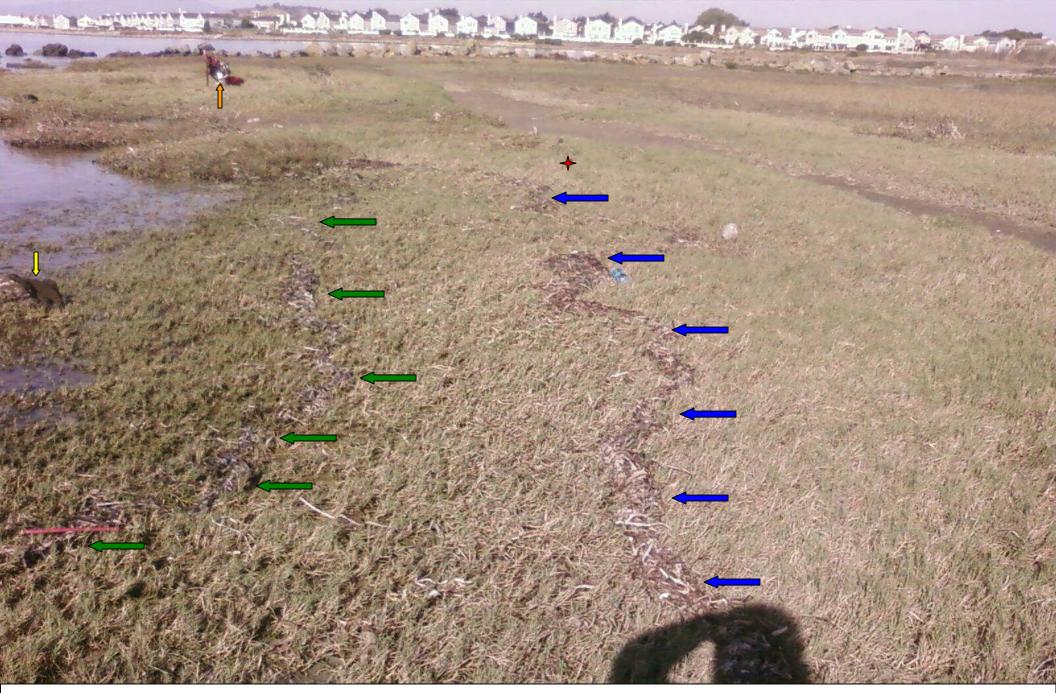
#318/10-6-10/10:06 a.m./PWL 5.77 ft/Winds SSW 2 – 3.8 mph. Looking to the West. Two distinct debris lines formed by tides on the 5<sup>th</sup>: PWL 6.01 ft at 10:42 a.m. S winds 5-10 mph (blue arrows); PWL 5.90 ft at 11:00 p.m. SW winds 4-8 mph (green arrows). The red star indicates the flag marking the approximate location Conner was found. The orange arrow points to my chair and stuff. As the water level rises, the rock (yellow arrow) will be a good indication of water depth.

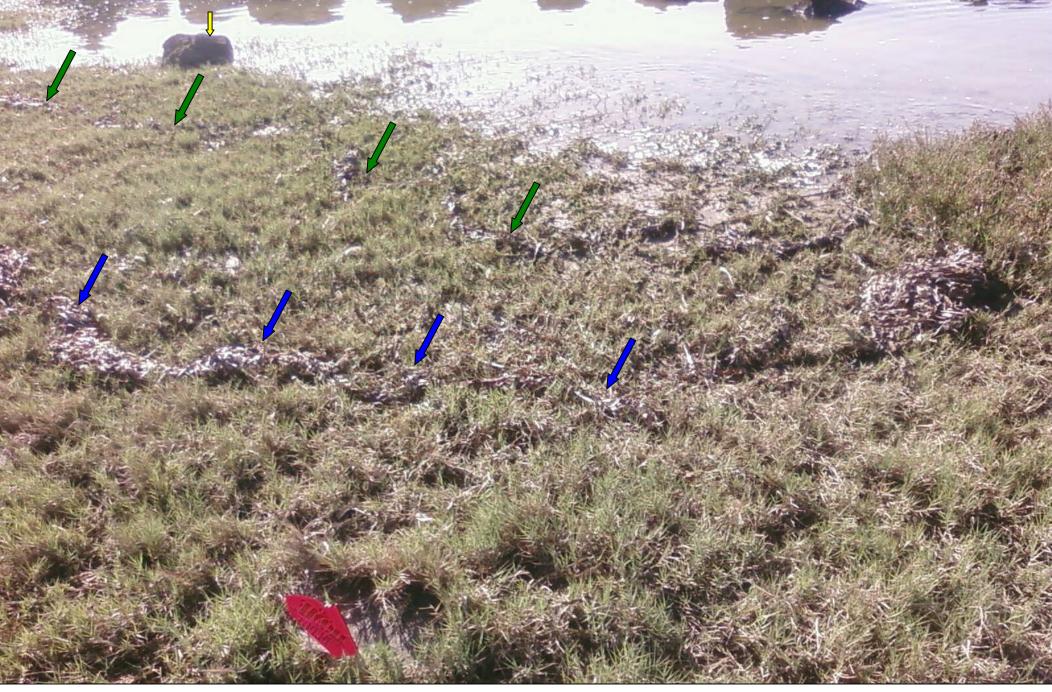
#319/10-6-10/10:06 a.m./PWL 5.77 ft/Winds SSW 2 – 3.8 mph. Looking to the South. You can see the reflection of the breakwater rocks in the water. Green arrows are the 5.90 debris line from the 5<sup>th</sup>; and the blue arrows are the 6.01 debris line from the 5th. The yellow arrow points to the rock that will be a good indication of the water depth as the tide rises. The red flag is next to the rock that was used to mark the approximate location of Conner's body, as measured on August 14, 2009 using a Nikon ProStaff 550 Laser.

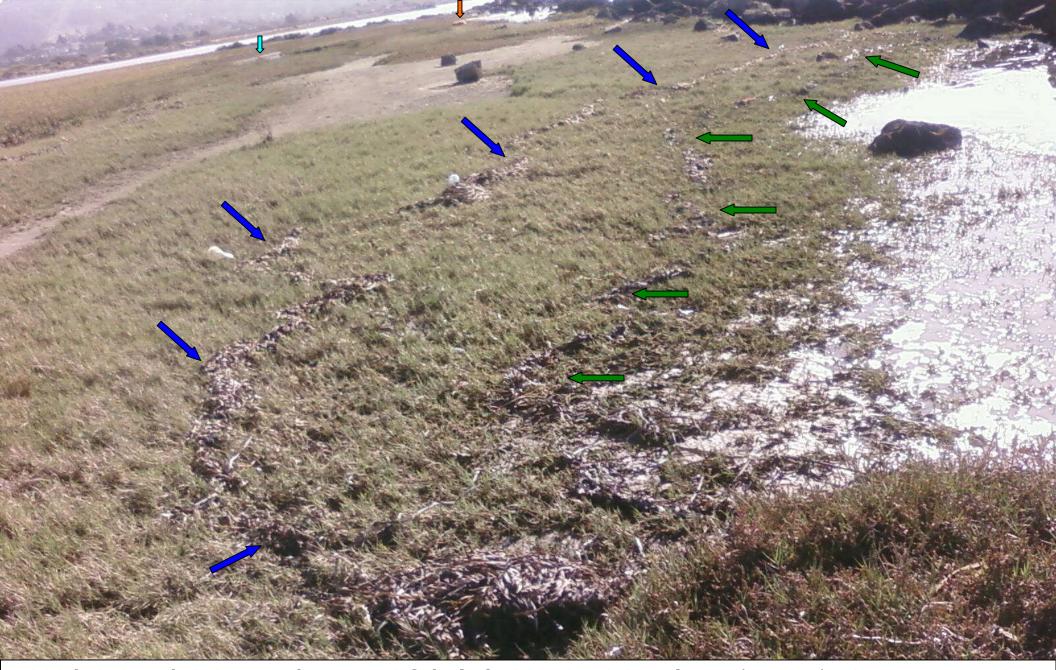
#320/10-6-10/10:07 a.m./PWL 5.78 ft/Winds SSW 2 – 3.8 mph. Looking to the SE corner. Green arrows are the 5.90 debris line and the blue arrows are the 6.01 debris line from the 5th. The orange arrow points to a very large orange styro-foam type object, about 5' long, 2'wide, and 1' tall. The turquoise arrow points to a tidal pool along the dirt path left over from high tides on the 5<sup>th</sup>. The stuffed animals do not show in this picture because they have not been washed far enough by the waves. The grass, which forms a natural barrier to debris, nonetheless becomes saturated with the rising tide.

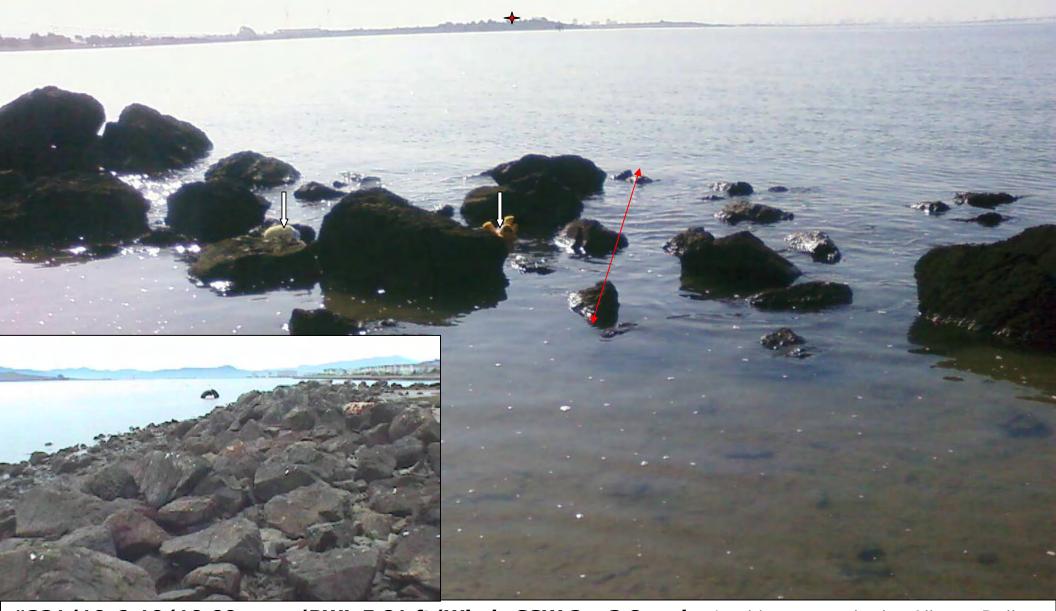
#321/10-6-10/10:09 a.m. /PWL 5.81 ft/Winds SSW 2 - 3.8 mph. Looking towards the Albany Bulb (red star). I brought 5 stuffed animals with me for the debris line and I threw 2 into the rocks (white arrows). What lurks beneath this calm surface are many rocks with very sharp, rough edges. The inset picture, taken at a very low tide, shows the rocks that comprise this section of the breakwater. From the front to the back of the top row of rocks (red line) is about 8-12 feet (estimated). The 5.77 ft higher high tide on April 12, 2003, during the storm, experienced winds of 26-32 mph (NOAA Richmond) or 20-32 mph (UC Berkeley). 5.81 feet is less than ½ inch more than 5.77 feet. The 5.88 ft higher high tide on April 13, 2003 experienced winds of 17-21 mph (NOAA Richmond) or 14-23 mph (UC Berkeley). 5.88 feet is about 7/8 inch more than the 5.81 feet captured in this picture, or about 1 1/3 inch more than 5.77.

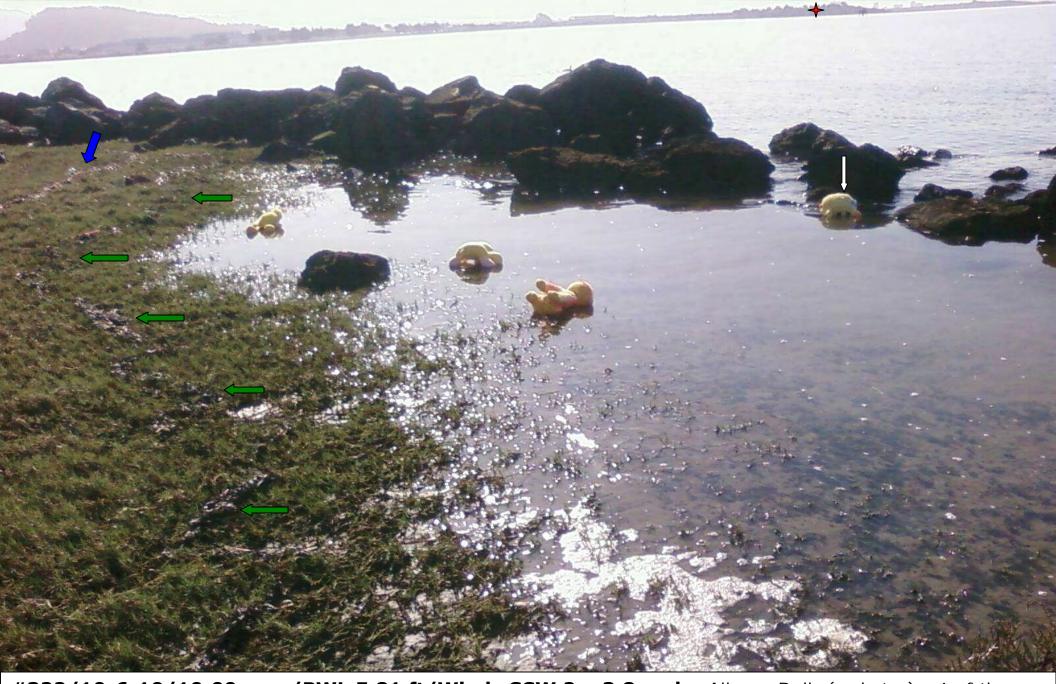
#322/10-6-10/10:09 a.m./PWL 5.81 ft/Winds SSW 2 – 3.8 mph. Albany Bulb (red star). 4 of the stuffed animals show in this picture; one I threw into the rocks is now laying atop a rock (white arrow). The green arrows show the 5.90 debris line and the blue arrow the 6.01 debris line from the 5<sup>th</sup>. The position of the stuffed animals compared to the extent of the water coverage shows that the grass and the slight slope forms a barrier for the debris line but does not prevent tidal pooling north of the debris line. Conner was found in a tidal pool north of the debris line.

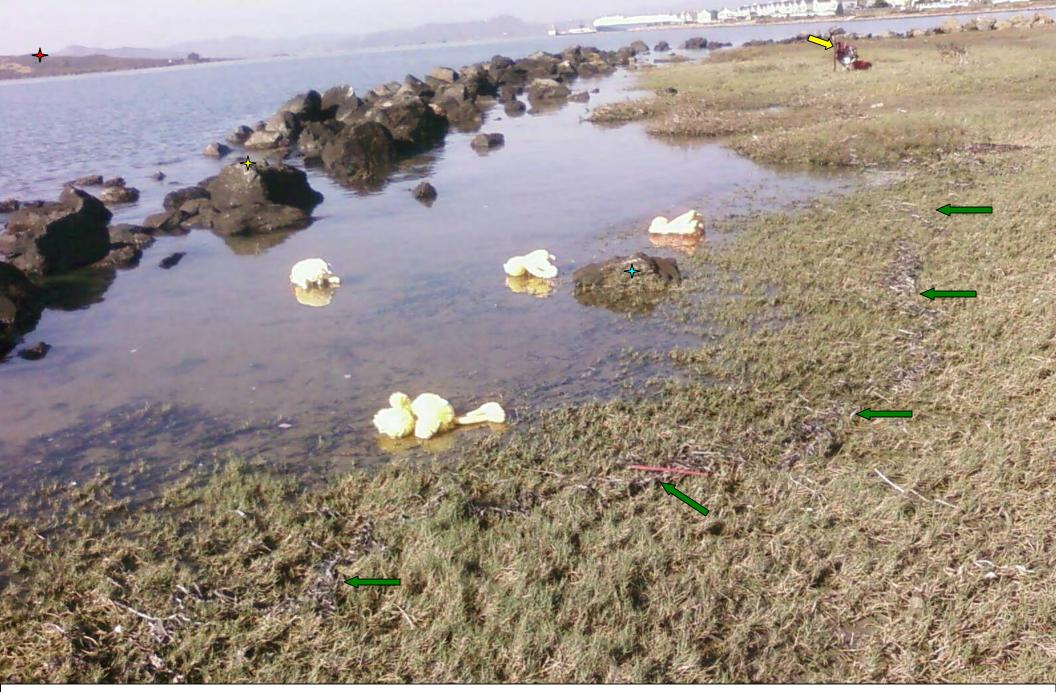
#323/10-6-10/10:10 a.m./PWL 5.82 ft/Winds SSW 2 – 3.8 mph. Looking towards the SW. Brooks Island in the upper left (red star). 4 of the stuffed animals show in this picture, one is still behind the big rock (yellow star). The green arrows show the 5.90 debris line from the 5<sup>th</sup>. The little rock (turquoise star) will be a good indicator of the water depth as the high tide comes in. You can see the gentle slope from the south to the north – the mudflat is not flat. The yellow arrow points to my red chair and stuff.

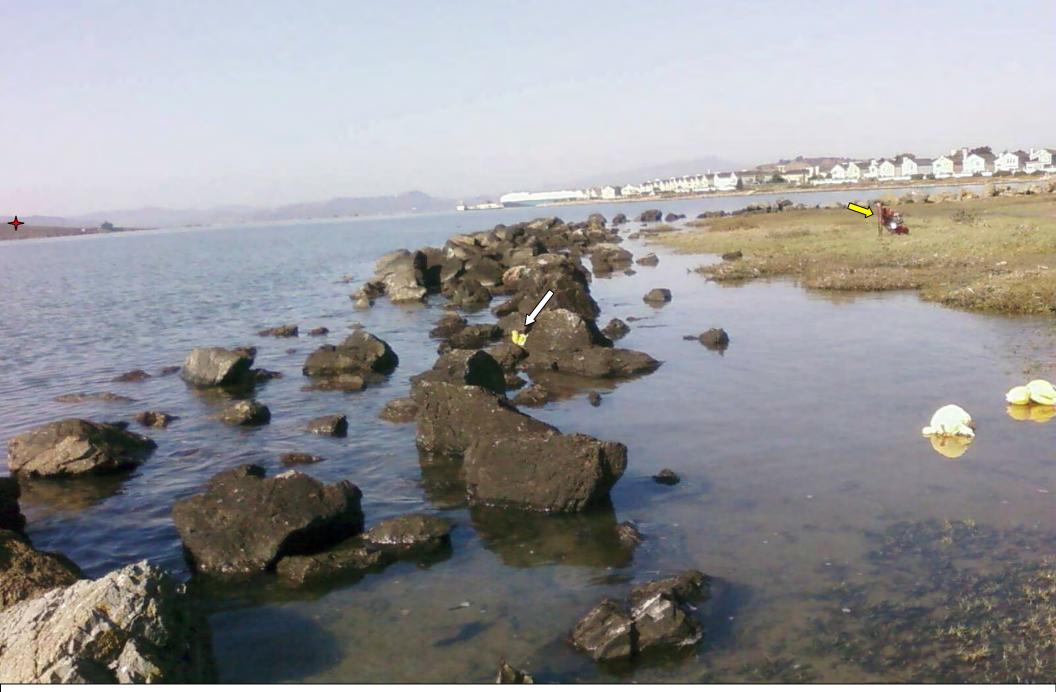
#324/10-6-10/10:10 a.m./PWL 5.82 ft/Winds SSW 2 – 3.8 mph. Looking Westward. Brooks Island in the upper left (red star). 3 of the stuffed animals show in this picture, one is still behind the big rock (white arrow). This picture shows more of the rocks that form the breakwater. A number of the smaller rocks still protrude above the water, with many more just under the surface. The yellow arrow points to my red chair and stuff.

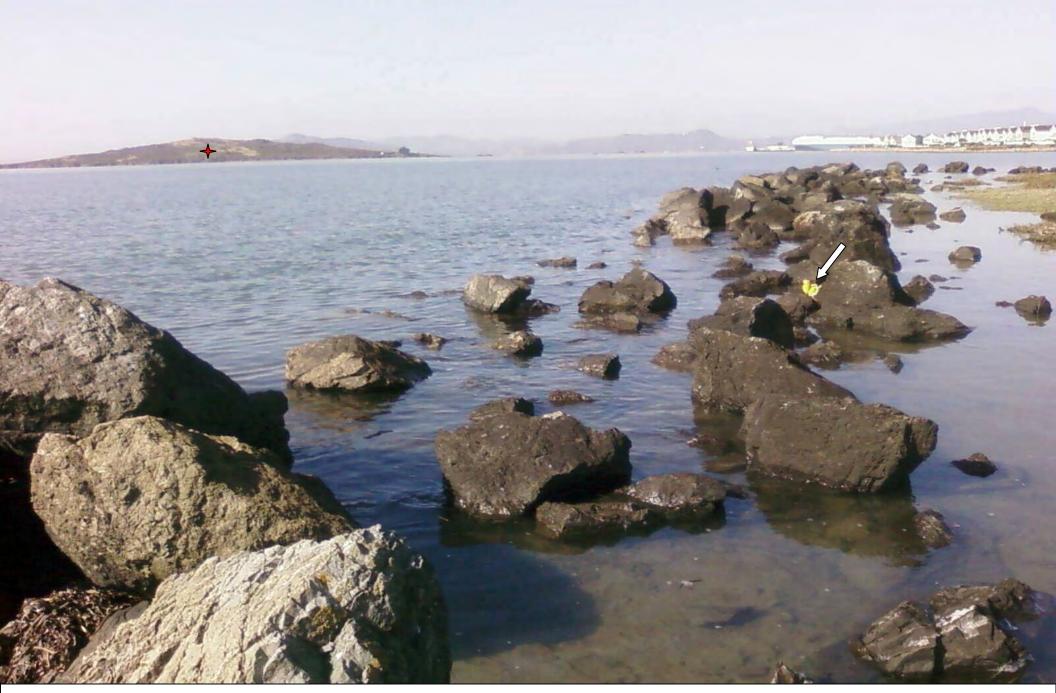
#325/10-6-10/10:10 a.m./PWL 5.82 ft/Winds SSW 2 – 3.8 mph. Looking straight at Brooks Island (red star). The right arrow points to the stuffed animal still behind the large rock. To the left in this picture you can see the size of the rocks in the breakwater, which do much more to block the waves than the section just to the west. In strong winds at this water level, the waves would be pounding against these rocks. The water level on April 12, 2003, during the storm, was 5.77 ft (verified by NOAA).

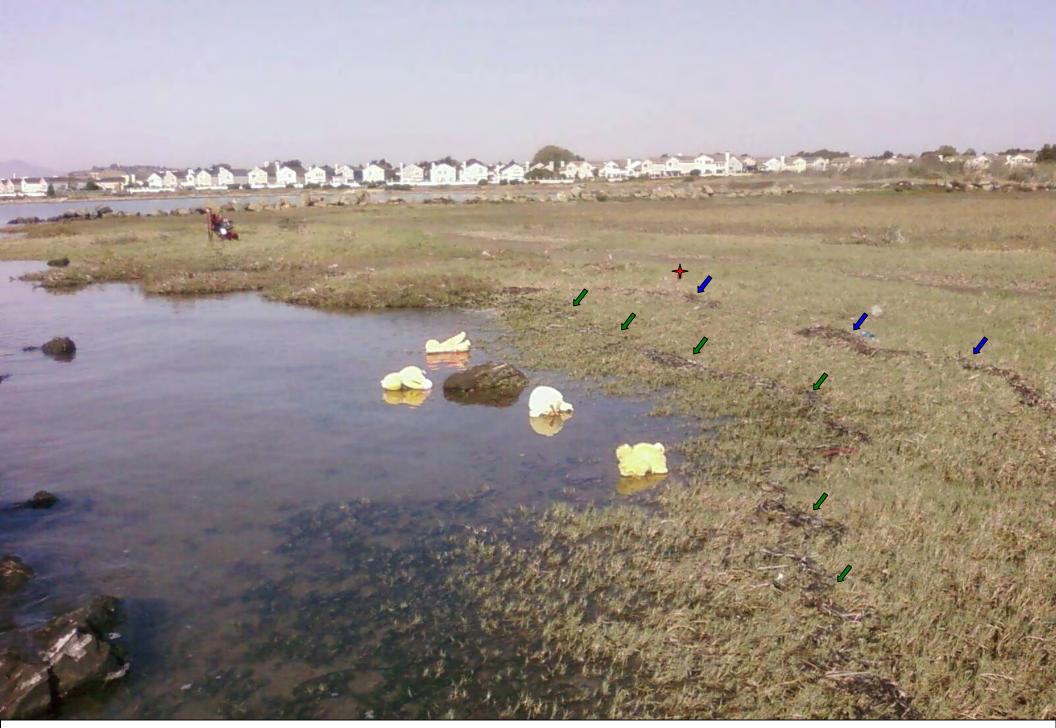
#326/10-6-10/10:10 a.m./PWL 5.82 ft/Winds SSW 2 – 3.8 mph. Looking NNW. The 5.90 ft debris line is still intact (green arrows). The 6.01 debris line is marked with blue arrows. The red star marks the approximate location where Conner's body was found. One stuffed animal is still behind the rock.

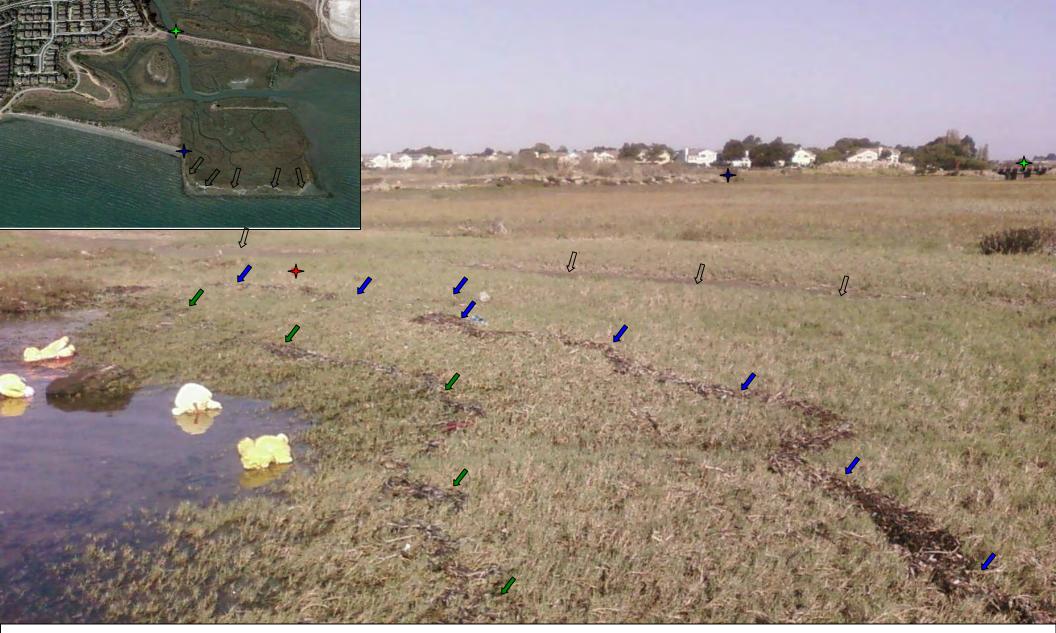
#327/10-6-10/10:12 a.m./PWL 5.85 ft/Winds SSW 2.7 – 3.8 mph. Looking NNW. The 5.90 ft debris line is still intact (green arrows), and the 6.01 debris line is marked with blue arrows. The red star marks the approximate location where Conner's body was found. One stuffed animal is still behind the rock. The inset picture gives a perspective on the layout of the mudflat. The blue stars mark where the beach leads to the mudflat; and the green stars mark the Bay Trail bridge. On the inset you can see all the creeks and ponds in the mudflat north of the path marked by the arrows. As the high tide comes in, these creeks and ponds will fill and then overflow, being fed mostly by the Meeker Slough, that large channel that runs under the Bay Trail bridge and westward into the Bay

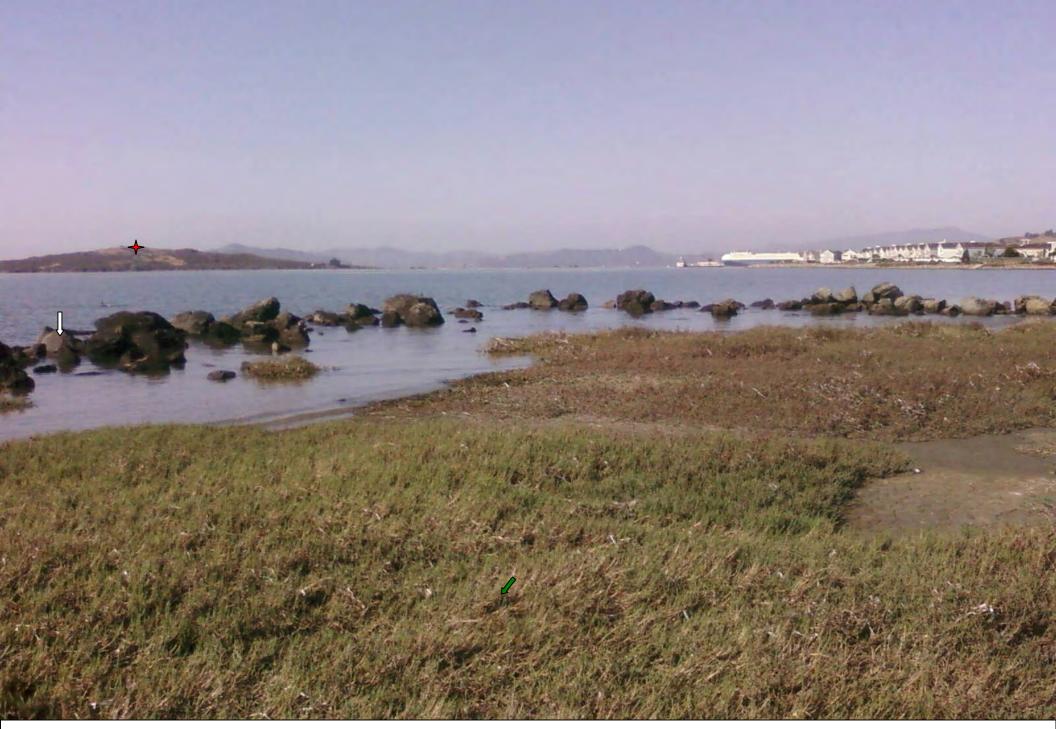
#328/10-6-10/10:12 a.m./PWL 5.85 ft/Winds SSW 2.7 – 3.8 mph. Looking at the SW corner, which has a low breakwater and lets in a lot of water. Brooks Island is marked by the red star. In the next few pictures, I pan to the East, marking reference rocks in each picture with a white arrow.

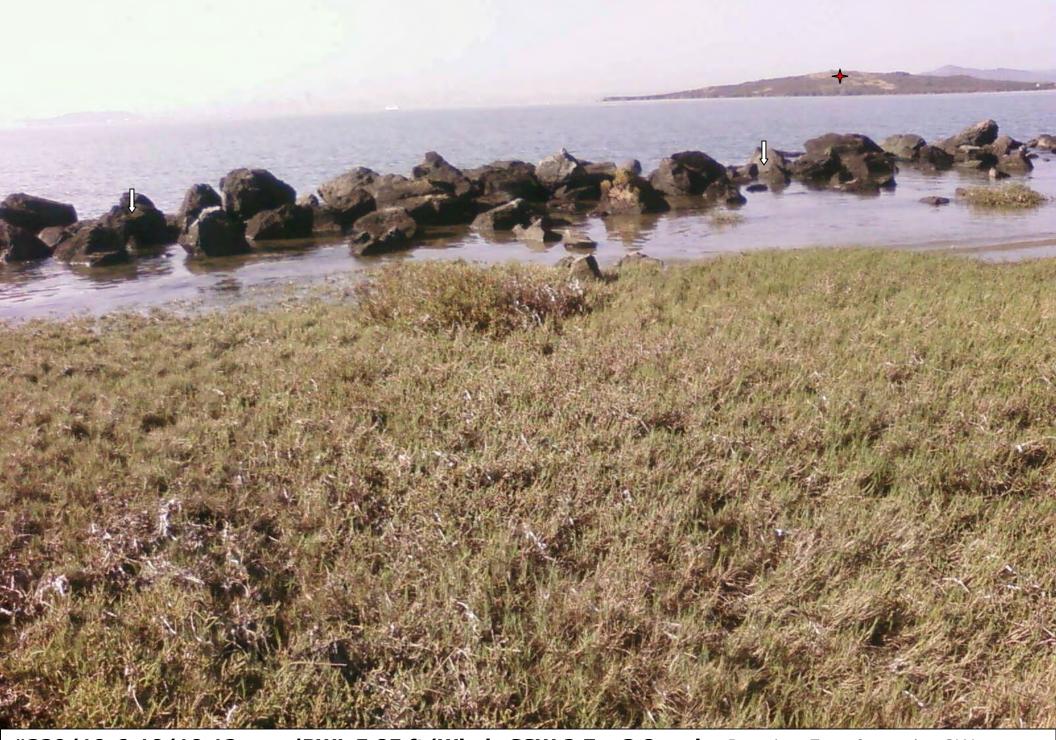
#329/10-6-10/10:12 a.m./PWL 5.85 ft/Winds SSW 2.7 – 3.8 mph. Panning East from the SW corner. The right white arrow is the reference rock from picture #328. This section of breakwater is fairly compact. Brooks Island is marked by the red star.

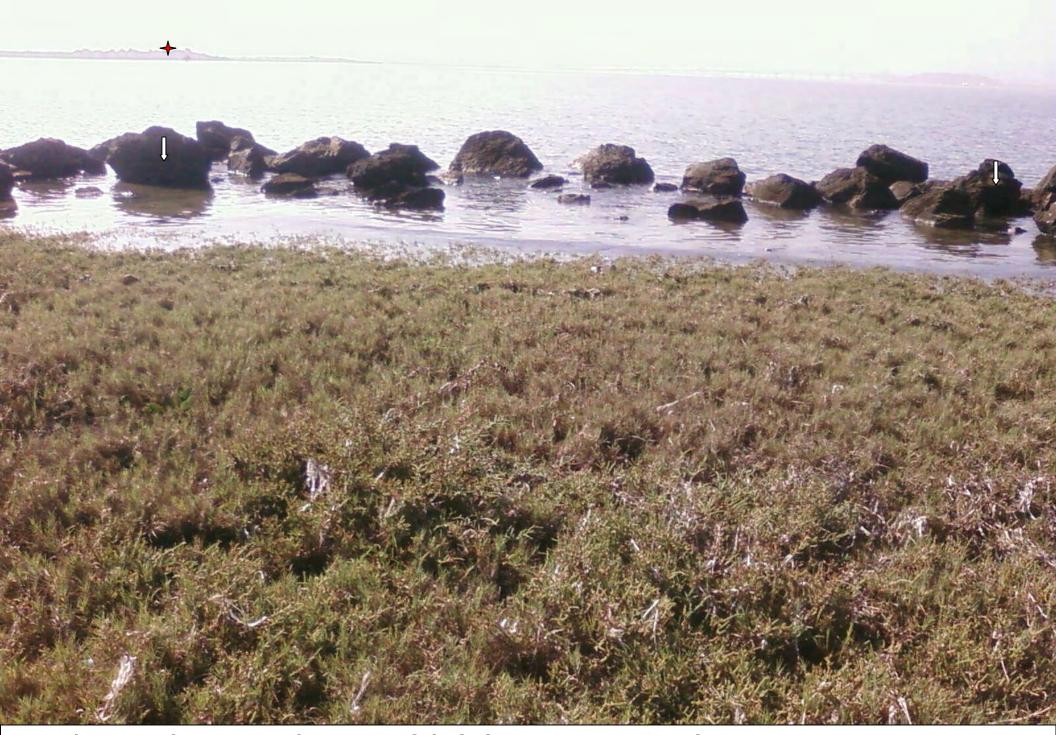
#330/10-6-10/10:12 a.m./PWL 5.85 ft/Winds SSW 2.7 – 3.8 mph. Still panning East to capture another section of the breakwater. The right white arrow is the reference rock from picture #329. This section of breakwater is not as compact. Albany Bulb is marked by the red star.

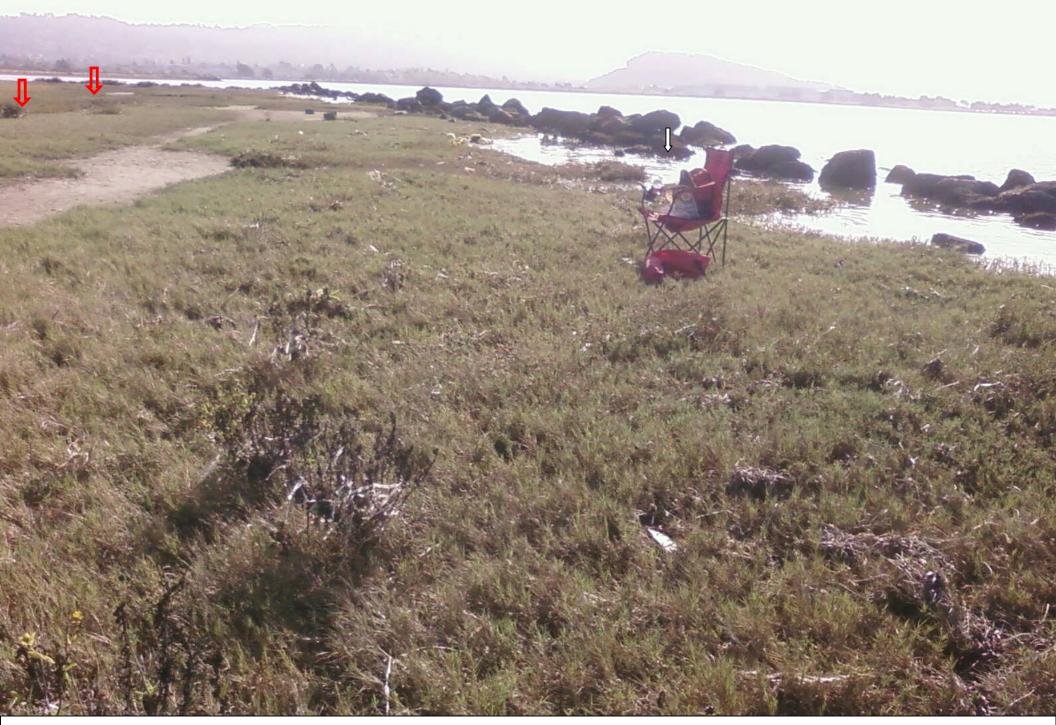
#332/10-6-10/10:13 a.m./PWL 5.86 ft/Winds SSW 2.7 – 3.8 mph. Still panning East to the SE corner. The white arrow is the reference rock from picture #331. This angle captures the slope of the terrain from the south to the north, reaching its peak in the high ridge/tall brush area (red arrows).

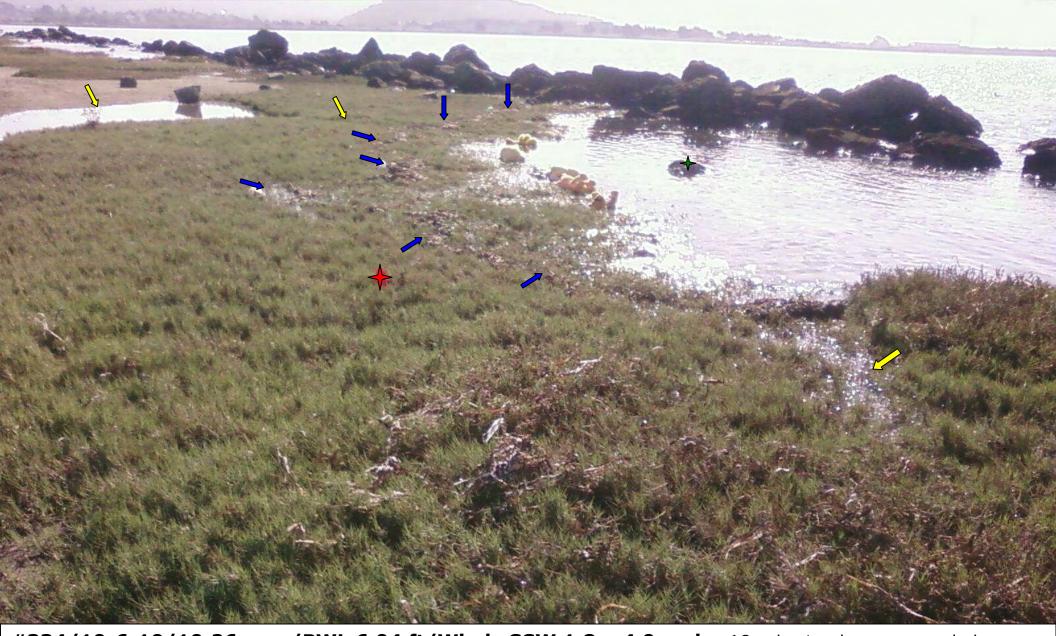
#334/10-6-10/10:26 a.m./PWL 6.04 ft/Winds SSW 1.8 – 4.0 mph. 13 minutes have passed since picture #332, and the water level has risen 2.16 inches. The 5.90 ft debris line from the 5<sup>th</sup> is obliterated by the new debris line which includes the stuffed animals, but the 6.01 debris line is still in place. The water level is now above the 5.88 ft high tide on April 13,2004, which allegedly washed baby Conner ashore. 6.05 ft is MHHW – the average of all higher high tides. Obviously the breakwater does its job protecting the mudflat against average higher high tides. The rock (green star) is now about half submerged. The yellow arrows indicate where the water is flowing between the grassy sections to fill the dirt path. The red star marks the approximate location of Conner's body.

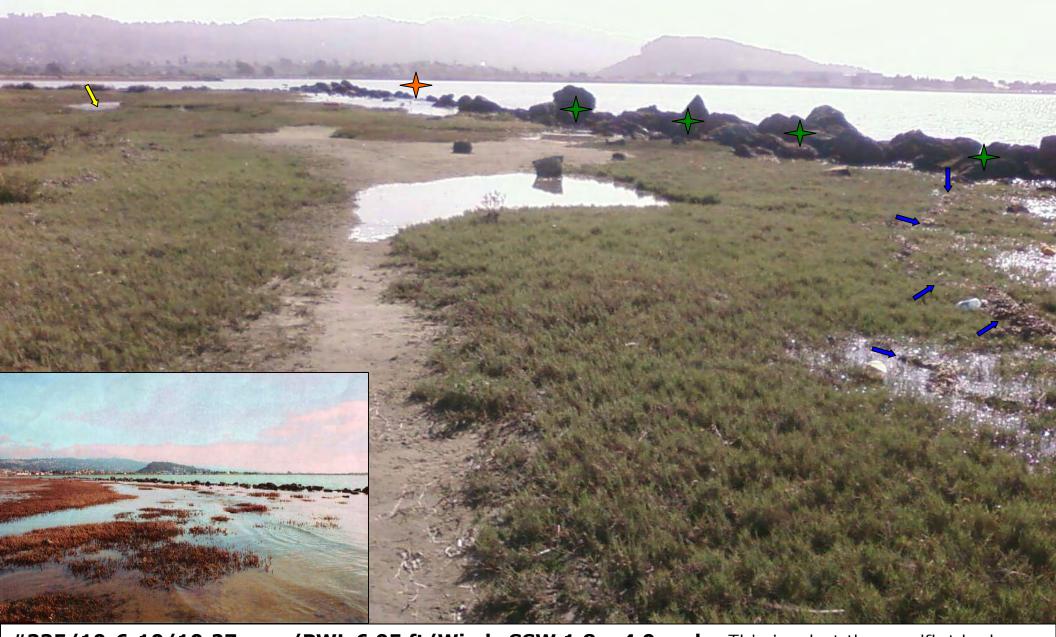
#335/10-6-10/10:27 a.m./PWL 6.05 ft/Winds SSW 1.8 – 4.0 mph. This is what the mudflat looks like in the southeastern section at MHHW with calm winds. The 6.01 debris line is still in place, but tidal pools are north of it. South winds during the 6.01 tide were a bit stronger, 5-8 mph. The yellow arrow marks a tidal pool on the dirt path from high tides on the 5<sup>th</sup>. The section of breakwater marked by the green stars has let in very little water compared to he section marked by the orange star. However, the mudflat is no where near what is depicted in People's 100 (the inset), which was pawned off on the Court as an accurate representation of the mudflat at all high tides. It doesn't even accurately represent the mudflat at MHHW, the average of all higher high tides.

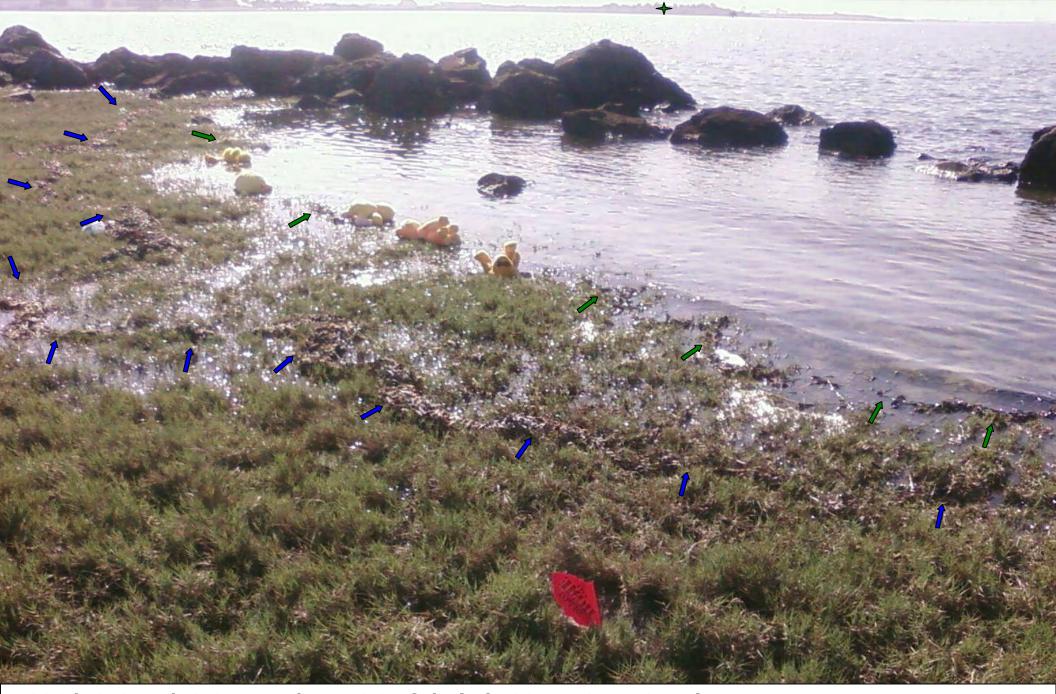
#336/10-6-10/10:27 a.m./PWL 6.05 ft/Winds SSW 1.8 – 4.0 mph. This shows the newly-forming debris line (green arrows) relative to the 6.01 debris line from the 5<sup>th</sup> (blue arrows) The extent of water coverage is well past the newly-forming debris line, and even past the 6.01 debris line in some places. Notice the irregular arc of the 6.01 debris line compared to the newly-forming line. The green star at the top marks the Albany Bulb, and the red flag at the bottom marks the approximate location of Conner's body.

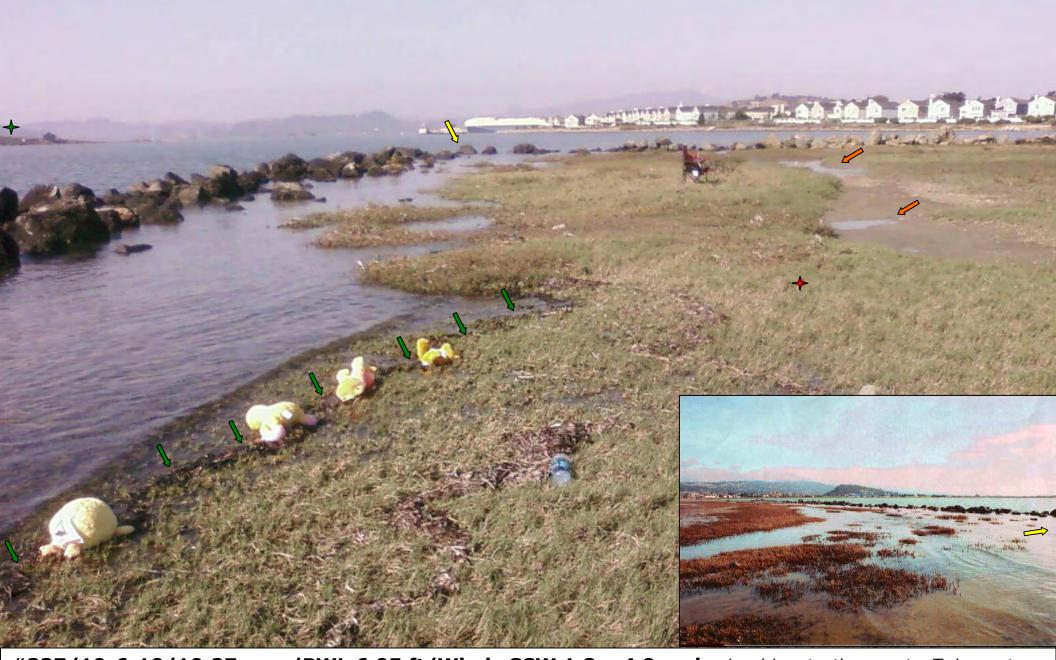
#337/10-6-10/10:27 a.m./PWL 6.05 ft/Winds SSW 1.8 – 4.0 mph. Looking to the west. Taken at the same water level as #336, but this angle shows the newly-forming debris line (green arrows) much better. The inset of People's 100 shows how much of a blatant lie it is to say that it depicts the mudflat at high tide. The orange arrows show the only water in this SW section that is from the current rising tide. 6.05 ft is not the average of all high tides, it's the average of all higher high tides. The yellow arrow in the inset points to the SW corner, also indicated in main picture by the yellow arrow. The green star marks Brooks Island, and the red star the approximate location of Conner's body.

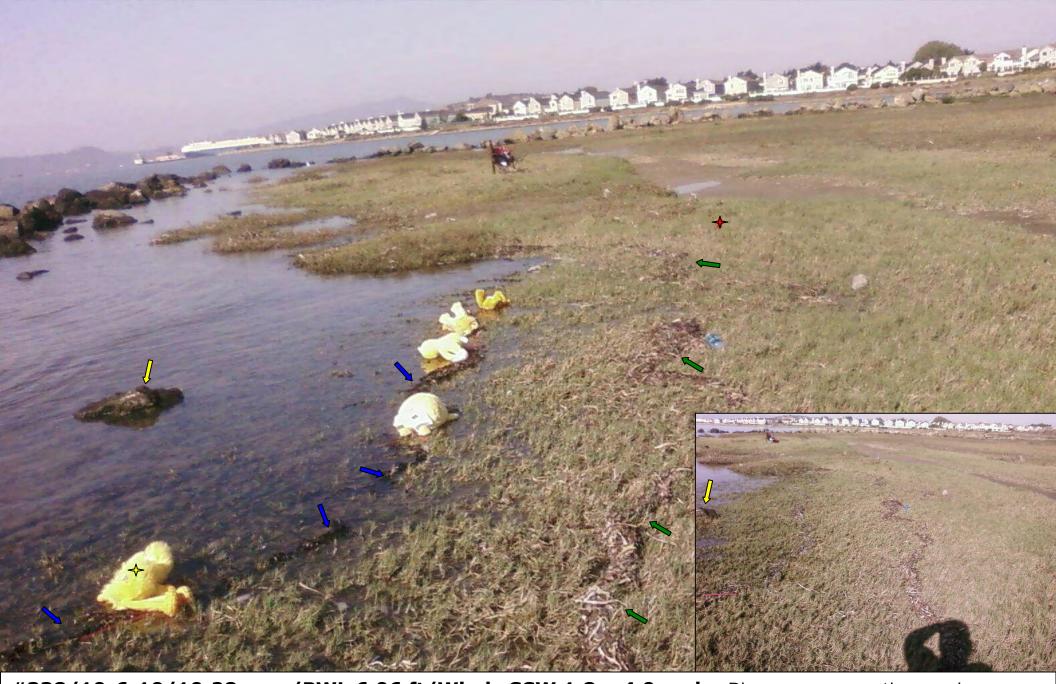
#338/10-6-10/10:28 a.m./PWL 6.06 ft/Winds SSW 1.8 – 4.0 mph. Blue arrows are the newly-forming debris line, which includes the heavier stuffed animals as well as the light debris. Green arrows show the 6.01 debris line from the 5<sup>th</sup> still intact. Red star indicates approximate location of Conner's body. Yellow arrow points to the rock that is the same rock marked by the yellow arrow in the inset, showing the effect of a 3.48 inch rise in water level (5.77->6.06). Yellow star marks the yellow bird that I threw westward to be more in the area of where Conner's body was found.

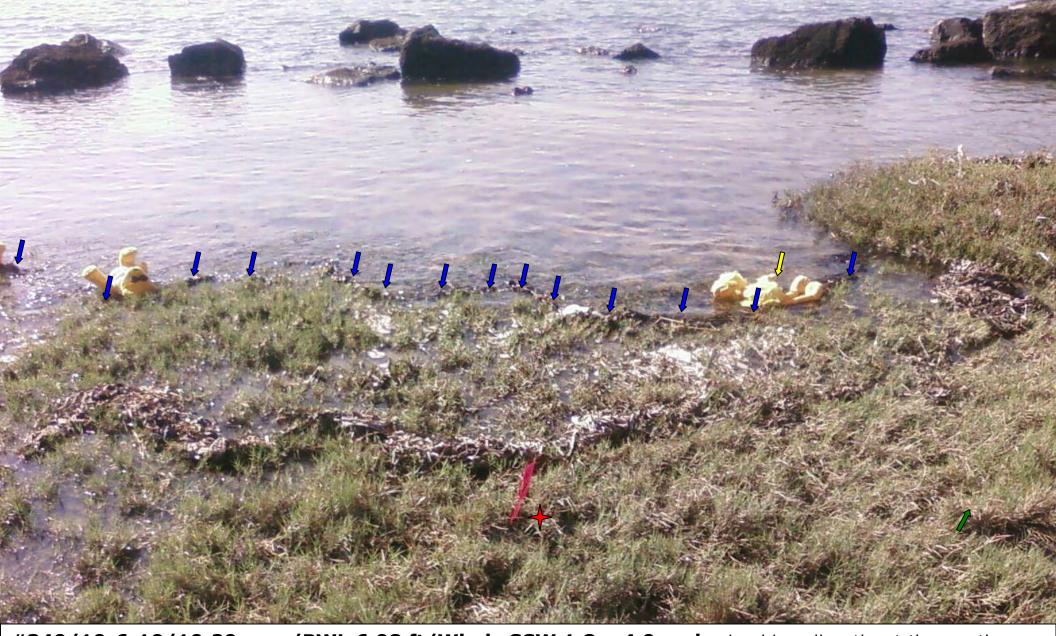
#340/10-6-10/10:29 a.m./PWL 6.08 ft/Winds SSW 1.8 – 4.0 mph. Looking directly at the south breakwater. Yellow bird (yellow arrow) has quickly caught up with the debris line from this high tide. This close-up picture shows the standing water in the grass to the left of the red flag (red star), the approximate location of Conner's body, compared to no visible standing water to its right. A baby found in the water behind the debris line (blue arrows) would not have <u>washed ashore</u>, unless it did so in a previous tide. The higher high tide on Apr 13, 2003 was 5.88 ft, and the higher high tide on the 12<sup>th</sup> was only 5.77 ft. Washing ashore during the higher high tide on the 12<sup>th</sup> would mean being on the shore more than 30 hours, an open prey for birds and insects. No birds or insects bothered Baby Conner.

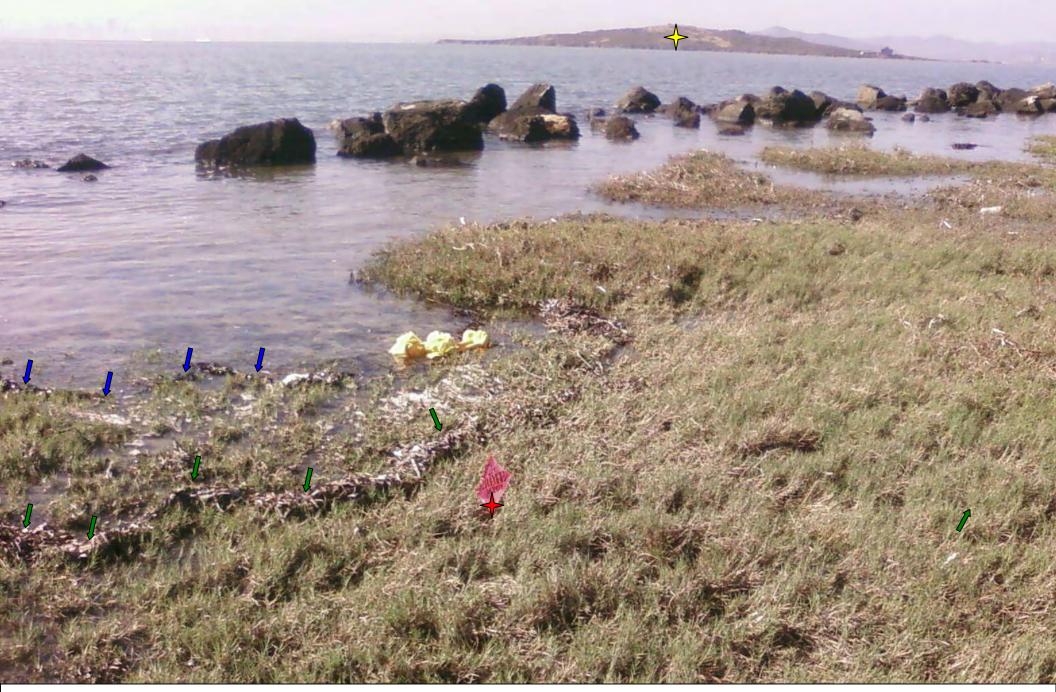
#341/10-6-10/10:31 a.m./PWL 6.10 ft/Winds SSW 2 – 3.6 mph. Looking towards Brooks Island (yellow star). Blue arrows mark the debris line from this high tide, and the green lines from the 6.01 ft high tide from the 5<sup>th</sup>. Differences in wind speed explains why the current debris line is still in front/south of the 6.01 debris line. Wind speeds during the 6.01 high tide were 5-10 mph. Red flag/star marks the approximate location of Conner's body.

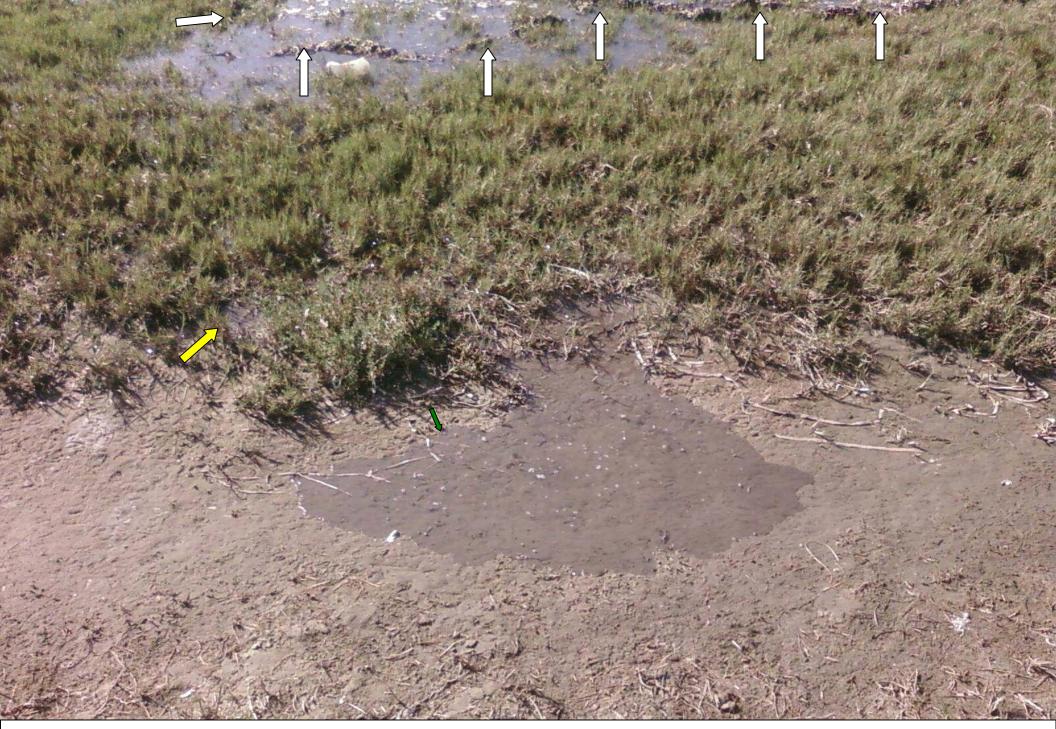
#342/10-6-10/10:32 a.m./PWL 6.11 ft/Winds SSW 2 – 3.6 mph. The water is beginning to seep onto the dirt path. White arrows point to a still intact 6.01 debris line from the 5<sup>th</sup>. This portion of the 6.01 debris line had the furthest reach north. The yellow arrow points to water that has almost reached the path.

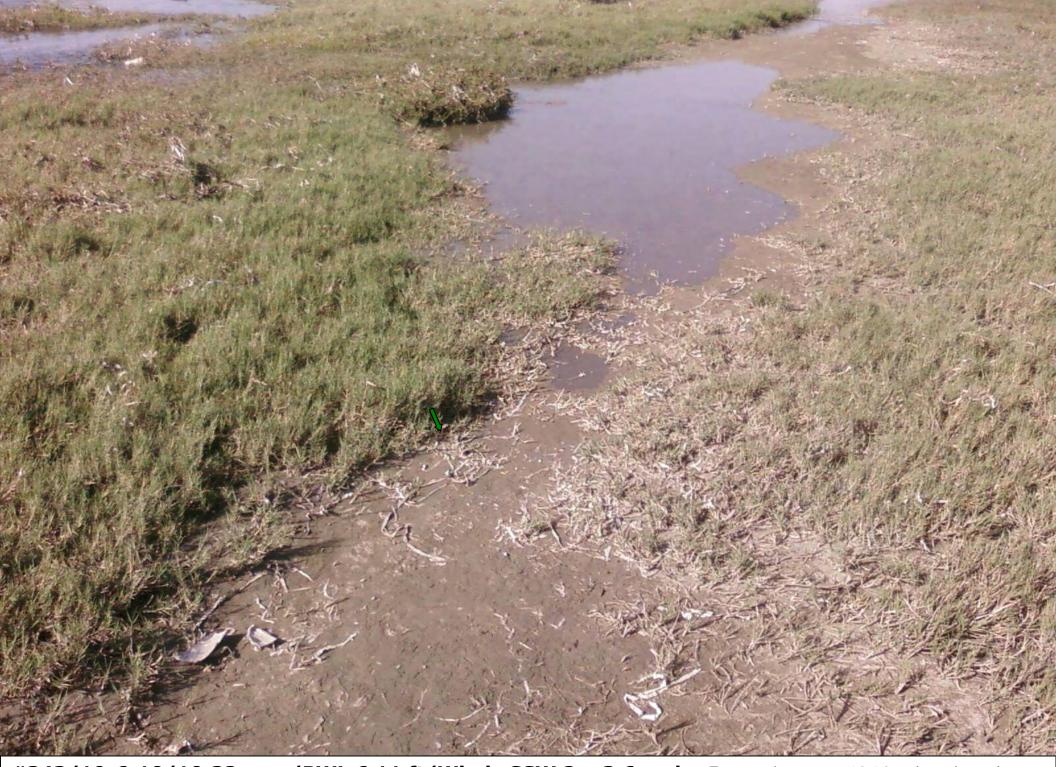
#343/10-6-10/10:32 a.m./PWL 6.11 ft/Winds SSW 2 - 3.6 mph. Exact time as #342, showing the dirt path to the west, which is not yet filled with water.

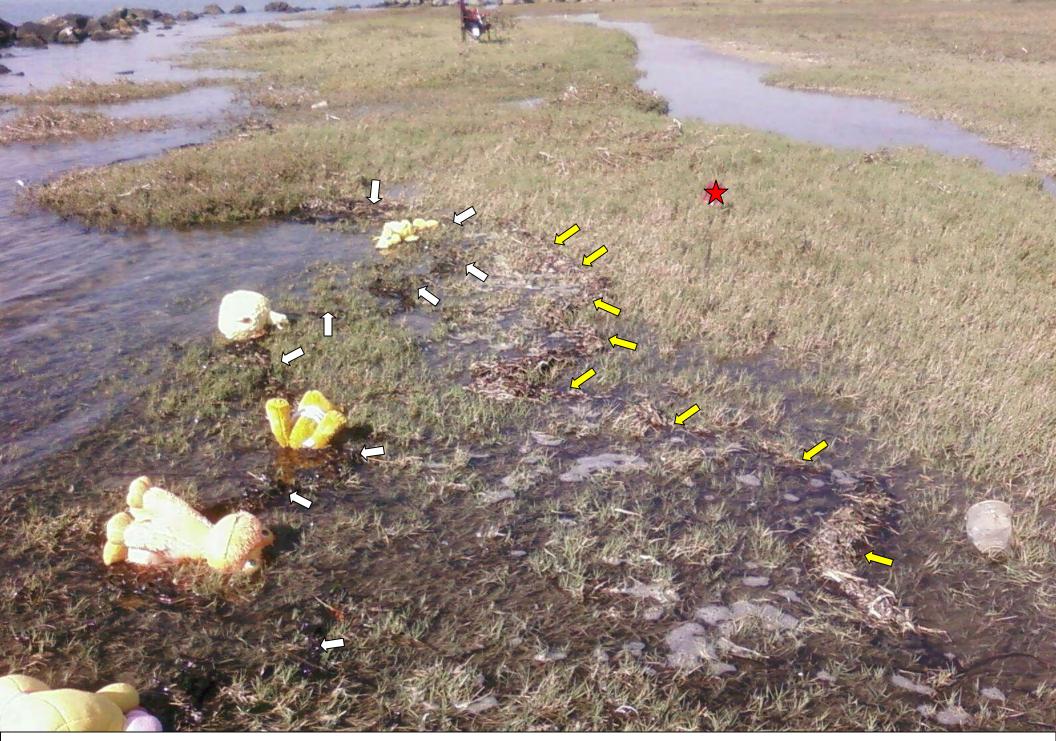
#345/10-6-10/10:34 a.m./PWL 6.13 ft/Winds SSW 2 – 3.6 mph. Close-up of the 2 debris lines – the one from this current, still-rising high tide (white arrows) and the 6.01 ft high tide from the 5<sup>th</sup> (yellow arrows). The red star marks the most probable location of Conner's body. All 5 stuffed animals are visible.

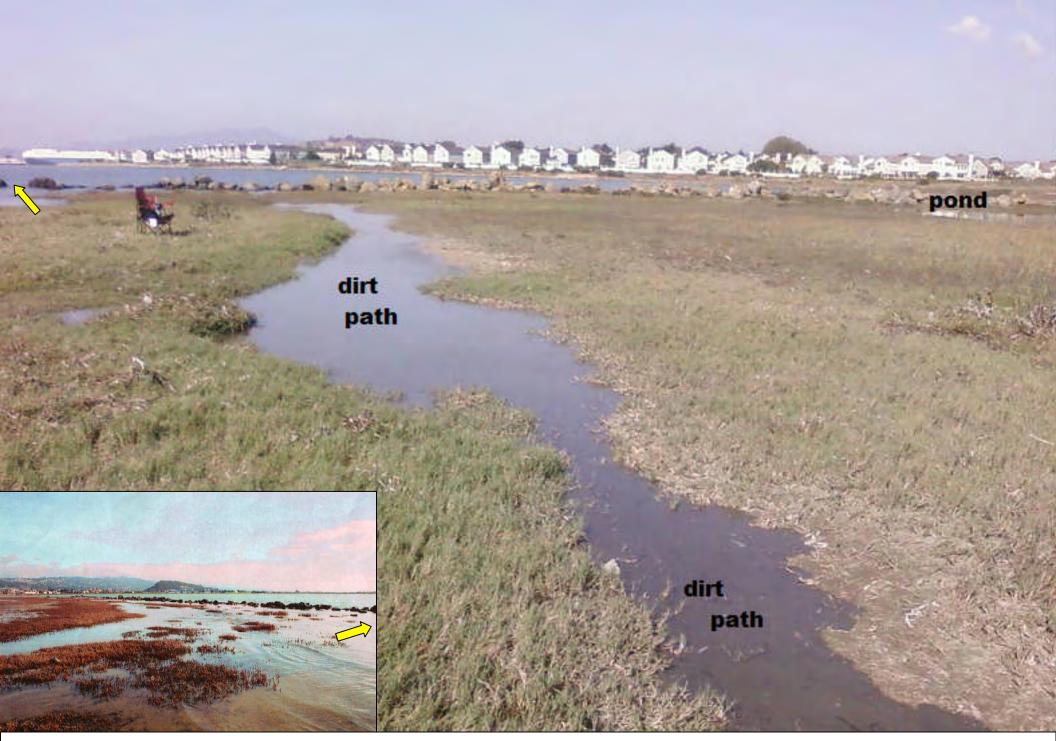
#347/10-6-10/10:34 a.m./PWL 6.13 ft/Winds SSW 2 – 3.6 mph. More evidence that the mudflat does not look like People's 100 (inset) at high tide. 6.13 ft is 3" higher than 5.88 (high tide on April 13, 2003) and an inch higher than 6.05, MHHW. Yellow arrows point towards the SW corner, for perspective.

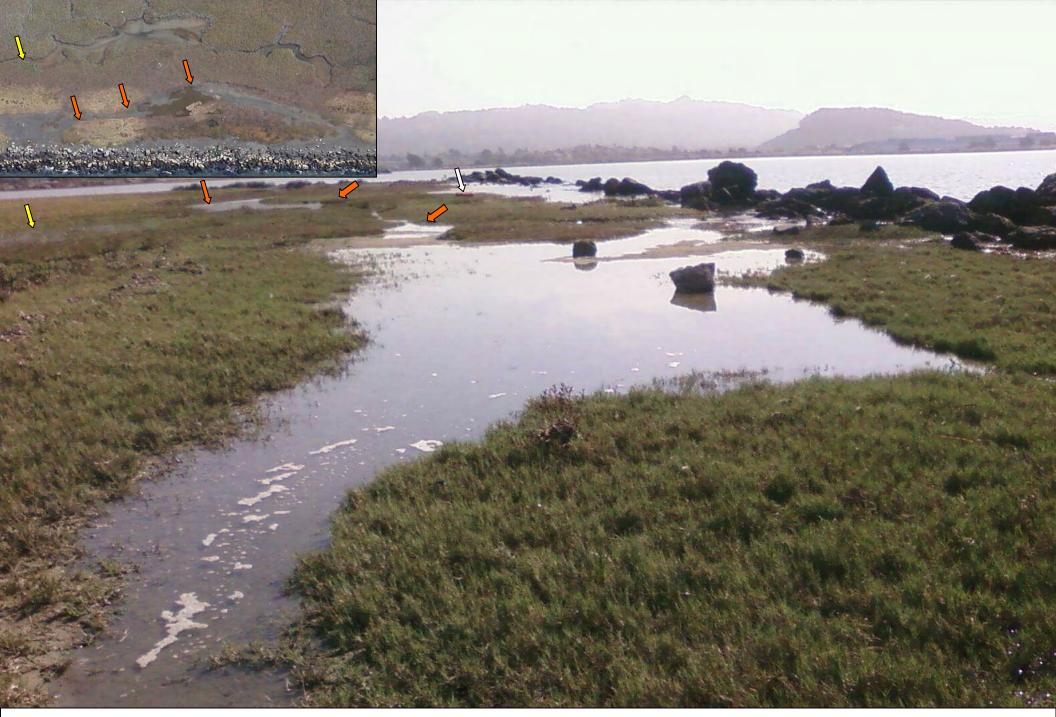
#348/10-6-10/10:34 a.m./PWL 6.13 ft/Winds SSW 2 – 3.6 mph. Looking towards the SE corner. The inset is an aerial view of the same section of the mudflat. Orange arrows indicate the dirt path, and the yellow arrows indicate the water from one of the creeks north of the dirt path. The inset shows other creeks and ponds, too. White arrow points to the very large Styrofoam object noted in earlier pictures.
