## **Conner Recovery Site Field Trip**

## October 6, 2010

The purpose of this field trip was to:

- 1. Observe whether People's 100 accurately represents the Conner Recovery site at high tide.
- 2. Observe what happens to debris as the tide recedes.

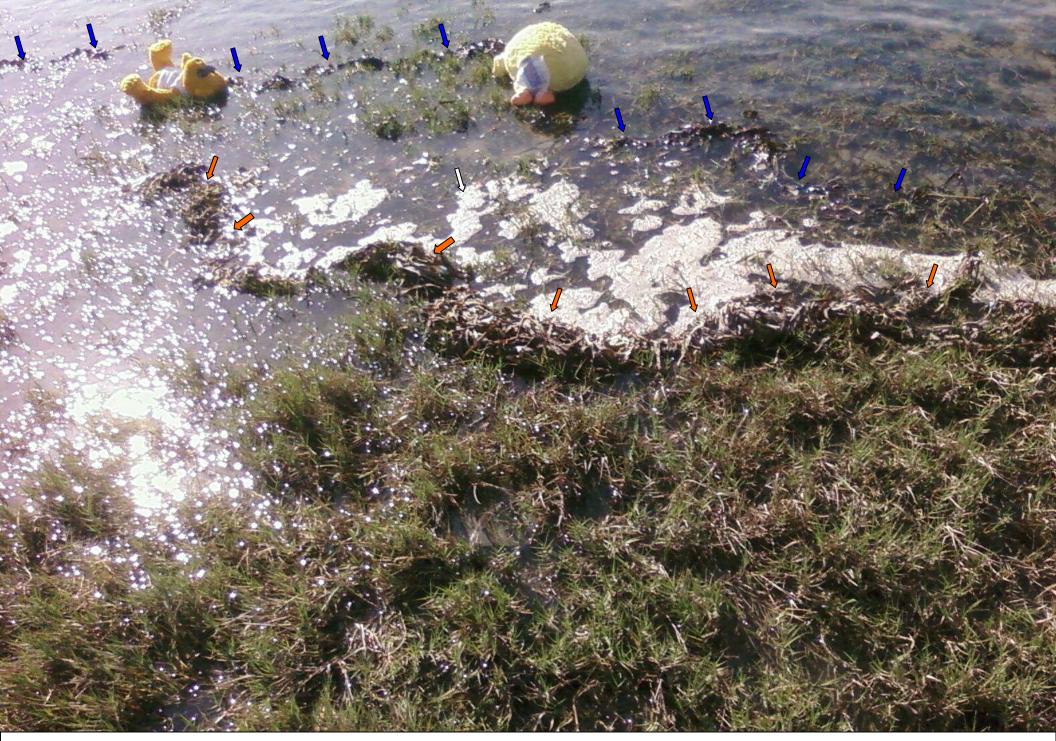
#349/10-6-10/10:35 a.m./PWL 6.14 ft/Winds SSW 2 – 3.6 mph. Close-up of the two debris lines – one from this rising tide (blue arrows) and the one from the 6.01 tide on the 5<sup>th</sup> (orange arrows). Lots of standing water north of the debris lines. Conner was found in a tidal pool north of the debris line.

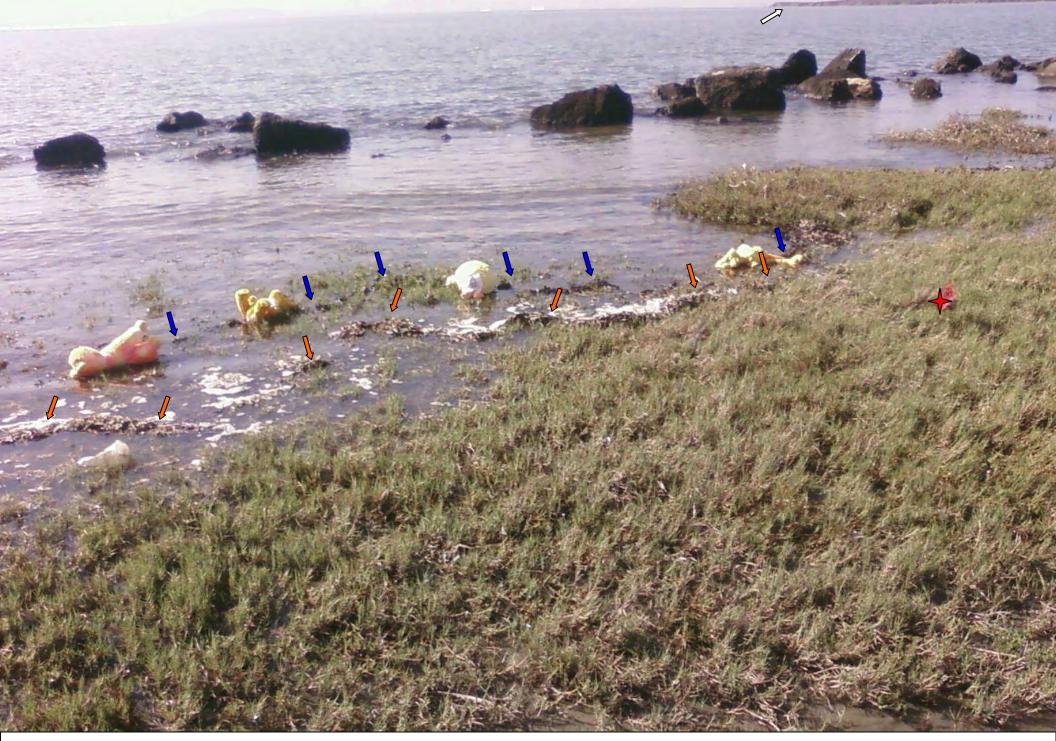
#350/10-6-10/10:36 a.m./PWL 6.15 ft/Winds SSW 1.3 – 2.2 mph. The debris line from today's rising tide (blue arrows) is almost merged with the 6.01 ft debris line from the 5<sup>th</sup> (orange arrows). White arrow points to Brooks Island. Red star marks approximate location of Conner's body.

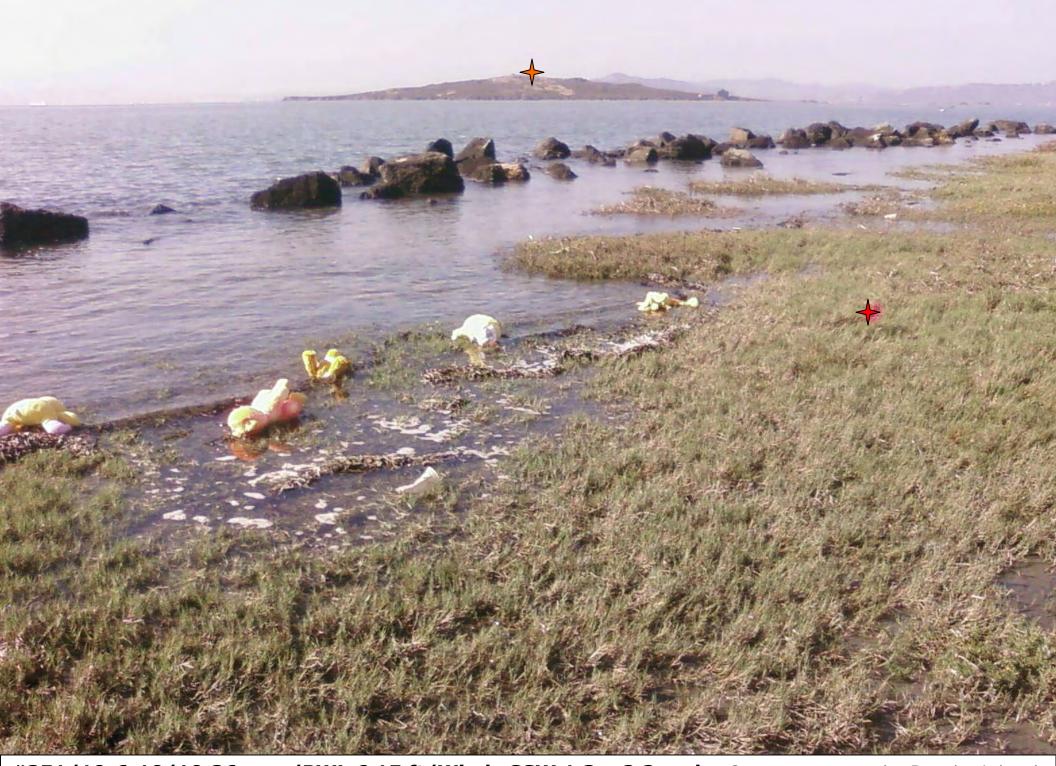
#351/10-6-10/10:36 a.m./PWL 6.15 ft/Winds SSW 1.3 – 2.2 mph. Orange star marks Brooks Island. Red star marks approximate location of Conner's body.

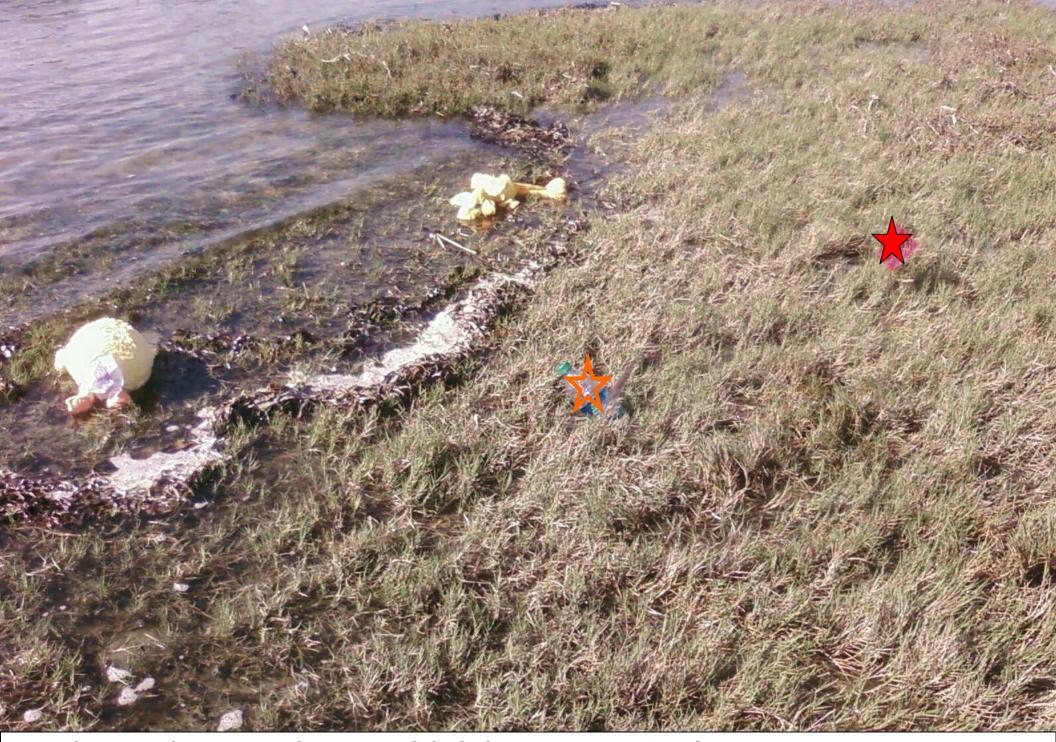
#352/10-6-10/10:37 a.m./PWL 6.16 ft/Winds SSW 1.3 – 2.2 mph. I put the water bottle up against the rock (orange star) that marked the alternate location for Conner's body (manual measurement). Red star marks most probable location for Conner's body based on laser measurements.

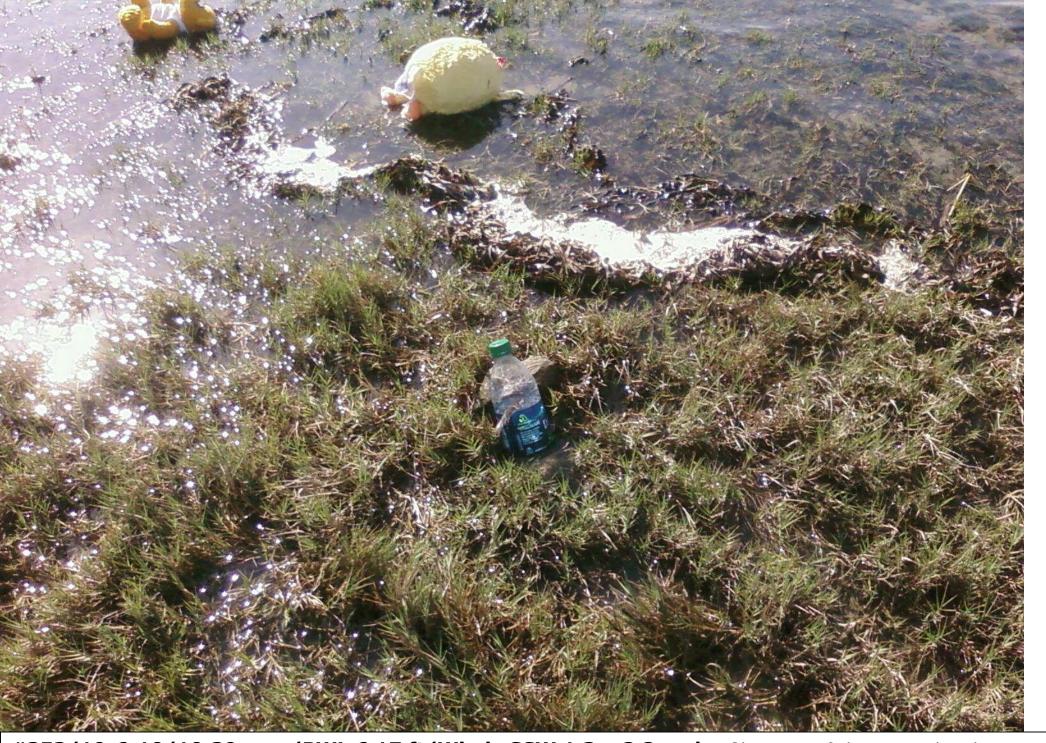
#353/10-6-10/10:39 a.m./PWL 6.17 ft/Winds SSW 1.3 – 2.2 mph. Close up of the water bottle leaning against the rock placed after manually measuring 173 ft from the west breakwater and 24 feet from the south breakwater on August 3, 2009. Lots of standing water north of the debris lines.

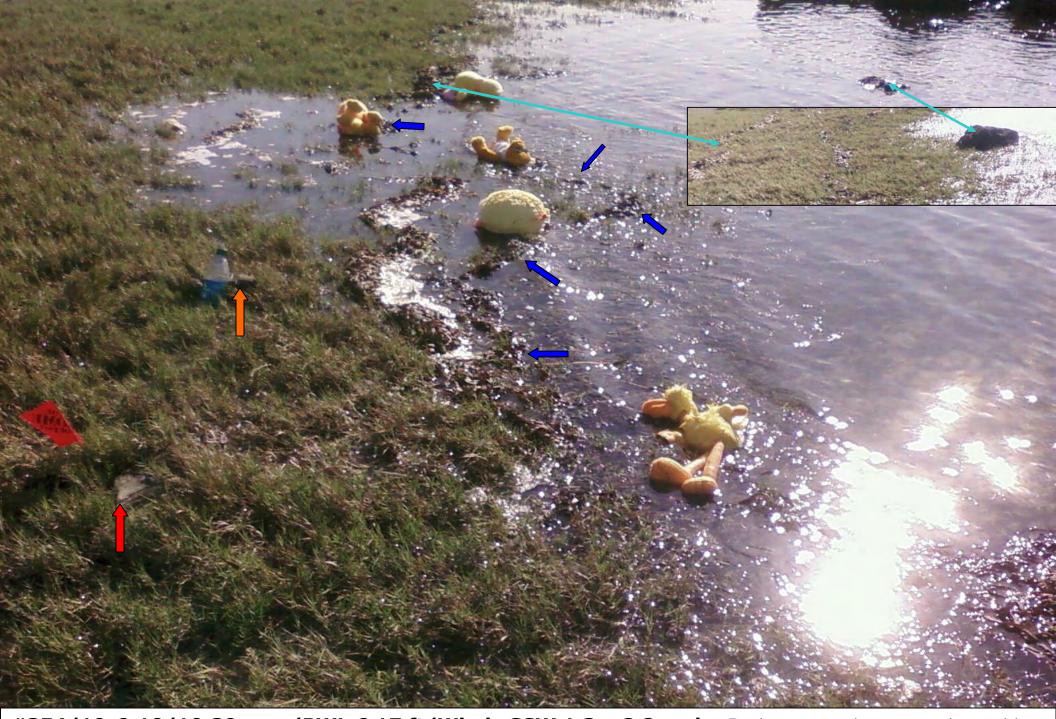
#354/10-6-10/10:39 a.m./PWL 6.17 ft/Winds SSW 1.3 – 2.2 mph. Red arrow points to rock marking laser measurement of Conner's location; orange arrow to rock marking manual measurement. Blue arrows marks the debris line for this rising tide. Inset shows the rock from #320 taken at 10:07, PWL 5.78 – water level difference is 4.68 inches.

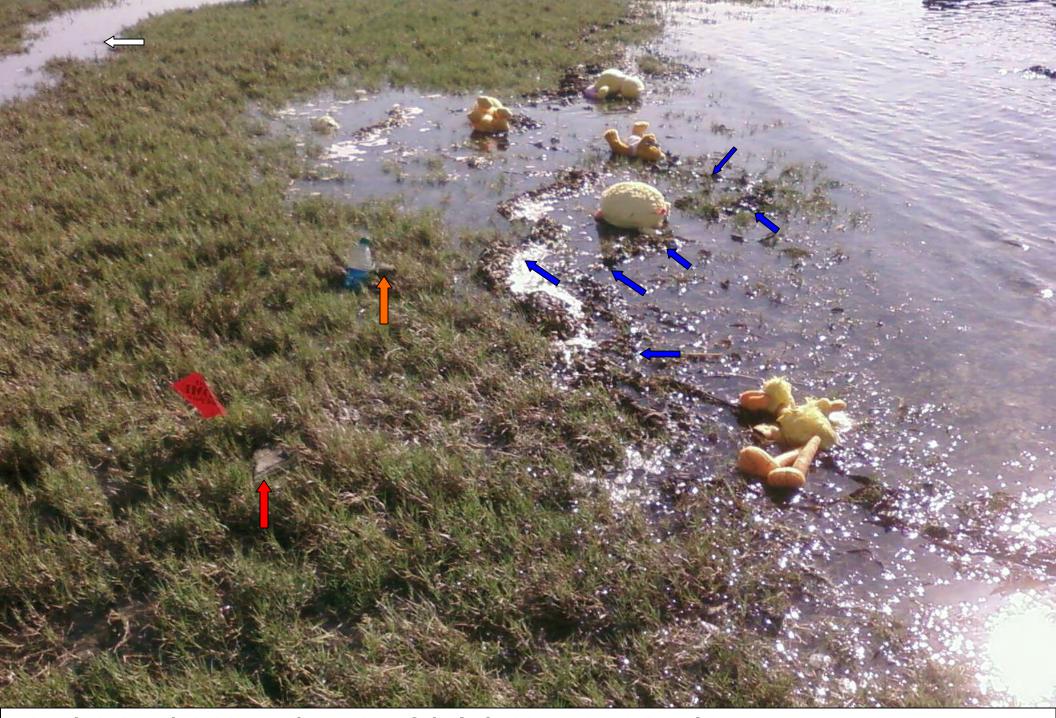
#355/10-6-10/10:39 a.m./PWL 6.17 ft/Winds SSW 1.3 – 2.2 mph. Red arrow points to rock marking laser measurement of Conner's location; orange arrow to rock marking manual measurement. Blue arrows mark the debris line for this rising tide. White arrow points to dirt path. The standing water around the red arrow rock is visible.

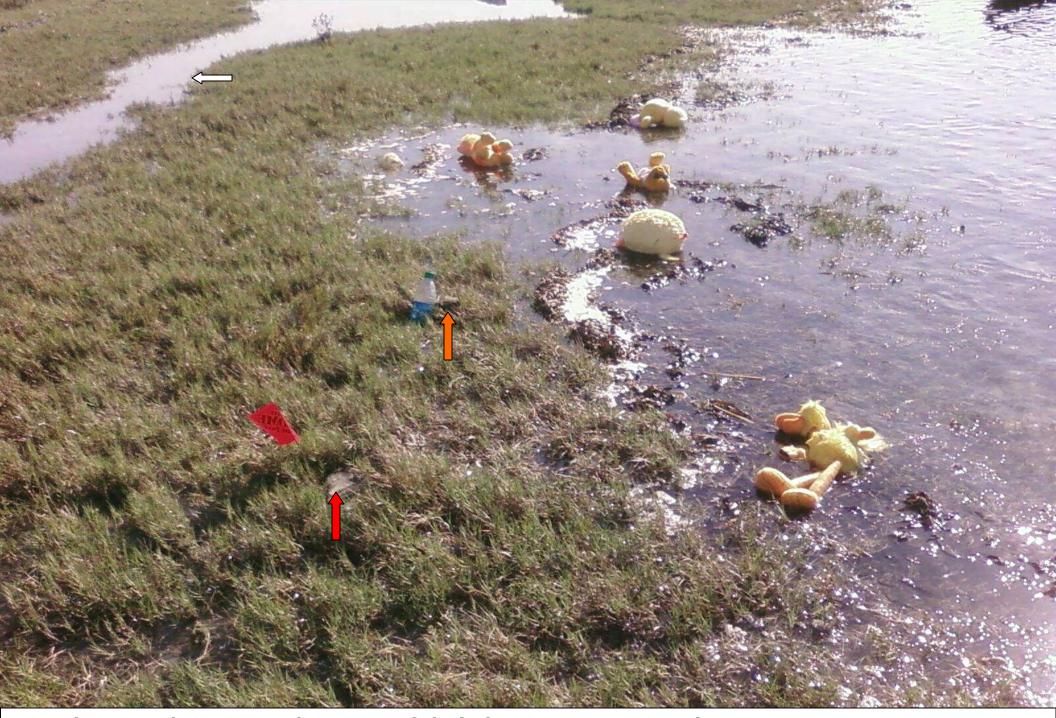
#356/10-6-10/10:40 a.m./PWL 6.18 ft/Winds SSW 1.3 – 2.2 mph. Red arrow points to rock marking laser measurement of Conner's location; orange arrow to rock marking manual measurement. Blue arrows mark the debris line for this rising tide. White arrow points to dirt path. The standing water around the red arrow rock is visible.

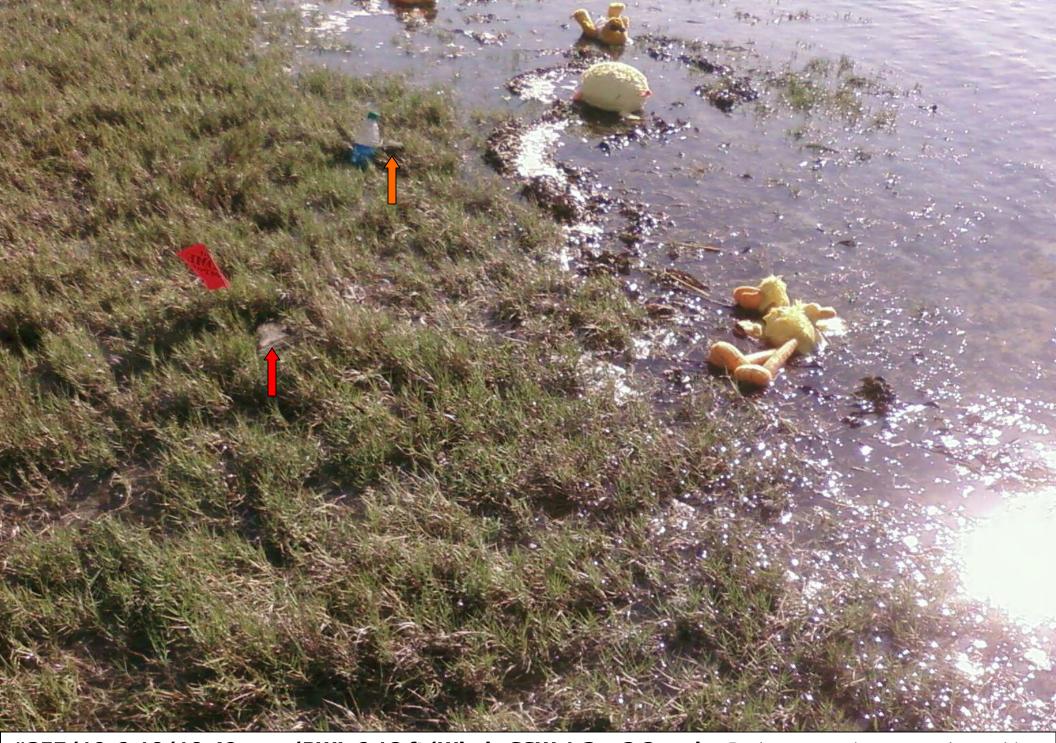
#357/10-6-10/10:40 a.m./PWL 6.18 ft/Winds SSW 1.3 – 2.2 mph. Red arrow points to rock marking laser measurement of Conner's location; orange arrow to rock marking manual measurement. The standing water around the red arrow rock is visible.

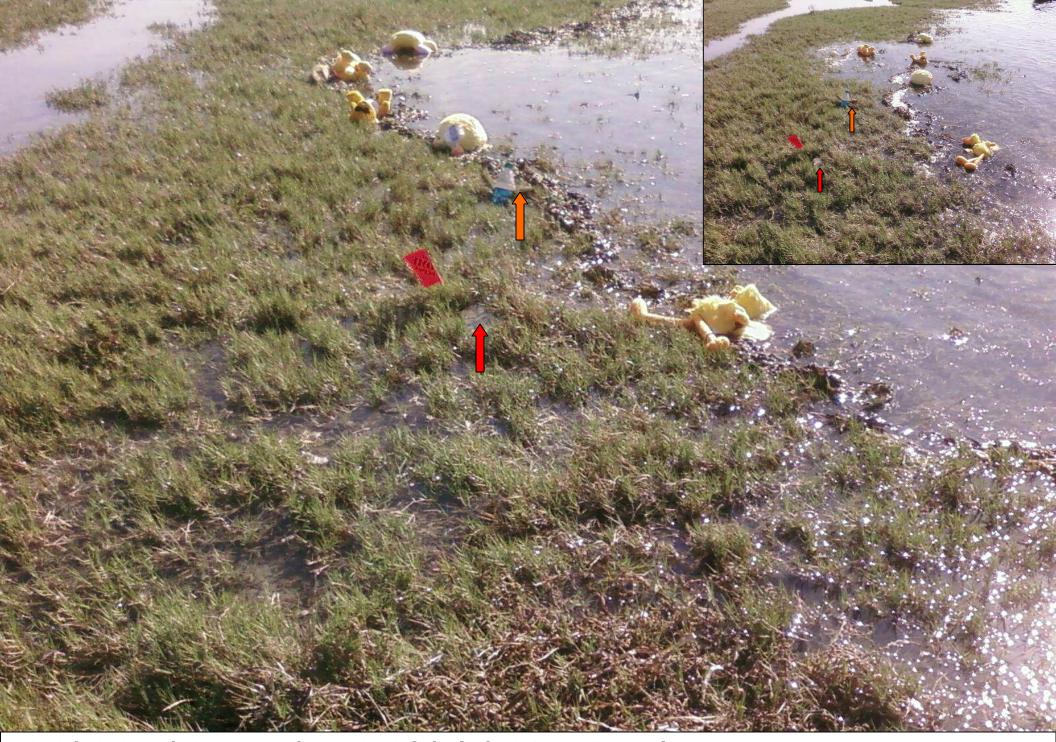
#358/10-6-10/10:51 a.m./PWL 6.28 ft/Winds S 0.7 – 3.4 mph. Red arrow points to rock marking laser measurement of Conner's location; orange arrow to rock marking manual measurement. It's been 11 minutes and a 1.2 inch rise in water level since #356 (inset).

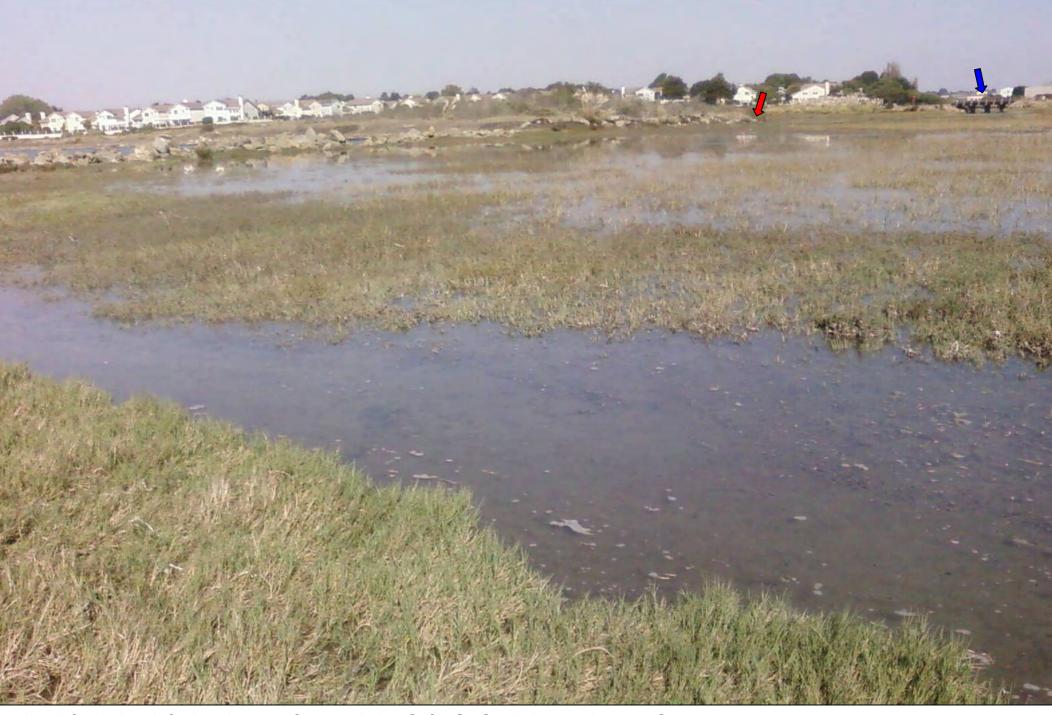
#359/10-6-10/10:52 a.m./PWL 6.28 ft/Winds S 0.7 – 3.4 mph. Large pond of water in the northwest section of the mudflat. Red arrow marks access from the beach; blue arrow marks the Bay Trail bridge. 6.28 ft is 2.76 inches above MHHW, and 4.8 inches above the 5.88 ft high tide on April 13, 2003. The mudflat is now looking like People's 100.

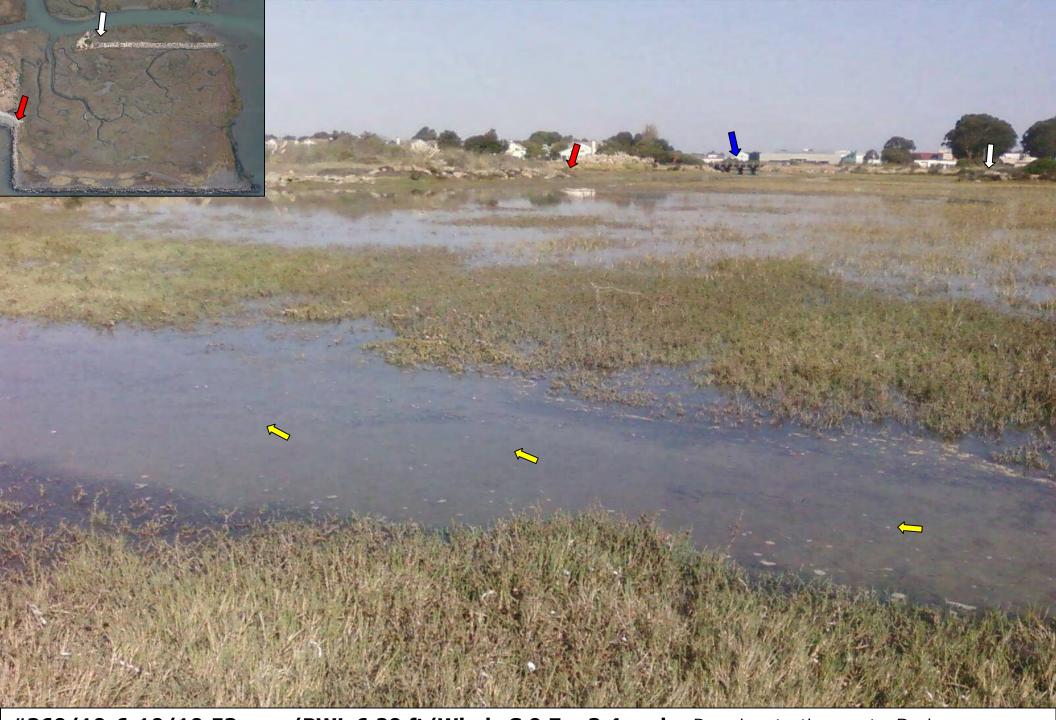
#360/10-6-10/10:53 a.m./PWL 6.29 ft/Winds S 0.7 – 3.4 mph. Panning to the east. Red arrow marks access from the beach; blue arrow marks the Bay Trail bridge; white arrow marks north breakwater. The water north of the dirt path (yellow arrows) comes from the Meeker Slough, which feeds all of the creeks and ponds (see inset)

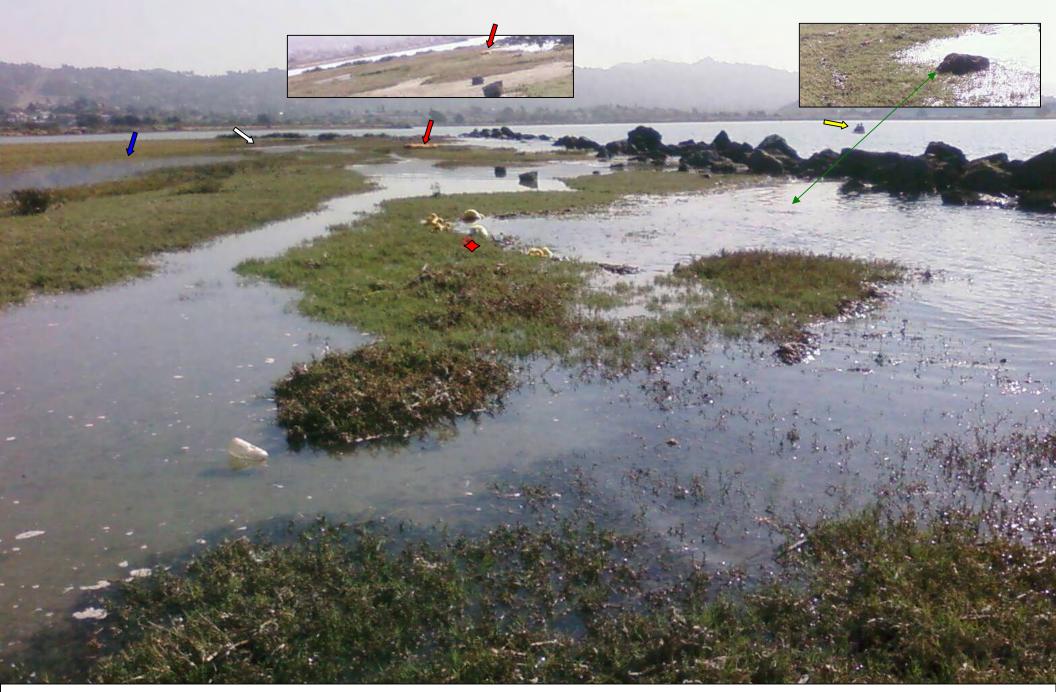
#363/10-6-10/10:55 a.m./PWL 6.30 ft/Winds W 0.7 - 2.2 mph. A good view of the amount of water in the SE section of the mudflat. Red arrow points to large Styrofoam object (inset #320), which has moved. The rock in #320 (inset) is barely visible. Blue arrow is water from the ponds/creeks. White arrow is the dirt path. Yellow arrow points to a boat (I don't know which direction it came from). Red star is approximate location of Conner's body.

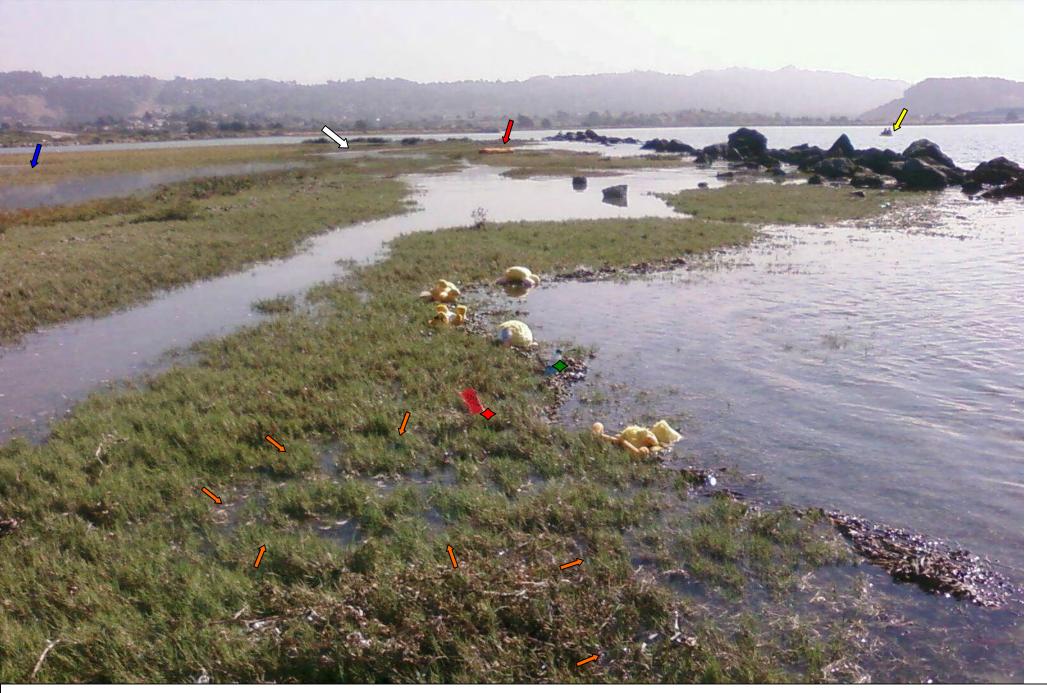
#365/10-6-10/10:55 a.m./PWL 6.30 ft/Winds W 0.7 - 2.2 mph. Shows more of the water on the North Eastern part of the mudflat (blue arrow). White arrow is the dirt path. Red arrow points to large Styrofoam object; yellow arrow to a boat. Red star marks most probable location (measured by laser) for Conner's body; green star is an alternate location (measured manually). A baby found in the tidal pools marked by the orange arrows would not have **washed ashore**.

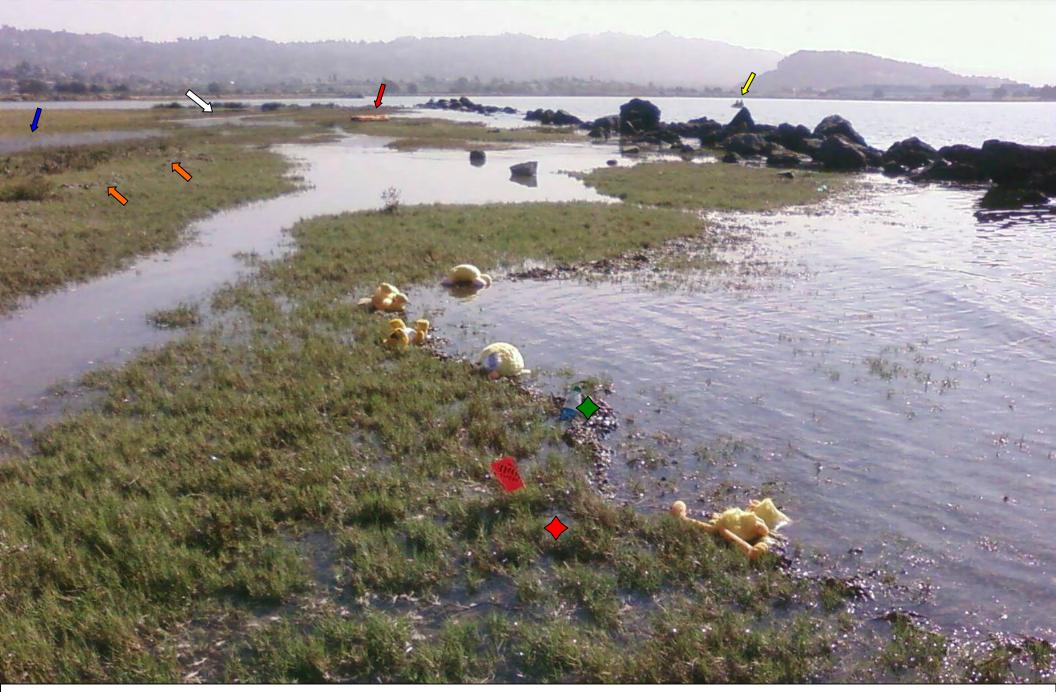
#366/10-6-10/10:56 a.m./PWL 6.31 ft/Winds W 0.7 - 2.2 mph. Red arrow points to large Styrofoam object; yellow arrow to a boat. Red star marks the rock which is the most probable location (measured by laser) for Conner's body; green star is an alternate location (measured manually). Boat (yellow arrow); large styrofoam object (red arrow); dirt path (white arrow); water from pond/creeks (blue arrow); remnants of a debris line from a previous very high tide (orange arrows).

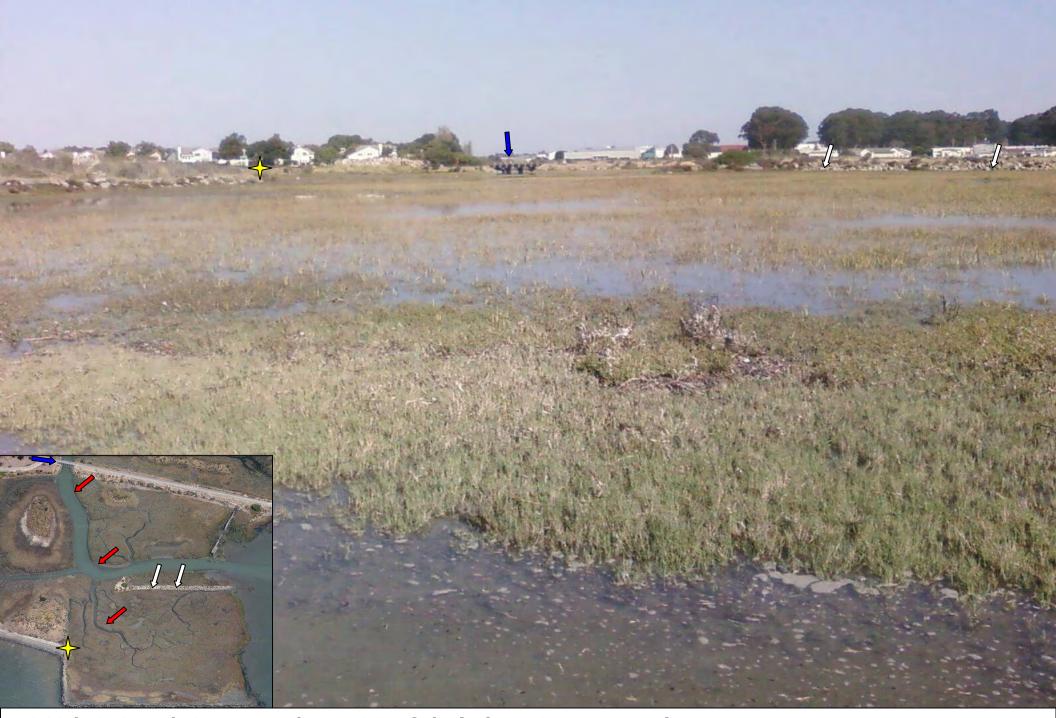
#368/10-6-10/10:57 a.m./PWL 6.31 ft/Winds W 0.7 - 2.2 mph. Northwest section of the mudflat. Aerial inset shows the ponds and creeks in this part of the mudflat which fill with water from Meeker's slough (red arrows). Blue arrows mark the Bay Trail bridge, yellow stars mark the access to the mudflat from the beach, and white arrows mark north breakwater.

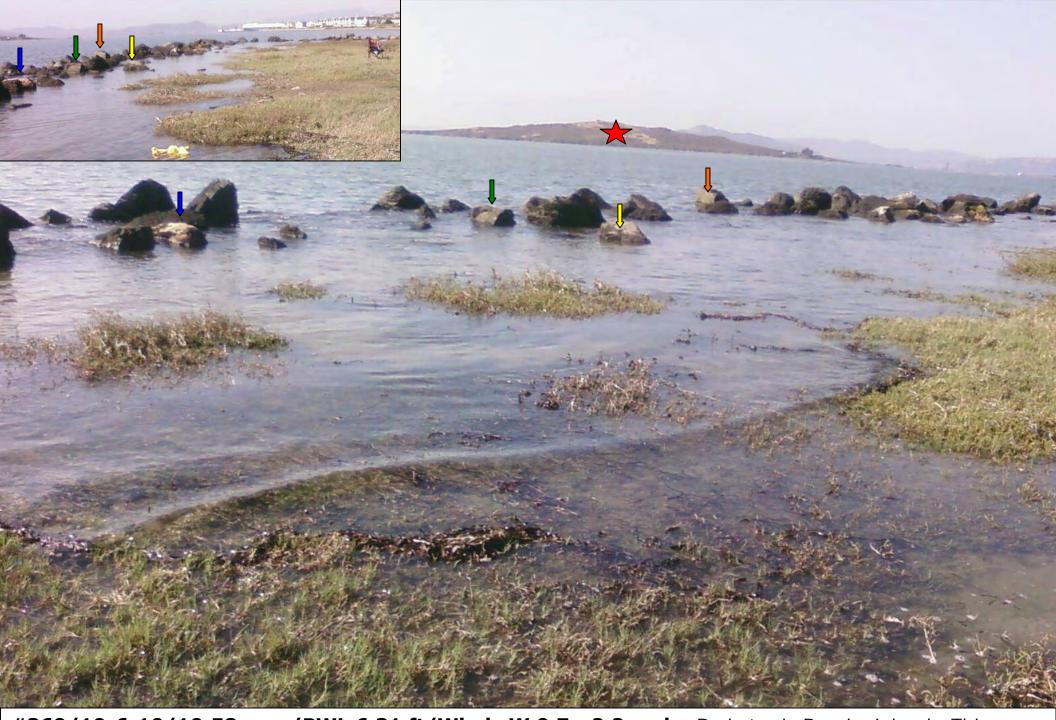
#369/10-6-10/10:58 a.m./PWL 6.31 ft/Winds W 0.7 - 2.2 mph. Red star is Brooks Island. This section of grass and breakwater is just to the west of the Conner location. The colored arrows in the picture are matched with the inset, taken at PWL 6.06 ft, just 1/10 of an inch above MHHW and 3 inches below the current PWL of 6.31.

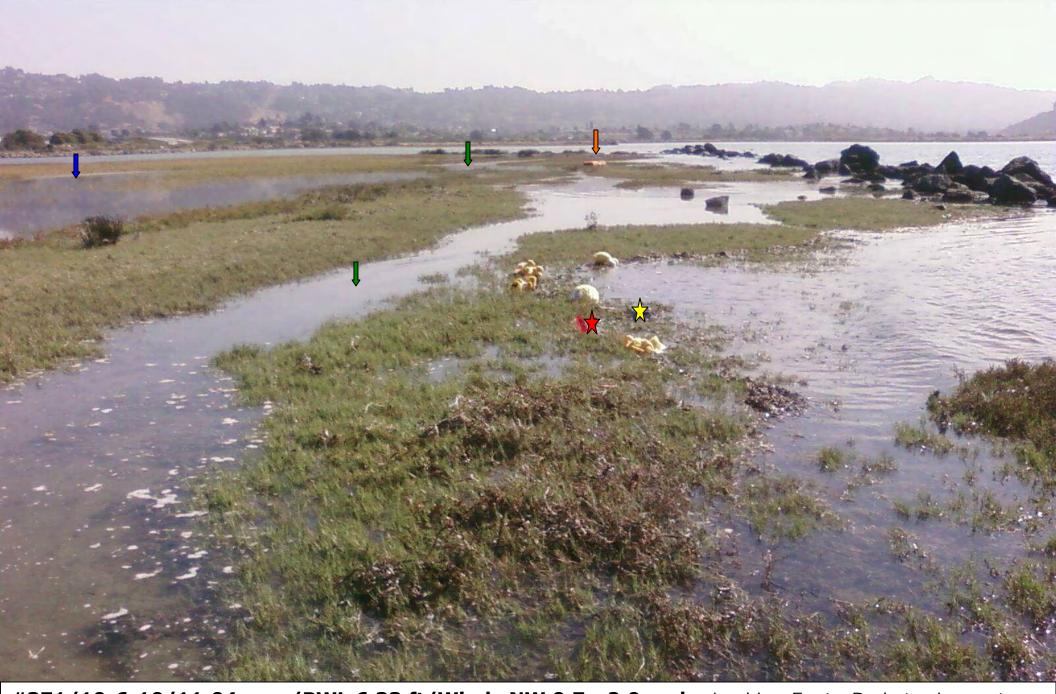
#371/10-6-10/11:04 a.m./PWL 6.33 ft/Winds NW 0.7 - 2.0 mph. Looking East. Red star is most probable location of Conner's body (measured by laser); yellow star is alternate location (measured manually). Blue arrow is water from the Northeast section; green arrows mark dirt path; orange arrow marks large Styrofoam object. Grass sections are very saturated well past the debris line. A baby found north of the debris line would not have gotten there by washing ashore.

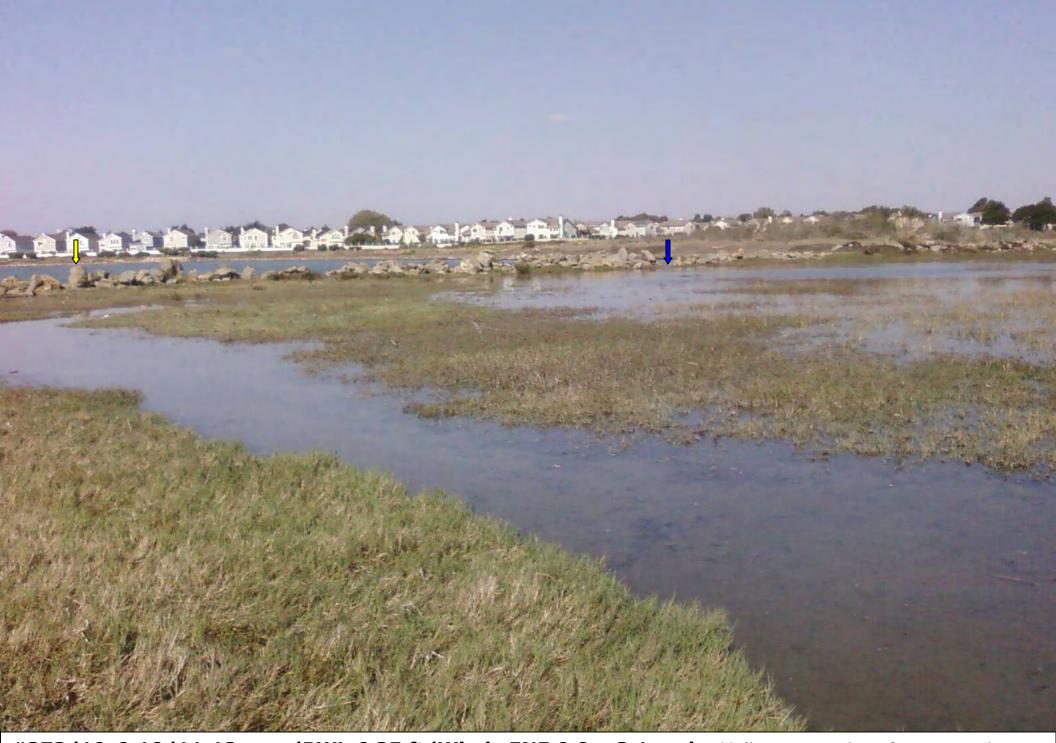
#373/10-6-10/11:12 a.m./PWL 6.35 ft/Winds ENE 0.9 – 3.1 mph. Yellow arrow is reference point from #372; blue arrow is reference point for #374. This high tide has peaked according to NOAA Richmond's preliminary data.

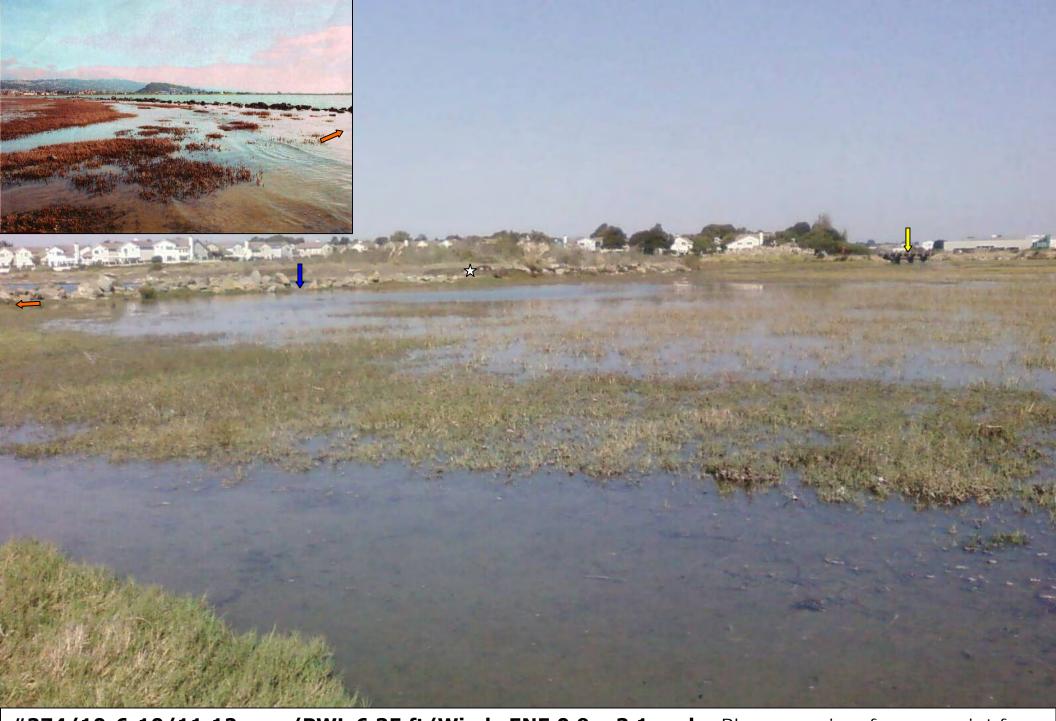
#374/10-6-10/11:12 a.m./PWL 6.35 ft/Winds ENE 0.9 – 3.1 mph. Blue arrow is reference point from #373; yellow arrow (Bay Trail bridge) is reference point for #375. Inset is People's 100, whose tide peaked at 6.39 ft, less than ½ inch higher than this PWL high tide. Orange arrows point to SW corner. White star depicts position from where People's 100 was taken.

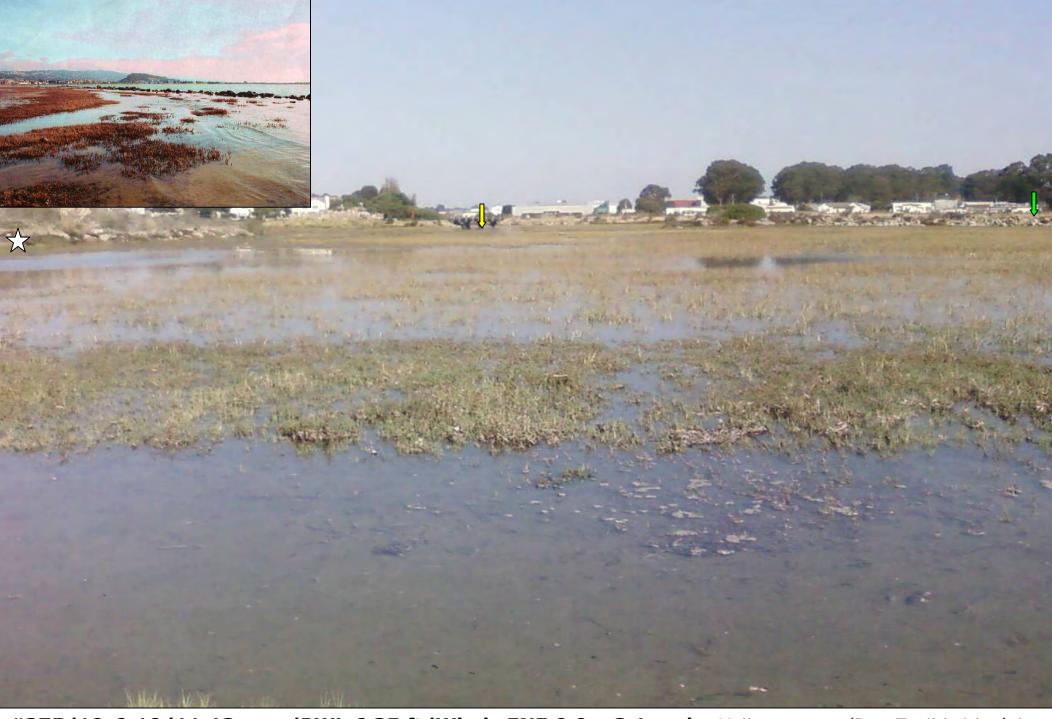
#375/10-6-10/11:13 a.m./PWL 6.35 ft/Winds ENE 0.9 – 3.1 mph. Yellow arrow (Bay Trail bridge) is reference point from #374; green arrow is reference point for #376. Inset is People's 100, whose tide peaked at 6.39 ft, less than ½ inch higher than this PWL high tide. White star depicts position from where People's 100 was taken.

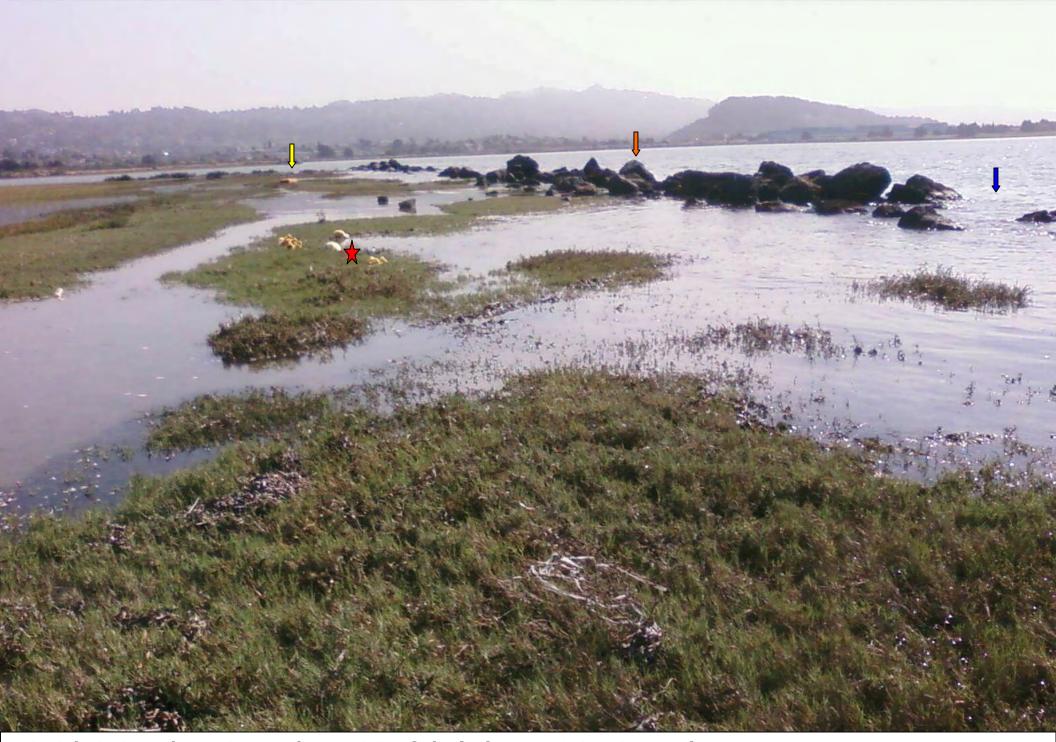
#378/10-6-10/11:13 a.m./PWL 6.35 ft/Winds ENE 0.9 – 3.1 mph. Blue arrow (SE corner) is reference point from #377; orange arrow (south breakwater) is reference point for #379. Yellow arrow points to large styrofoam object. Red star is approximate location of Conner's body.

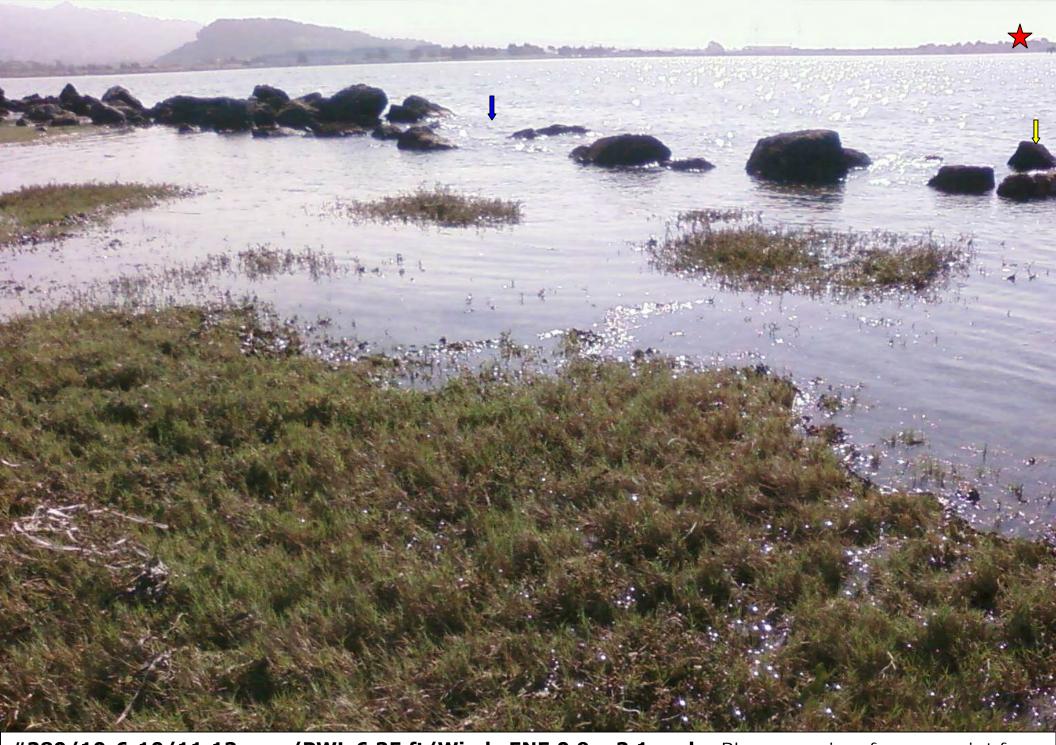
#379/10-6-10/11:13 a.m./PWL 6.35 ft/Winds ENE 0.9 – 3.1 mph. Orange arrow is reference point from #378; blue arrow is reference point for #380. Yellow arrow points to large styrofoam object. Red star is approximate location of Conner's body.

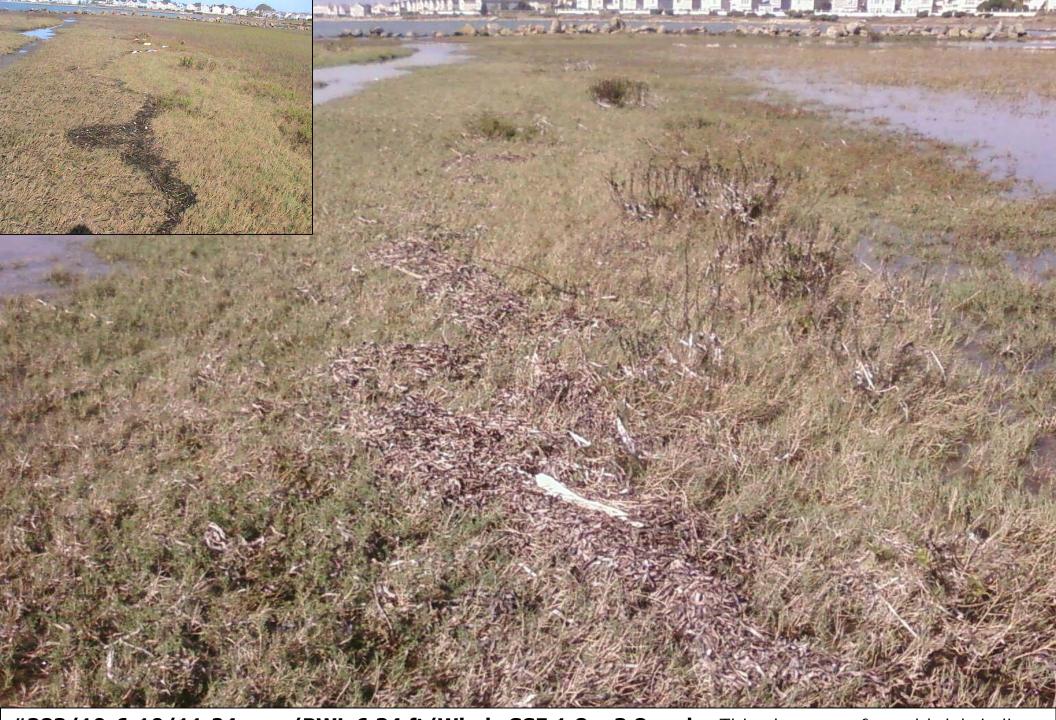
#382/10-6-10/11:23 a.m./PWL 6.34 ft/Winds ENE 0.9 – 3.1 mph. This close-up shows an old debris line formed along the high ridge/tall brush area. Yellow arrow is north of this ridge, and blue arrows mark the dirt path. The 6.49 ft (NOAA verified) tide on August 15, 2009 laid down a well-defined debris line, as captured on film the morning of August 16, 2009 (inset). Winds were 14-20 mph (UC Berkeley). #382 is facing East and the inset is facing West.

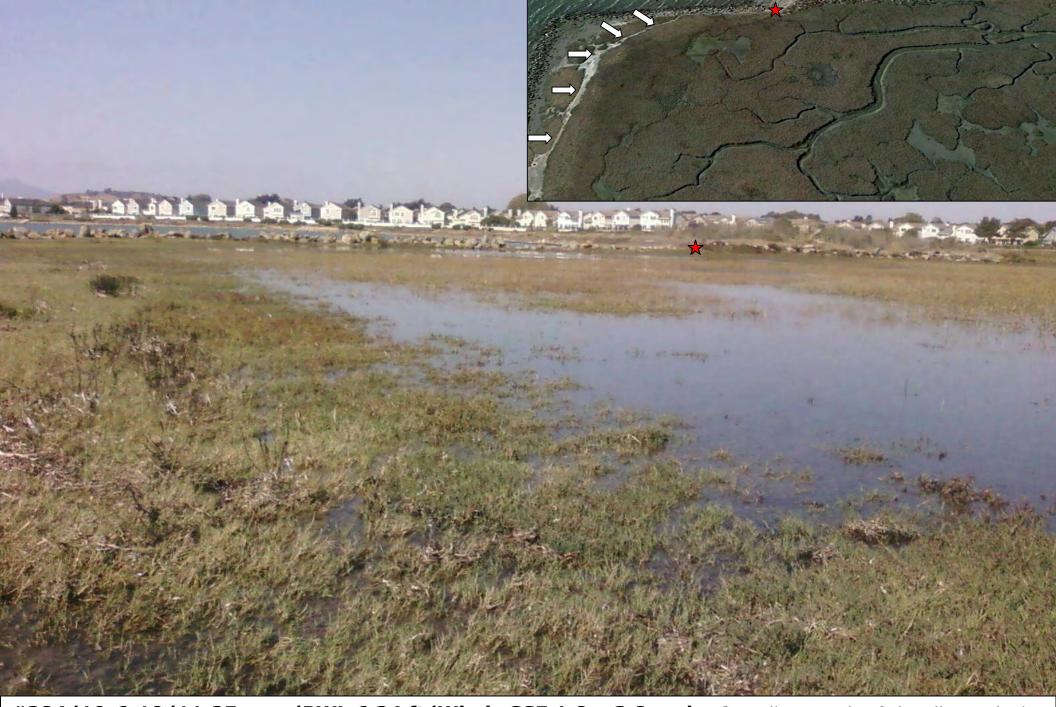
#383/10-6-10/11:24 a.m./PWL 6.34 ft/Winds SSE 1.8 – 3.8 mph. This close-up of an old debris line formed along the high ridge/tall brush area faces West, the same as the inset, which is the well-defined debris line left by the 6.49 ft (NOAA verified) tide on August 15, 2009, captured on film the morning of August 16, 2009. Winds were 14-20 mph (UC Berkeley).

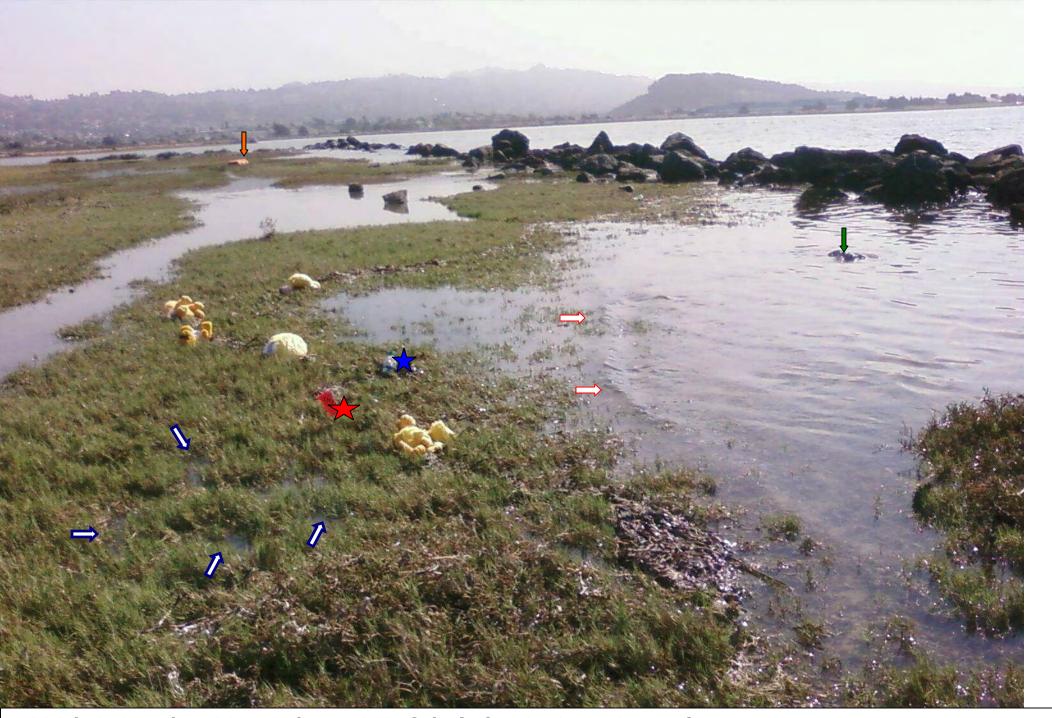
#392/10-6-10/11:30 a.m./PWL 6.34 ft/Winds ESE 2.5 – 3.1 mph. Red star, probable location of Conner's body; blue star, alternate possibility; green arrow, rock used to gauge water depth; red arrows, current wave reach in the receding tide; blue arrows, standing water (tidal pools) north of the debris line. Conner was found in a tidal pool north of the debris line.
