## **Conner Recovery Site Field Trip**

## October 6, 2010

The purpose of this field trip was to:

- 1. Observe whether People's 100 accurately represents the Conner Recovery site at high tide.
- 2. Observe what happens to debris as the tide recedes.

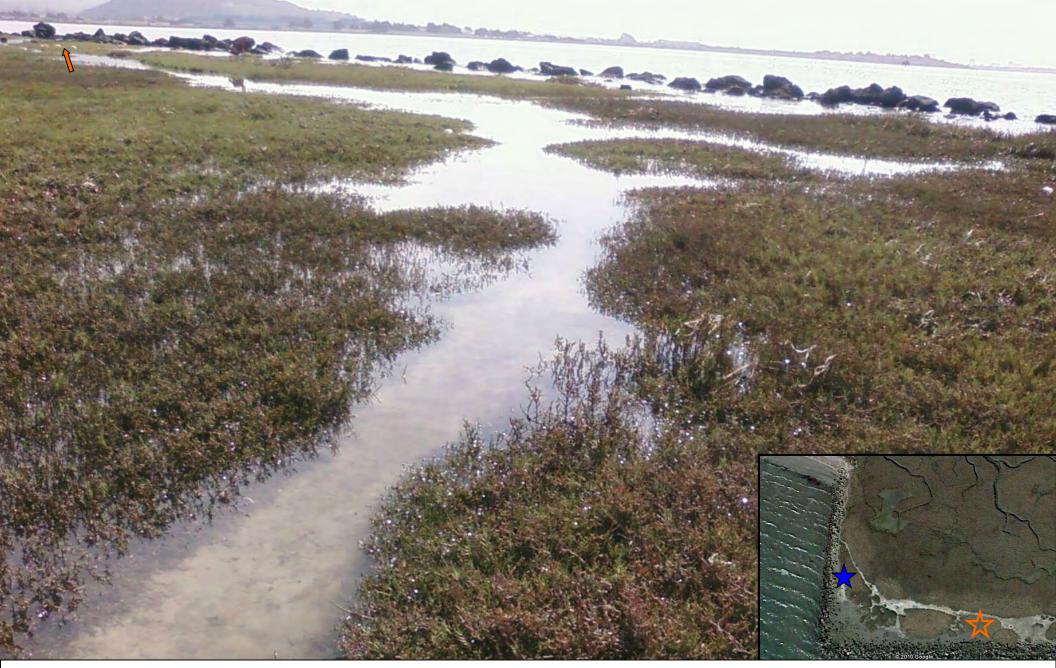
#393/10-6-10/11:38 a.m./PWL 6.31 ft/Winds SE 2.0 – 3.6 mph. Orange arrow points to the debris line. The blue star (aerial inset) shows where I am standing to take this picture, and the orange star indicates grass section where Conner was found. The preliminary water level has receded about half an inch. The ebb tide doesn't suck water off the mudflat, as Distaso claimed –it merely stops putting water onto it, leaving what is there as "standing water" to be absorbed into the ground, while the creeks and ponds shrink down to their low-tide state. The next few pictures pan to the NE and then to the North.

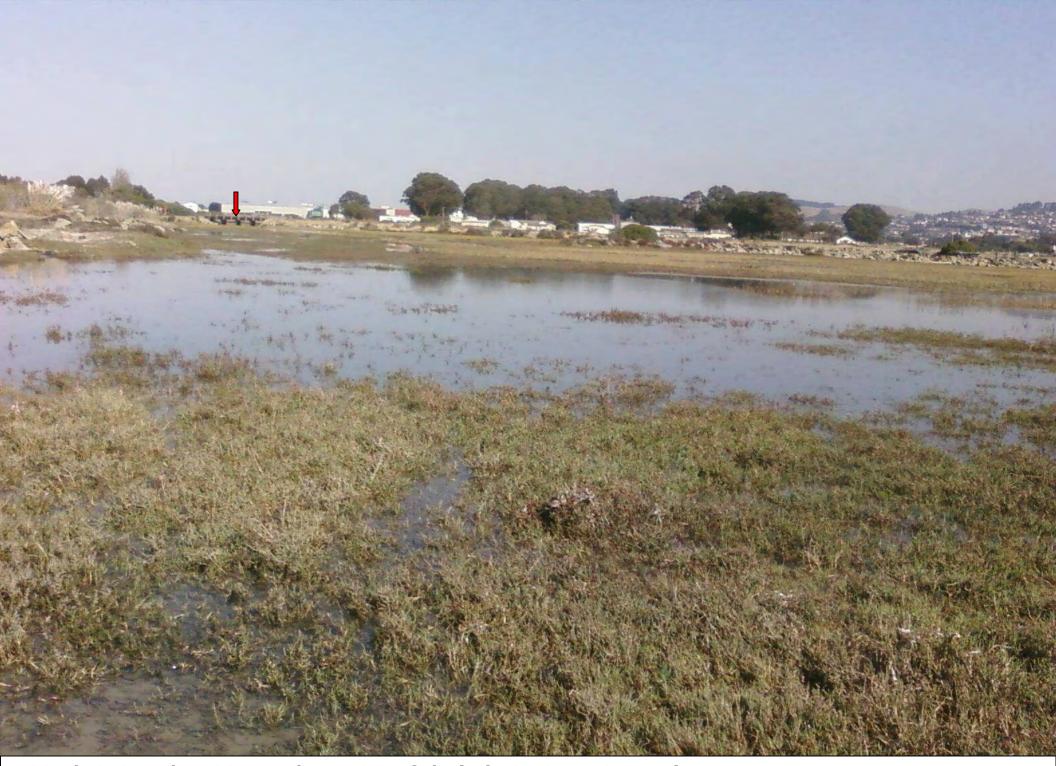
#394/10-6-10/11:38 a.m./PWL 6.31 ft/Winds SE 2.0 – 3.6 mph. Standing at the same place as in #393, along the west breakwater, looking towards to the NE to see the standing water, creeks, and ponds.

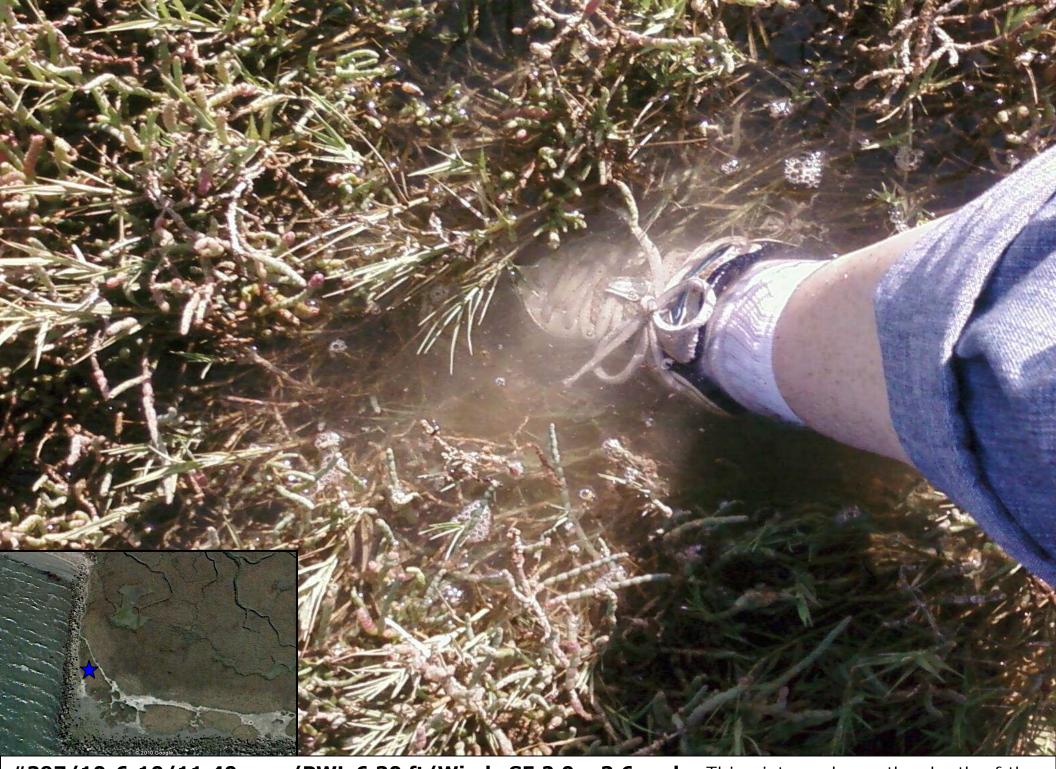
#397/10-6-10/11:40 a.m./PWL 6.30 ft/Winds SE 2.0 – 3.6 mph. This picture shows the depth of the standing water in the grass section near the west breakwater. (blue star in inset)

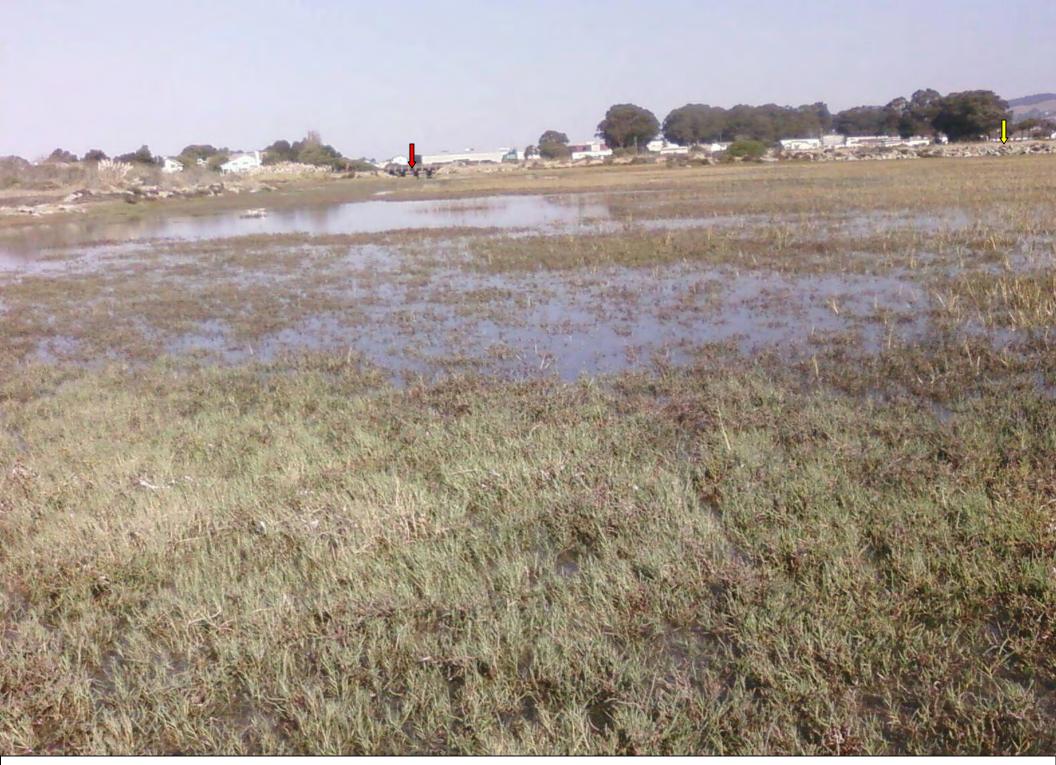
#398/10-6-10/11:41 a.m./PWL 6.30 ft/Winds SE 2.0 – 3.6 mph. More documentation of the amount of water on the mudflat north of the dirt path. Red arrow points to the Bay Trail bridge, blue star marks access to the mudflat from the beach. According to the Preliminary data, water level has dropped 0.6 inches from the peak high tide.

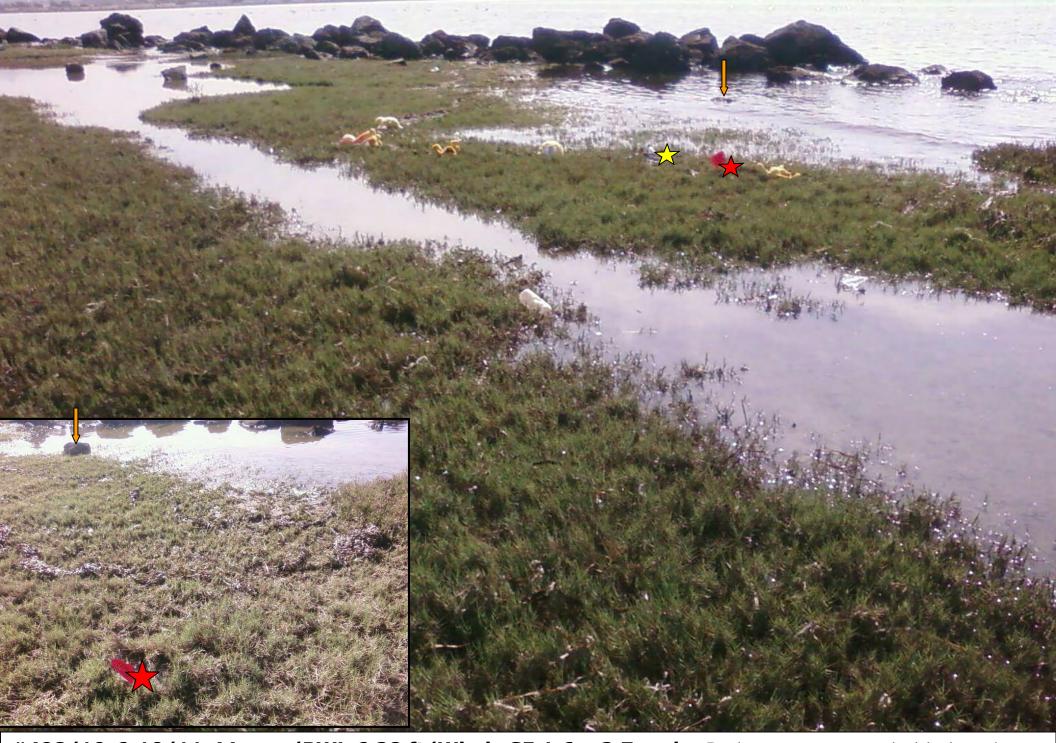
#408/10-6-10/11:44 a.m./PWL 6.28 ft/Winds SE 1.6 – 2.7 mph. Red stars, most probable location of Conner's body (laser-measured); yellow star, alternate location (manual-measured); orange arrows point to rock used to gauge water depth (inset is #319, 10:06 a.m., PWL 5.77 feet).

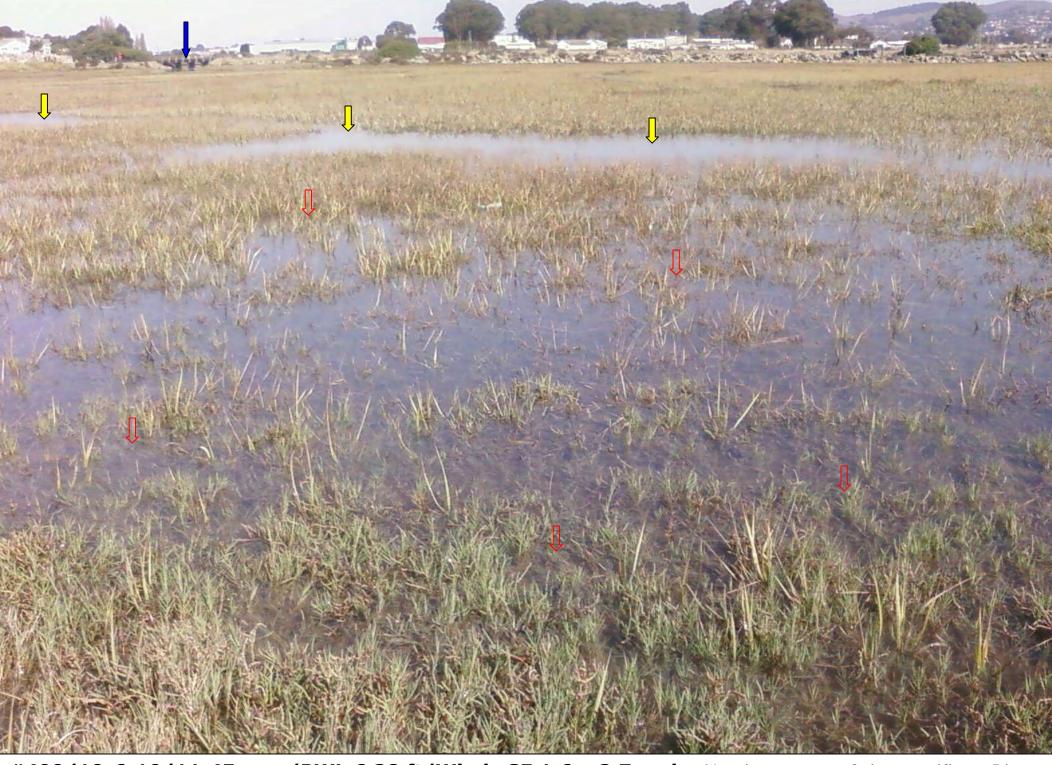
#409/10-6-10/11:45 a.m./PWL 6.28 ft/Winds SE 1.6 – 2.7 mph. Northern part of the mudflat. Blue arrow, Bay Trail bridge; yellow arrows, deeper water in creeks; red arrows, shallower overflow water.

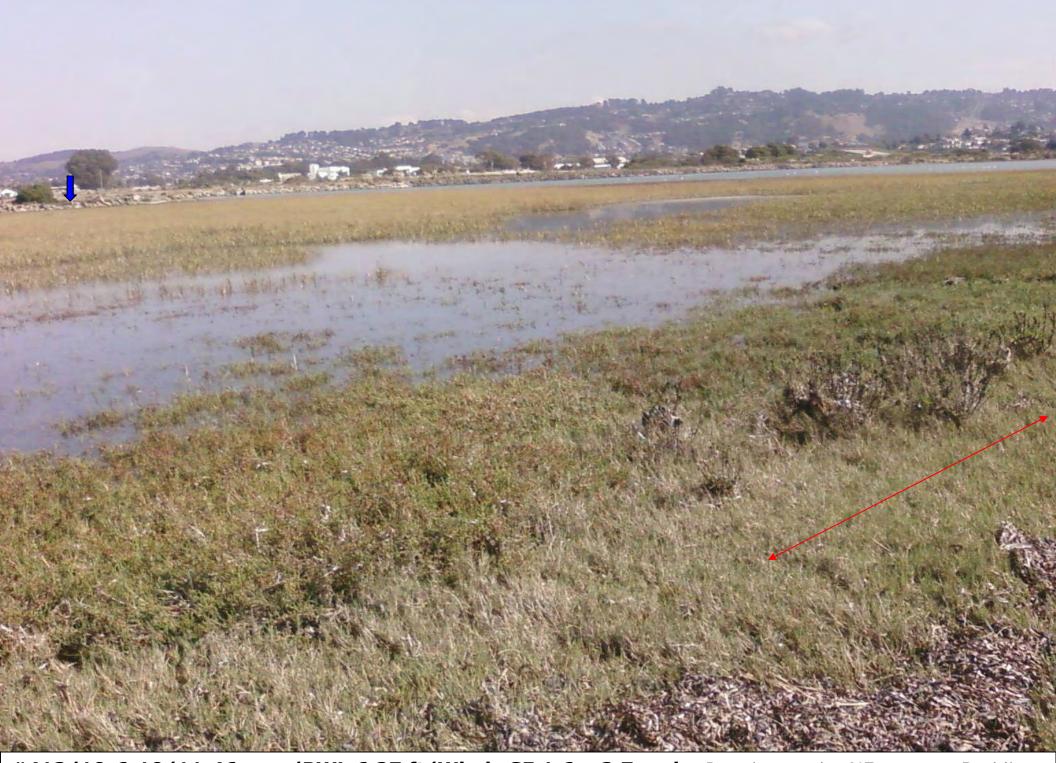
#411/10-6-10/11:46 a.m./PWL 6.27 ft/Winds SE 1.6 – 2.7 mph. Looking towards the SE corner. A good view of the high ridge/tall brush strip. Lot of standing water still to its north (red arrow) and to its south (blue arrow) the dirt path is still filled with water. Tides high enough to leave behind this old debris line (green arrows) usually occur only one week in the month (see inset at left). The 6.49 verified water level on Aug 15, 2009, left a debris line in this area; the PWL 6.57 on Oct 10, 2010 also left a debris line in this area. Orange arrow, large Styrofoam object.

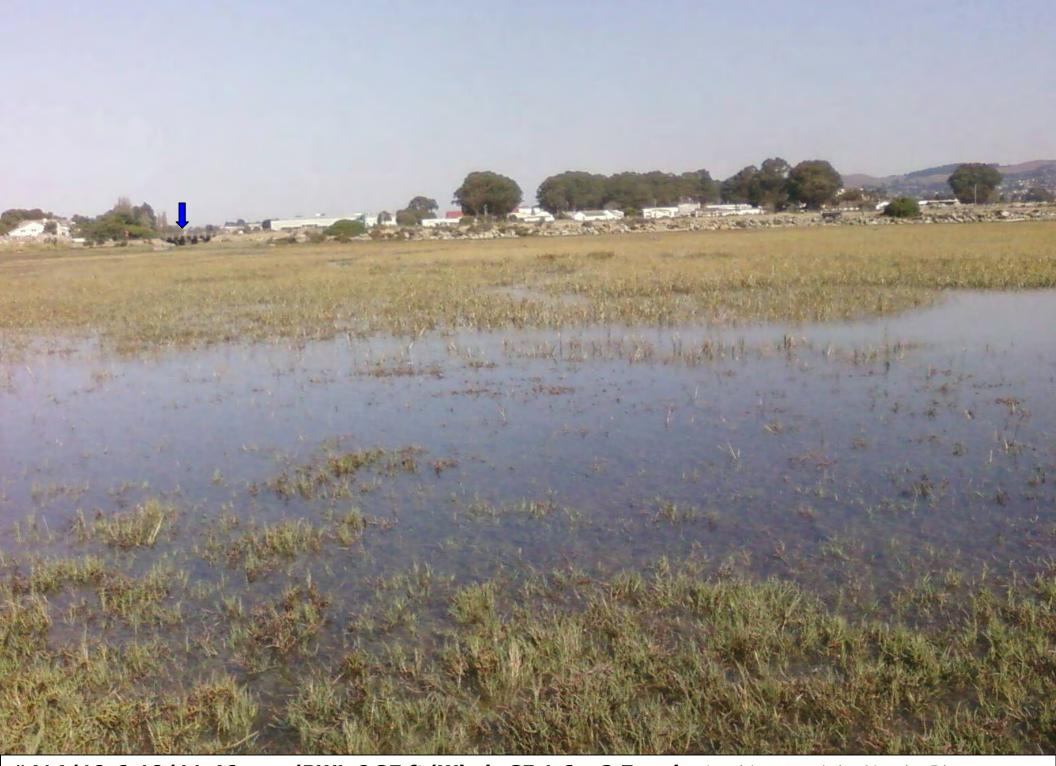
#413/10-6-10/11:46 a.m./PWL 6.27 ft/Winds SE 1.6 – 2.7 mph. Looking to the NE corner, but closer to the larger bodies of standing water. Blue arrows point to the deeper water.

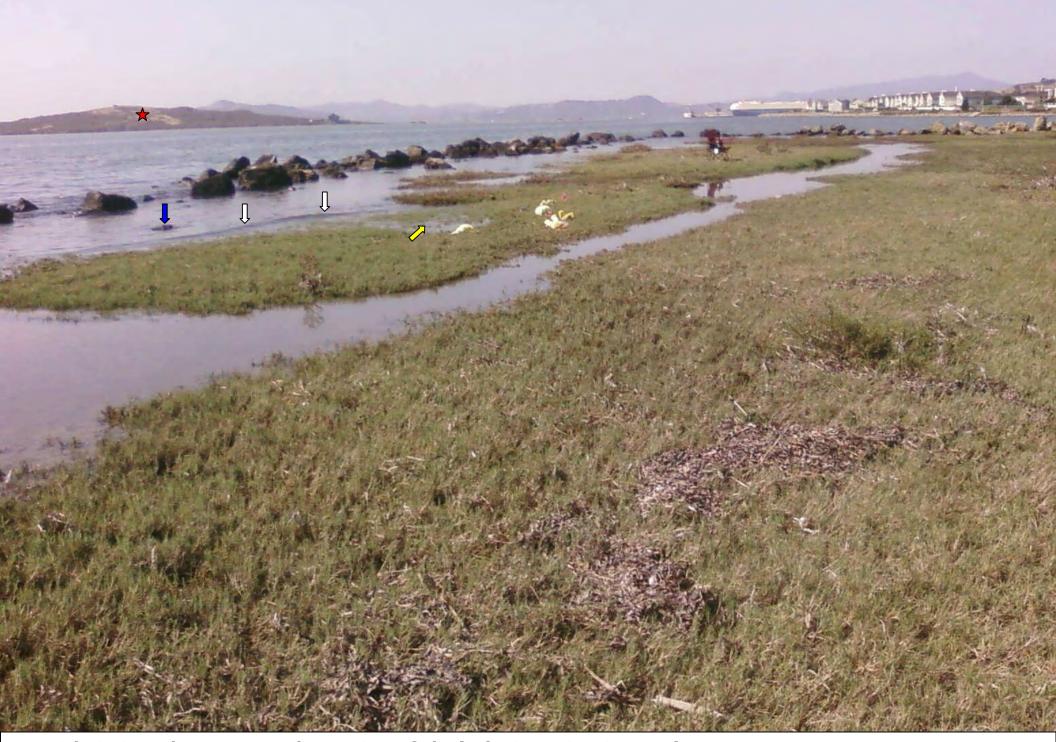
#415/10-6-10/11:46 a.m./PWL 6.27 ft/Winds SE 1.6 – 2.7 mph. Looking West. Yellow arrows, deeper water in creeks & ponds; red arrows, shallower overflow water.

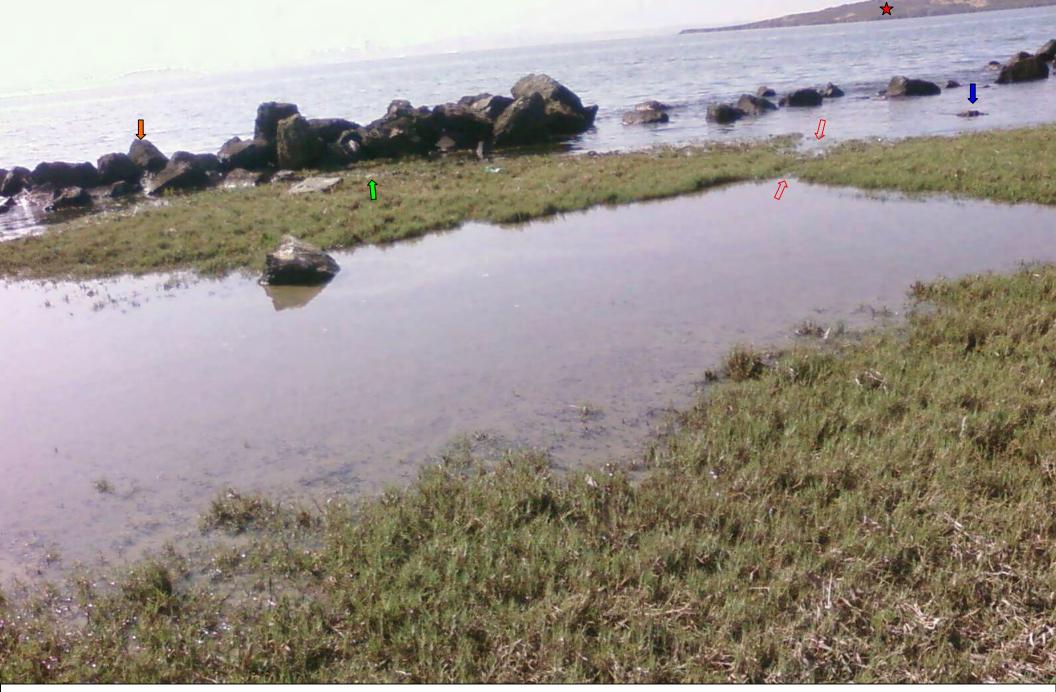
#416/10-6-10/11:47 a.m./PWL 6.27 ft/Winds SE 1.6 – 2.7 mph. Red star is Brooks Island. Dirt path is still filled with water. White arrows, reach of the current waves; yellow arrow, water still standing north of the wave reach; blue arrow, rock being used as indicator of water depth.

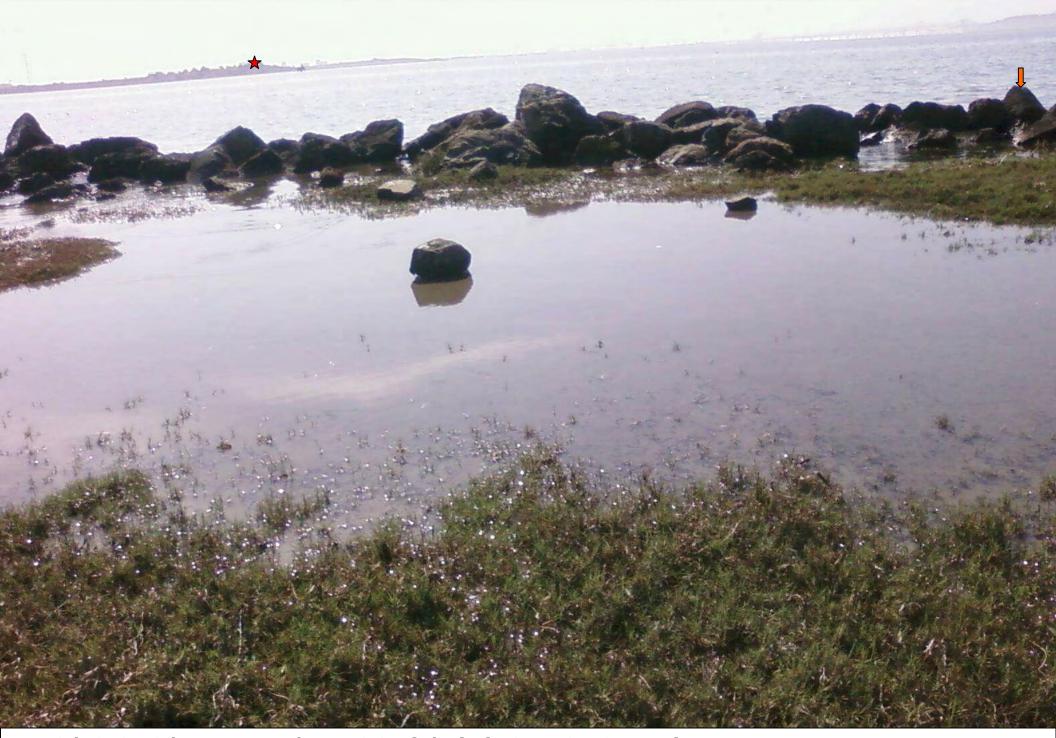
#417/10-6-10/11:47 a.m./PWL 6.27 ft/Winds SE 1.6 – 2.7 mph. Panning East along the south breakwater, showing the difference between sections of the breakwater, in size and compactness. Red star is Brooks Island; blue arrow is rock from #416 being used as indicator of water depth; green arrow, barely discernible is the eastward limit of today's debris line; red arrows, flow of water as the tide rises, water remains captured by the grass as the tide recedes; orange arrow, reference point for #418.

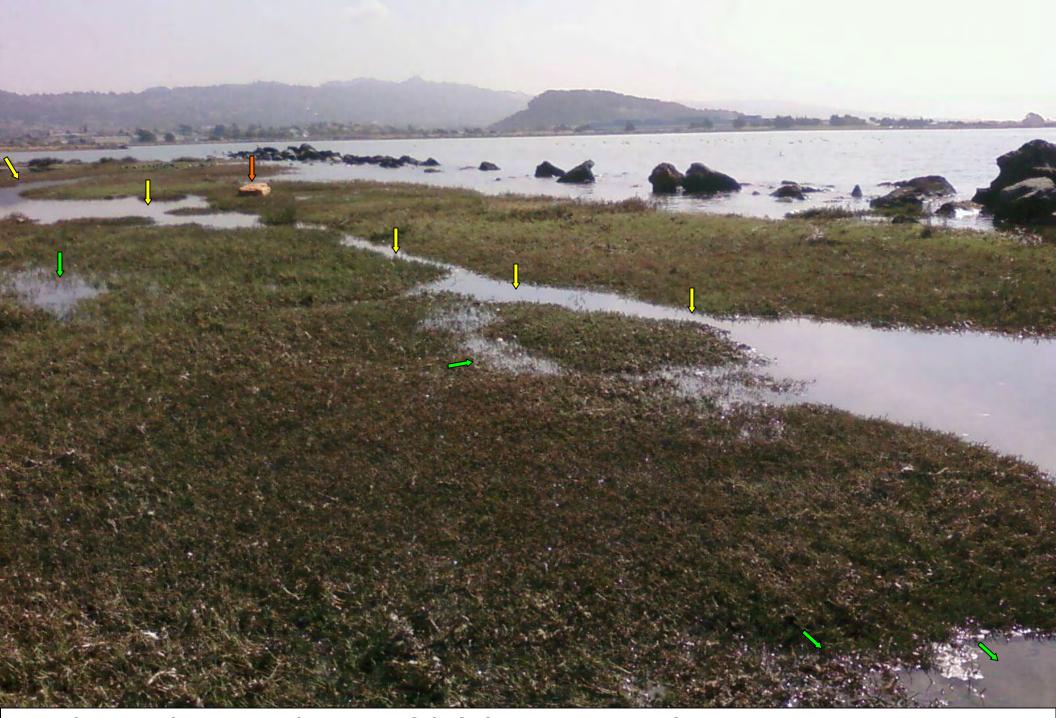
#418/10-6-10/11:47 a.m./PWL 6.27 ft/Winds SE 1.6 – 2.7 mph. Panning East along the south breakwater. Orange arrow, reference point from #417; red star, Albany Bulb. The water is captured in ponds until it is absorbed into the ground.

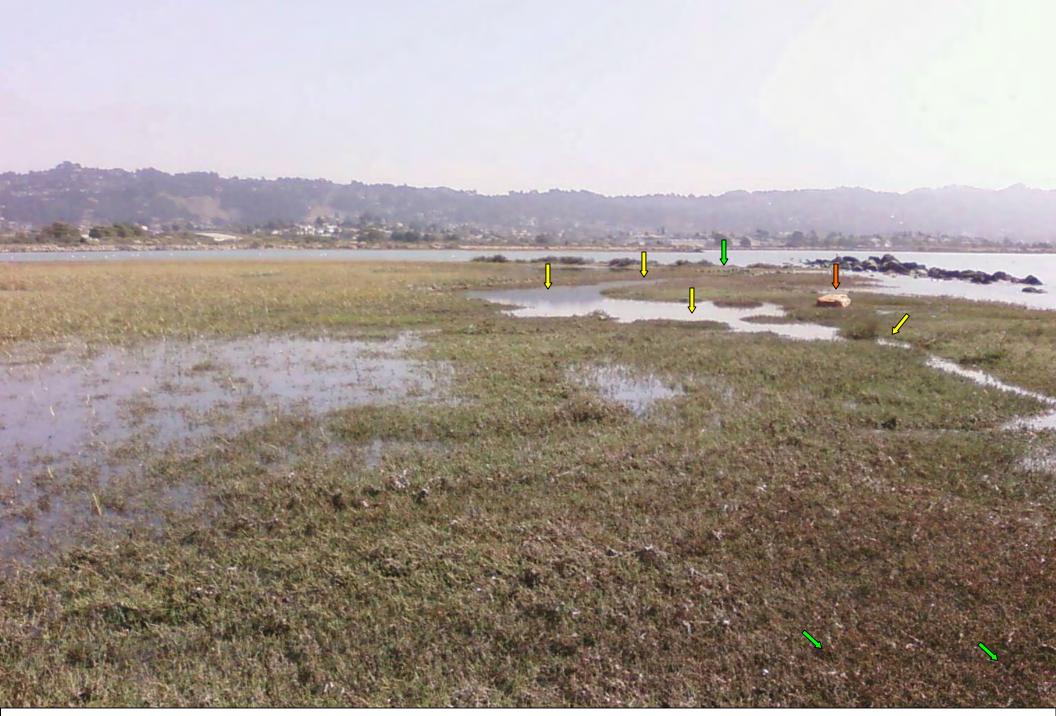
#419/10-6-10/11:47 a.m./PWL 6.27 ft/Winds SE 1.6 – 2.7 mph. SE corner, exposing a very low area of South breakwater. Orange arrow, large Styrofoam object, which remains where it was at the peak of high tide; yellow arrows, dirt path; green arrows, standing water north of dirt path. Standing water is captured and will remain until it is absorbed into the ground – it does not recede southward as Distaso claimed.

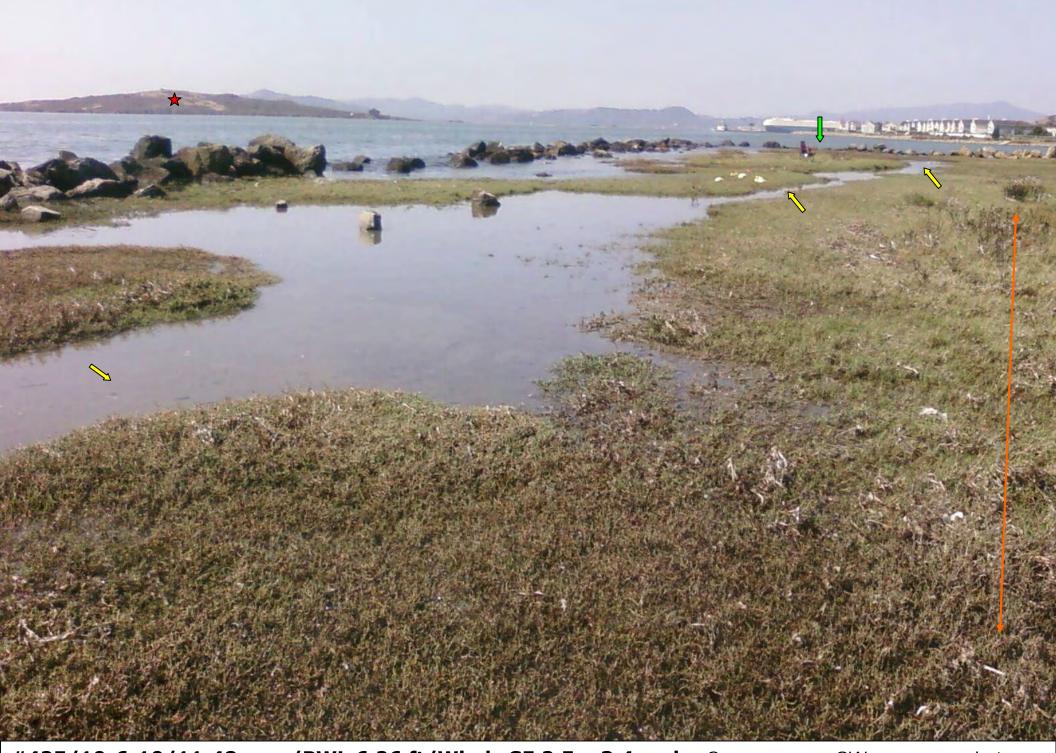
#424/10-6-10/11:48 a.m./PWL 6.26 ft/Winds SE 2.5 – 3.4 mph. Yellow arrow points to the water-filled dirt path; red star is access to the mudflat from the beach; green arrows point to deeper water. The orange line shows the high ridge/tall brush area that traps the overflow water in the northern part of the mudflat.

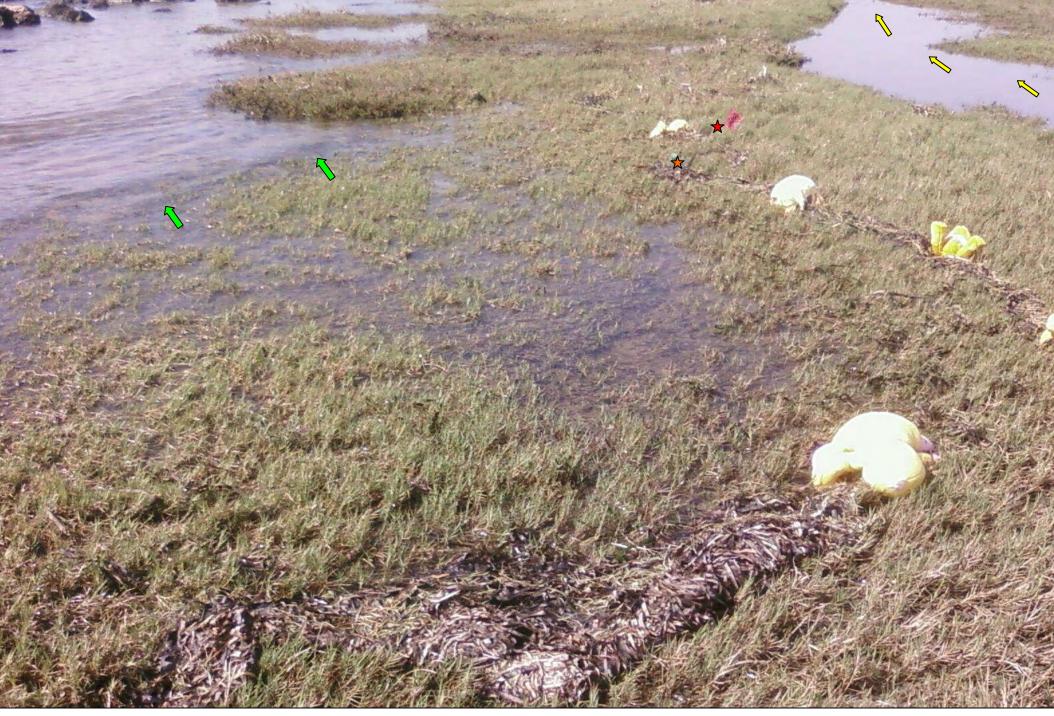
#427/10-6-10/11:49 a.m./PWL 6.26 ft/Winds SE 2.5 – 3.4 mph. With the tide receding, the debris line becomes obvious (green arrows); light debris is mixed in with heavier debris; yellow arrows follow the water-filled dirt path; red star is most probably location of Conner's body; orange star another possible location. Standing water on both the north and south of the debris line.

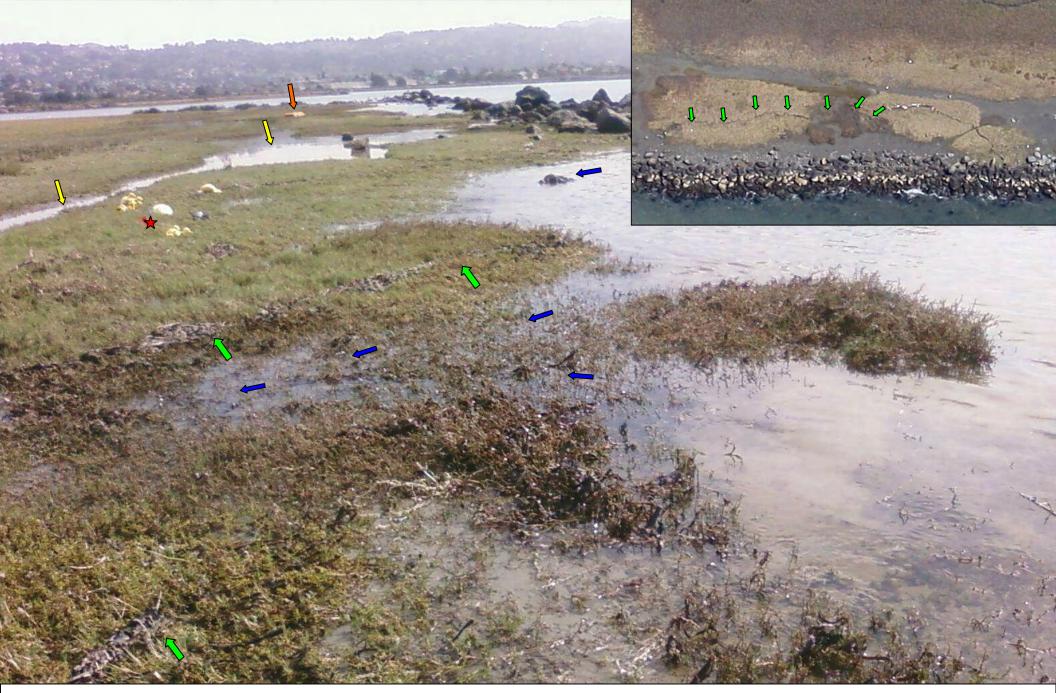
#428/10-6-10/11:49 a.m./PWL 6.26 ft/Winds SE 2.5 – 3.4 mph. Close-up of the water just in front of/south of the debris line; green arrows show the reach of the current wave action; red star is most likely location for Conner's body (laser measured); orange star is another possible location (manually measured); and the yellow arrows follow the water-filled dirt path.

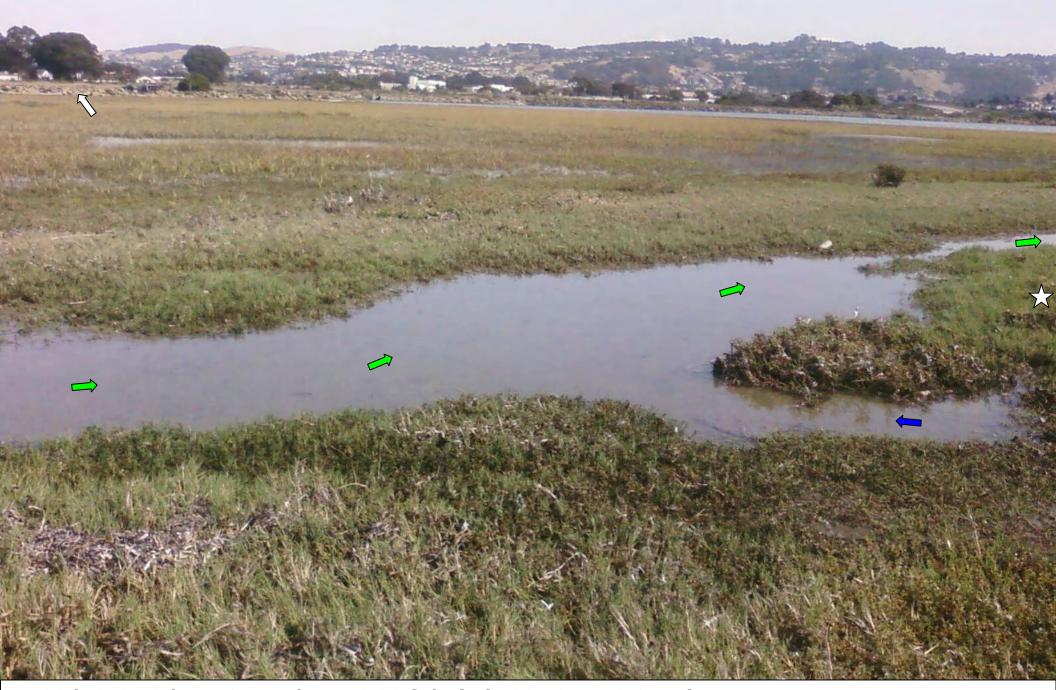
#430/10-6-10/11:56 a.m./PWL 6.22 ft/Winds SSE 2.7 – 3.8 mph. White star is the grass section where Conner was found – I am taking this picture from the grass section to its West. Green arrows show the dirt path, which is still covered with water; blue arrow shows the stream of water flow from the south breakwater (from #429); white arrow points to the north breakwater, which protects the north section of the mudflat from even more flooding at these higher than MHHW tides.

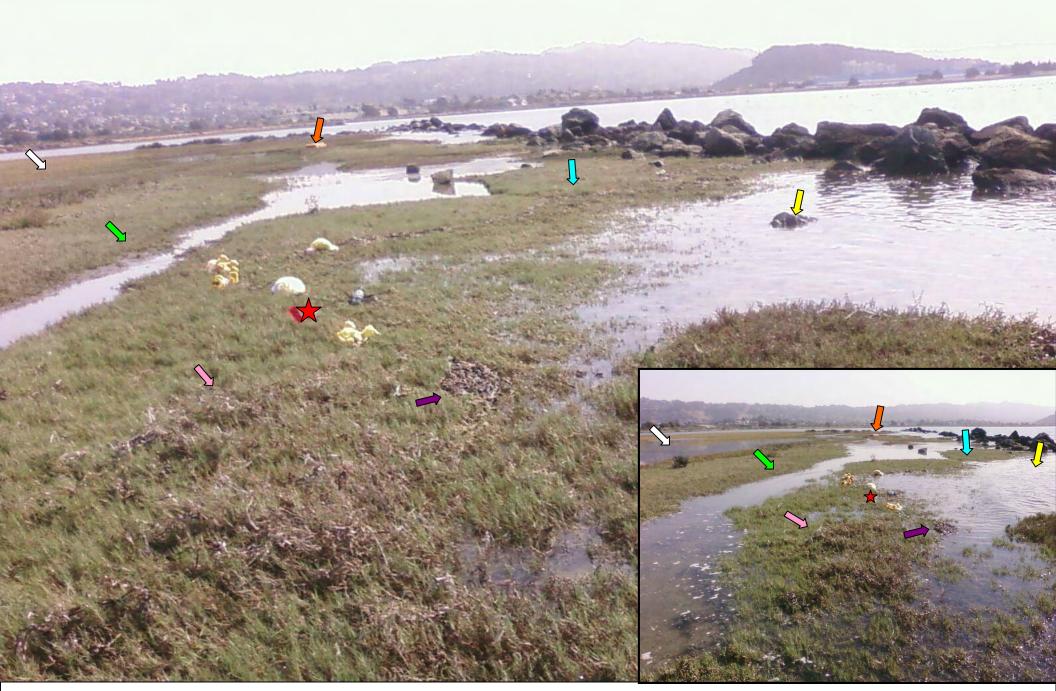
#431/10-6-10/11:56 a.m./PWL 6.22 ft/Winds SSE 2.7 – 3.8 mph. Yellow arrow, Bay Trail bridge; orange arrow, north breakwater; green arrows, deeper water in streams & ponds; pink arrow, standing overflow water; blue arrows, path facing West; white arrows, puddles that remain along the path as the water is gradually absorbed into the ground.

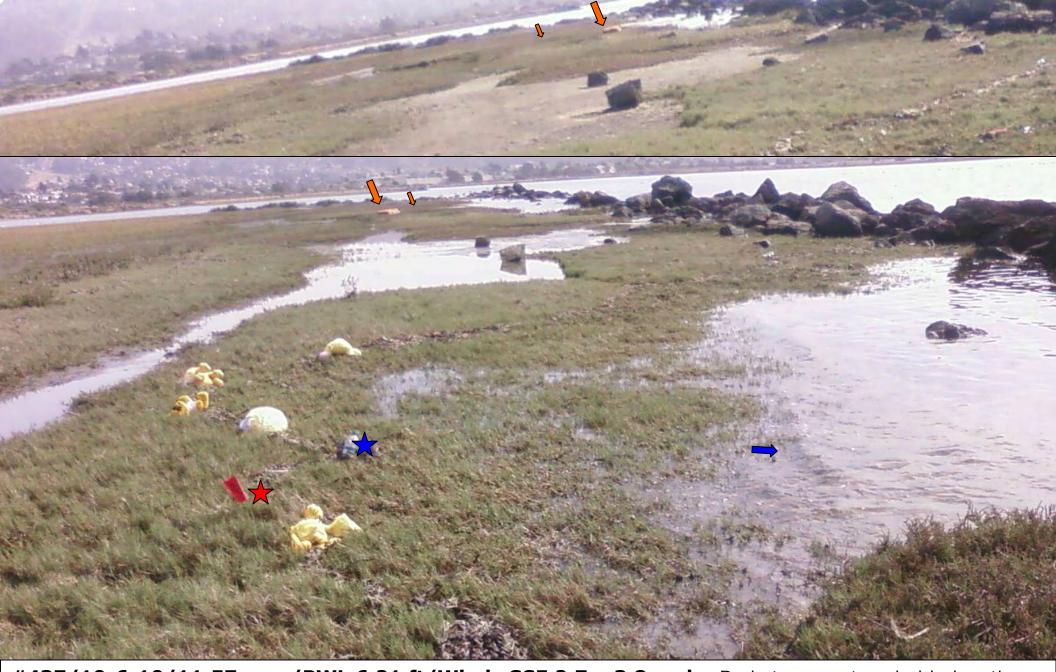
#436/10-6-10/11:57 a.m./PWL 6.21 ft/Winds SSE 2.7 – 3.8 mph. It's been approximately 45 minutes since high tide peaked, and this picture shows how much water has been absorbed into the ground (see inset, #371 taken at peak high tide). Colored arrows correspond with arrows in the inset. The higher ground and taller grass/brush trap the overflow water, which gradually soaks into the ground, while the creeks and ponds shrink back to their low-tide sizes.

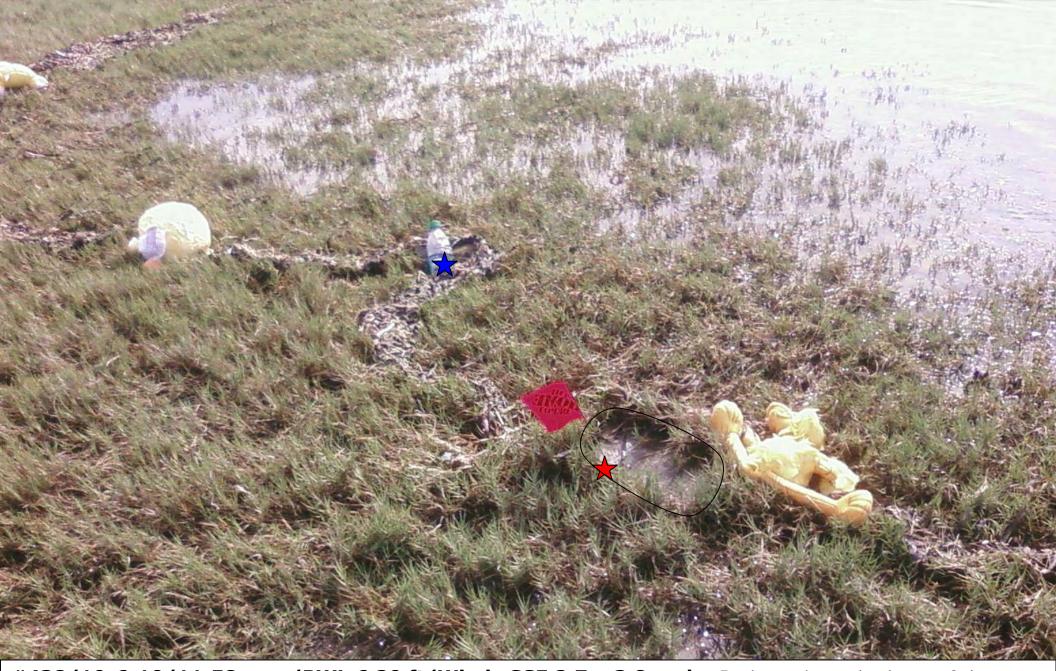
#437/10-6-10/11:57 a.m./PWL 6.21 ft/Winds SSE 2.7 – 3.8 mph. Red star, most probable location of Conner's body; blue star, alternate location; large Orange arrows, large Styrofoam object; small orange arrows, landmark to determine relative location. Top panel is #320, taken at 10:06 a.m., PWL 5.77 feet. Styrofoam object has moved from its beginning location south of the landmark to its final location north of it. Wave action and the rising tide moved it to its current location; it didn't get there by being deposited as the water level dropped in the receding tide. Blue arrow, extent of current wave action.

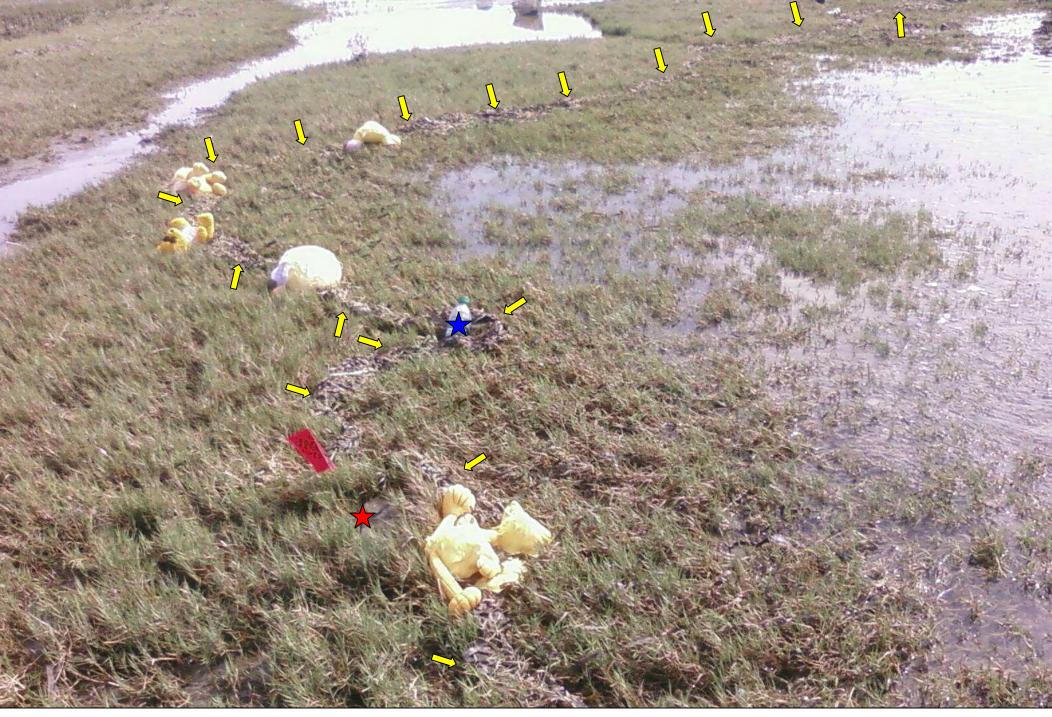
#438/10-6-10/11:58 a.m./PWL 6.20 ft/Winds SSE 2.7 – 3.8 mph. Red star is at the base of the Home Depot flag. You can see the rock that was laid on August 14, 2009, to mark the location of Conner's body, based on laser measurements of 173 feet from the west breakwater and 24 feet from the south breakwater. For the alternate measurement, so it would be distinguished in the pictures, I placed another rock on top of the rock that was laid on August 13, 2009 after manually measuring the distances, and then rested the filled bottle against it (blue star). The stacked rocks did act as a barrier for the light debris.

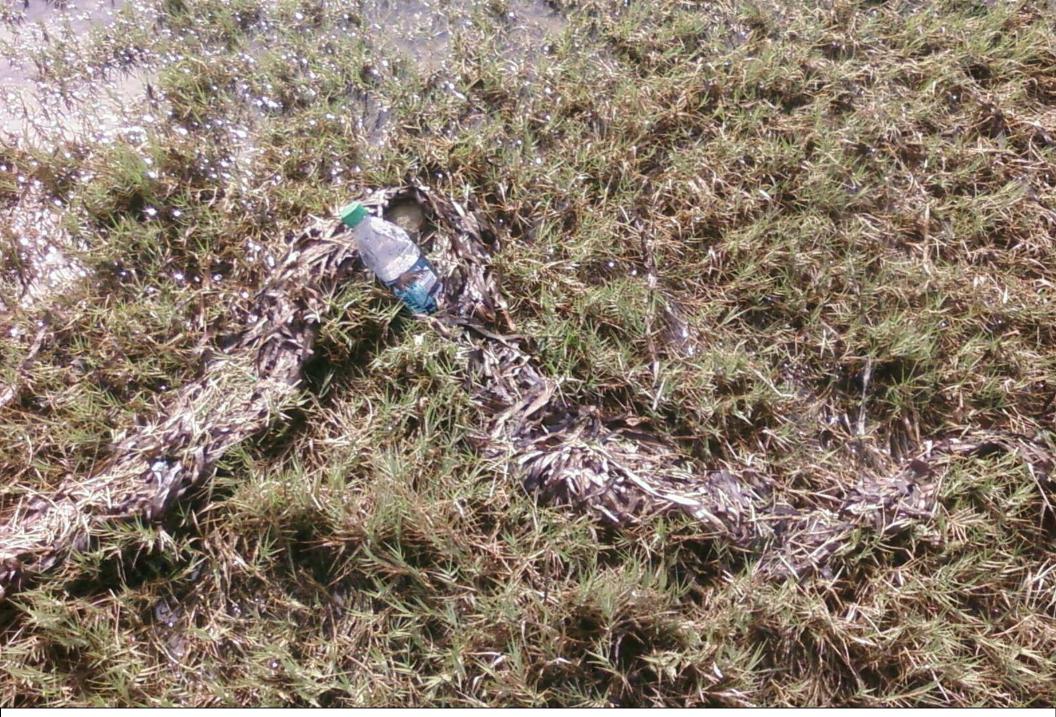
#439/10-6-10/11:58 a.m./PWL 6.20 ft/Winds SSE 2.7 – 3.8 mph. Red star, most probable location of Conner's body based on laser measurements taken on August 14, 2009; blue star, alternate location based on manual measurements taken August 13, 2009. Well-formed debris line is very visible (yellow arrows). Without exception, the heavier debris (stuffed animals) is interspersed with the lighter debris.

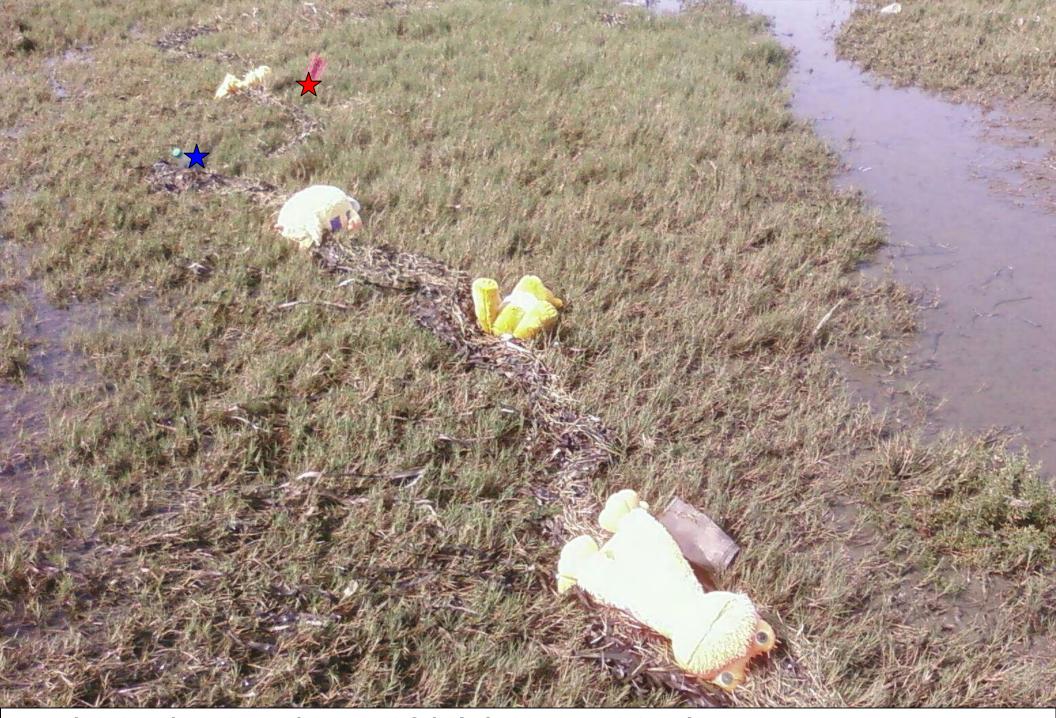
#440/10-6-10/11:58 a.m./PWL 6.20 ft/Winds SSE 2.7 – 3.8 mph. A close-up of the stacked rocks to mark the alternate location for Conner's body, as measured manually on August 13, 2009. The stacked rocks were tall enough to catch the debris. There is standing water to each side of the debris line, as well as to the south of the rocks/bottle, and even some to the north of the debris line (bottom of the picture).

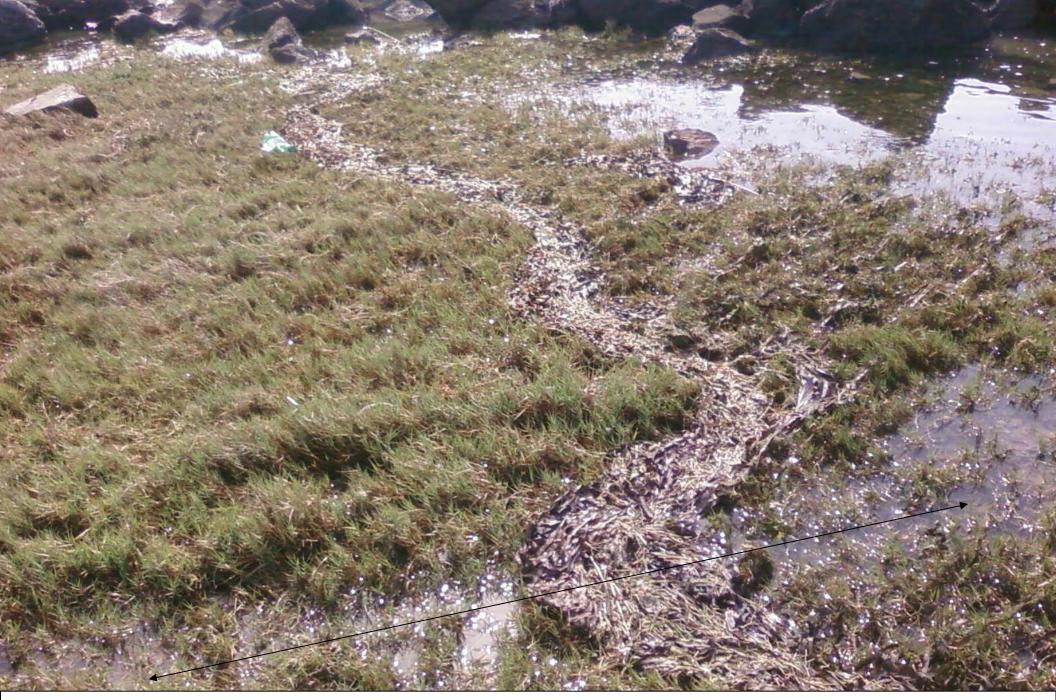
#441/10-6-10/11:58 a.m./PWL 6.20 ft/Winds SSE 2.7 – 3.8 mph. Facing West to get a close-up of this portion of the debris line, compelling evidence that the heavier debris stays with the lighter debris. Debris lines are formed by the waves and the rising tide, not deposited by the receding tide. Stars mark alternate locations for Conner's body.

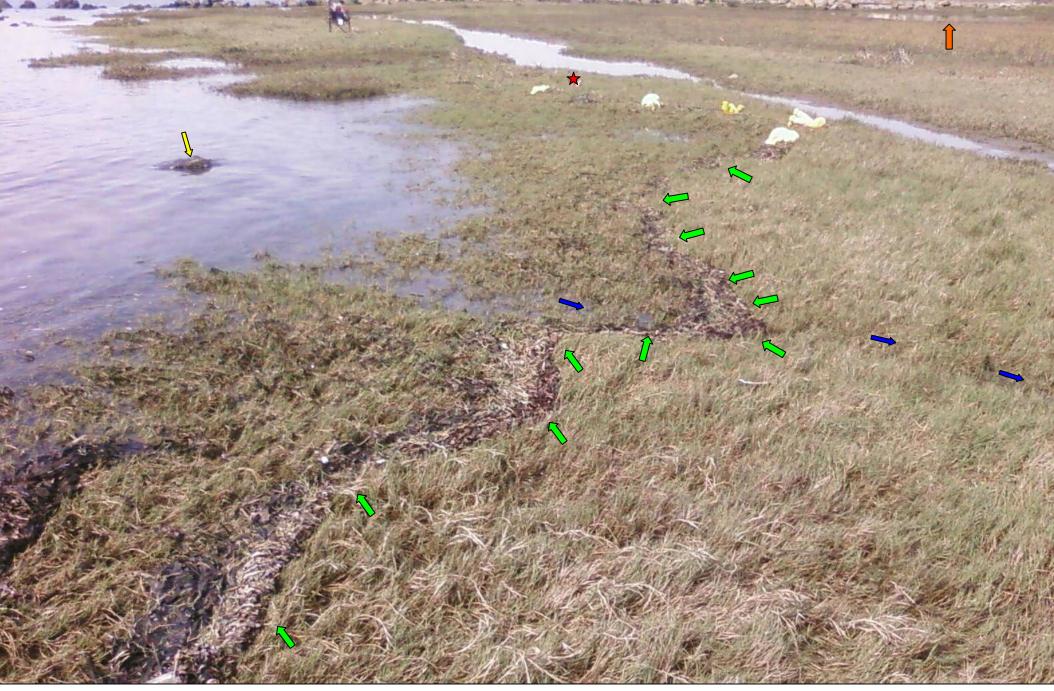
#442/10-6-10/11:58 a.m./PWL 6.20 ft/Winds SSE 2.7 – 3.8 mph. A very good view of the southeastern portion of the debris line. Very well formed. The black line illustrates the flow of water between the 2 grass sections, and yet the debris line stays together.

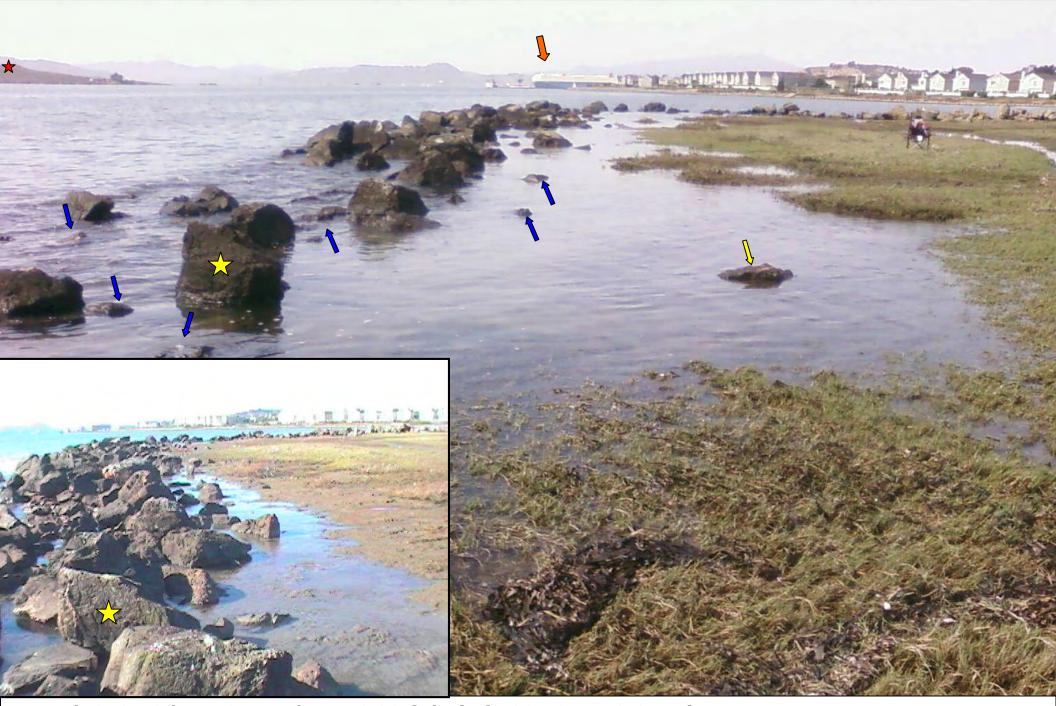
#444/10-6-10/11:59 a.m./PWL 6.20 ft/Winds SSE 2.7 – 3.8 mph. Red star, Brooks Island; orange arrow, very large cargo ship; yellow arrow, rock that indicates water depth; blue arrows, a number of rocks becoming visible under the water. Inset is #00019 taken Dec 5, 2005, Verified water level 5.48, Winds NE 7, a close-up of the rocks in this section of the south breakwater. Yellow star identifies same rock.
