## **Conner Recovery Site Field Trip**

## October 6, 2010

The purpose of this field trip was to:

- 1. Observe whether People's 100 accurately represents the Conner Recovery site at high tide.
- 2. Observe what happens to debris as the tide recedes.

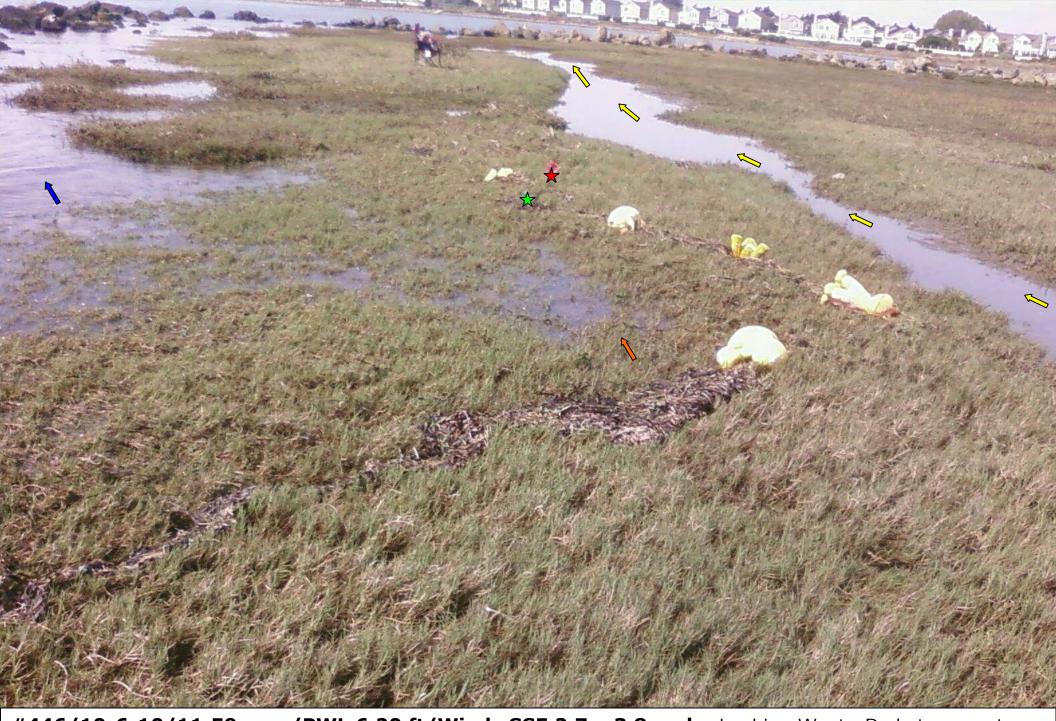
#445/10-6-10/11:59 a.m./PWL 6.20 ft/Winds SSE 2.7 – 3.8 mph. Panning a little to the south. Red star, Brooks Island; orange arrow, very large cargo ship; yellow arrow, rock that indicates water depth; blue arrows, a number of rocks becoming visible under the water. Inset #00020 also taken Dec 5, 2005, Verified water level 5.49, Winds NE 7, a close-up of the rocks in this section of the south breakwater. Yellow star identifies same rock.

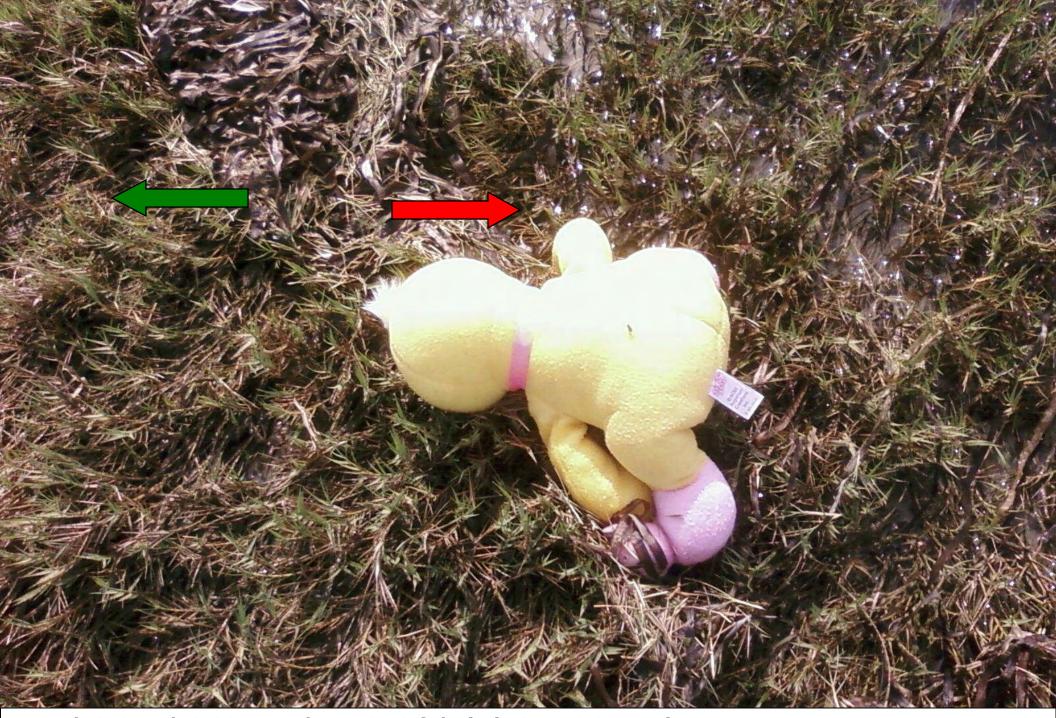
#447/10-6-10/12:00 Noon/PWL 6.19 ft/Winds SE 1.6-2.9 mph. First in a series of close-ups of the stuffed animals. Green arrow points south, towards the breakwater; Red arrow points North, towards the path. There is still standing water north of the stuffed animal/debris line. Conner was found in a tidal pool north of the debris line on April 13, 2003.

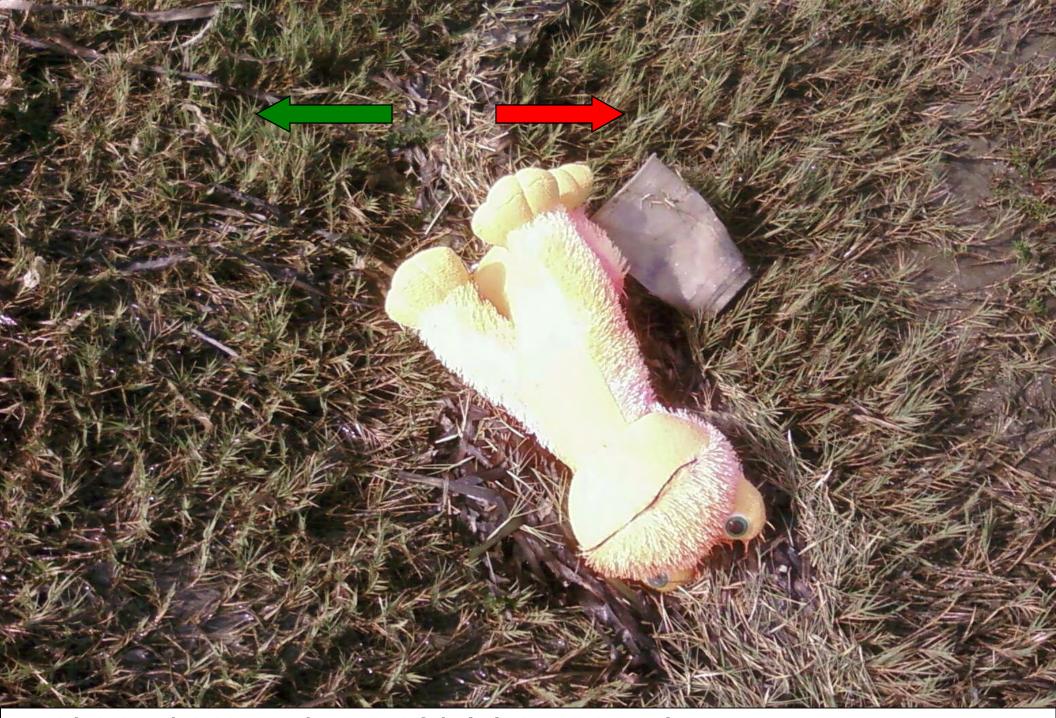
#448/10-6-10/12:00 Noon/PWL 6.19 ft/Winds SE 1.6-2.9 mph. Second in a series of close-ups of the stuffed animals.. Green arrow points south, towards the breakwater; Red arrow points North, towards the path. There is still standing water north of the stuffed animal/debris line. Conner was found in a tidal pool north of the debris line on April 13, 2003.

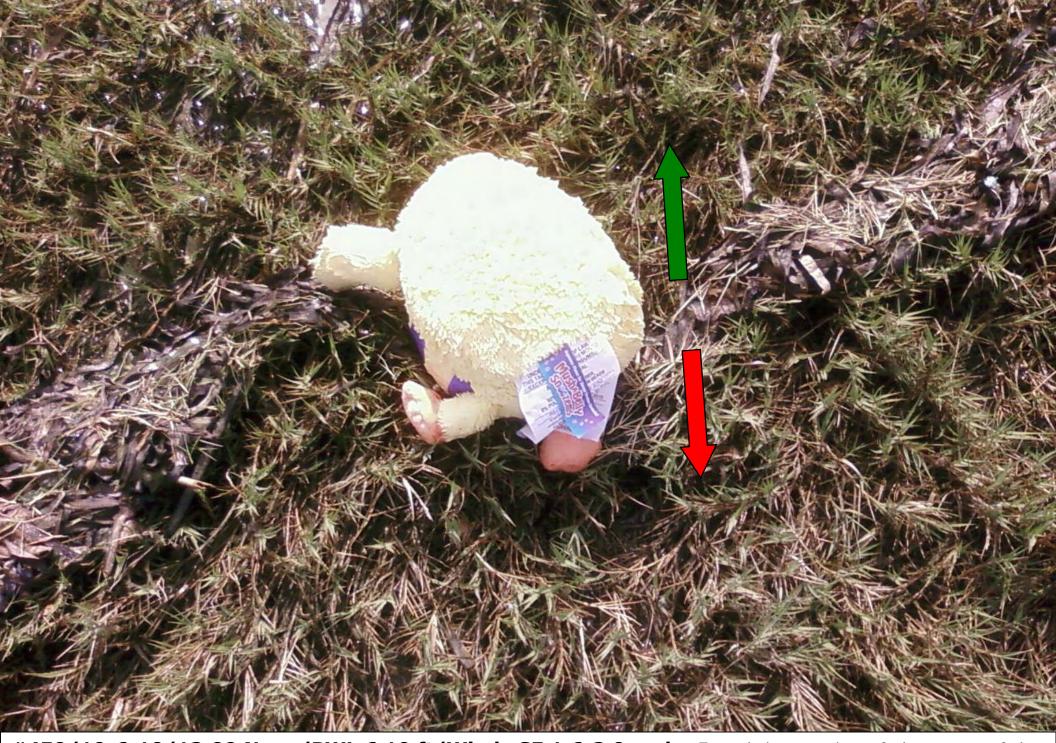
#449/10-6-10/12:00 Noon/PWL 6.19 ft/Winds SE 1.6-2.9 mph. Third in a series of close-ups of the stuffed animals.. Green arrow points south, towards the breakwater; Red arrow points North, towards the path. No standing water north of the debris line is clearly visible in this picture.

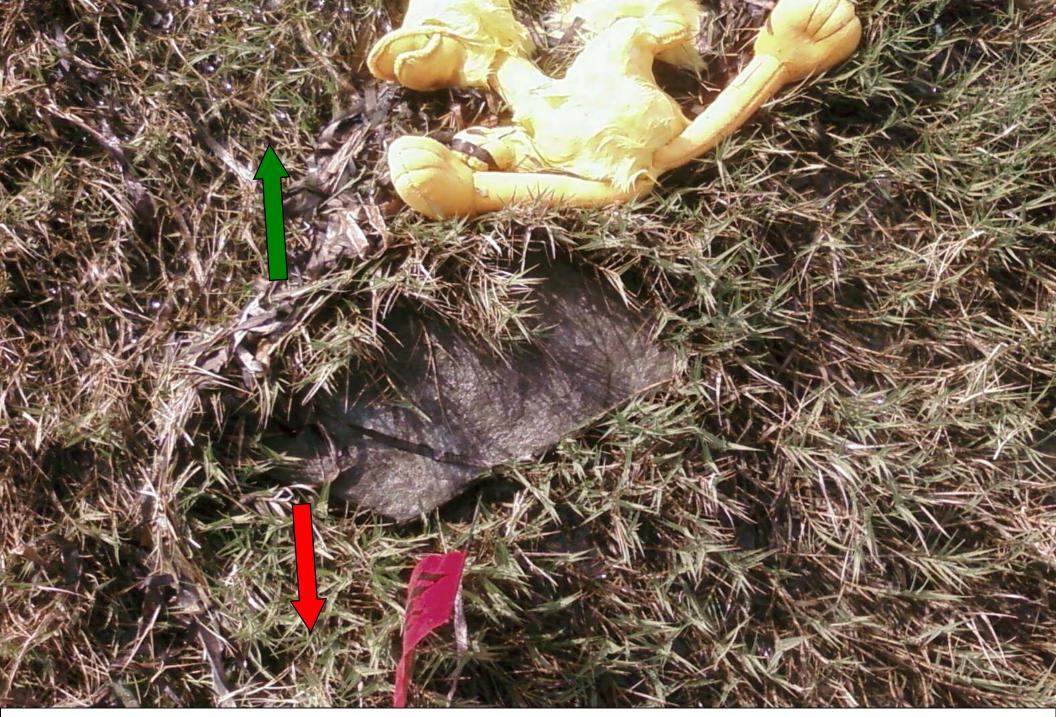
#450/10-6-10/12:00 Noon/PWL 6.19 ft/Winds SE 1.6-2.9 mph. Fourth in a series of close-ups of the stuffed animals. Green arrow points south, towards the breakwater; Red arrow points North, towards the path. No standing water north of the debris line is clearly visible in this picture.

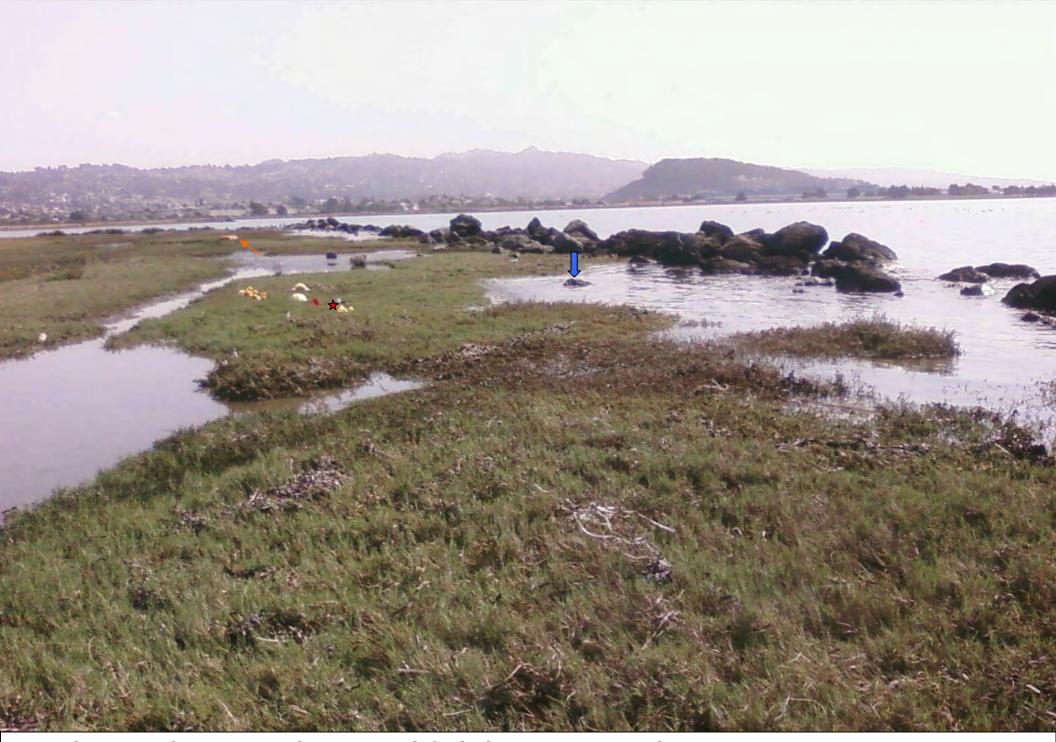
#452/10-6-10/12:01 p.m./PWL 6.19 ft/Winds SE 1.6-2.9 mph. Orange arrow, large Styrofoam object; blue arrows, the northernmost reach of the debris line; red star, most probable location of Conner's body (laser measurements); green star, alternate location (manual measurements); white arrows, path is beginning to dry up; pink arrow, standing water still visible behind the high ridge/tall brush area.

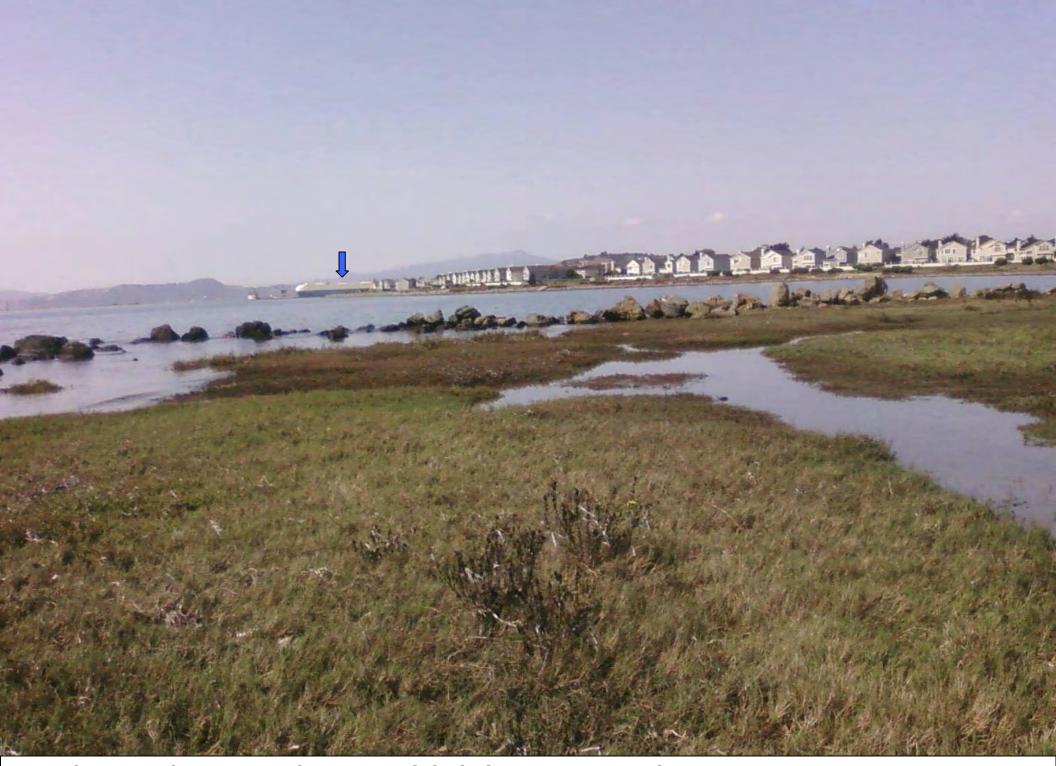
**#453/10-6-10/12:03 p.m./PWL 6.18 ft/Winds SE 1.6-2.9 mph.** Orange arrow, large Styrofoam object; blue arrow, rock used to indicate water depth; red star, most probable location of Conner's body (laser measurements). Lot of water still standing.

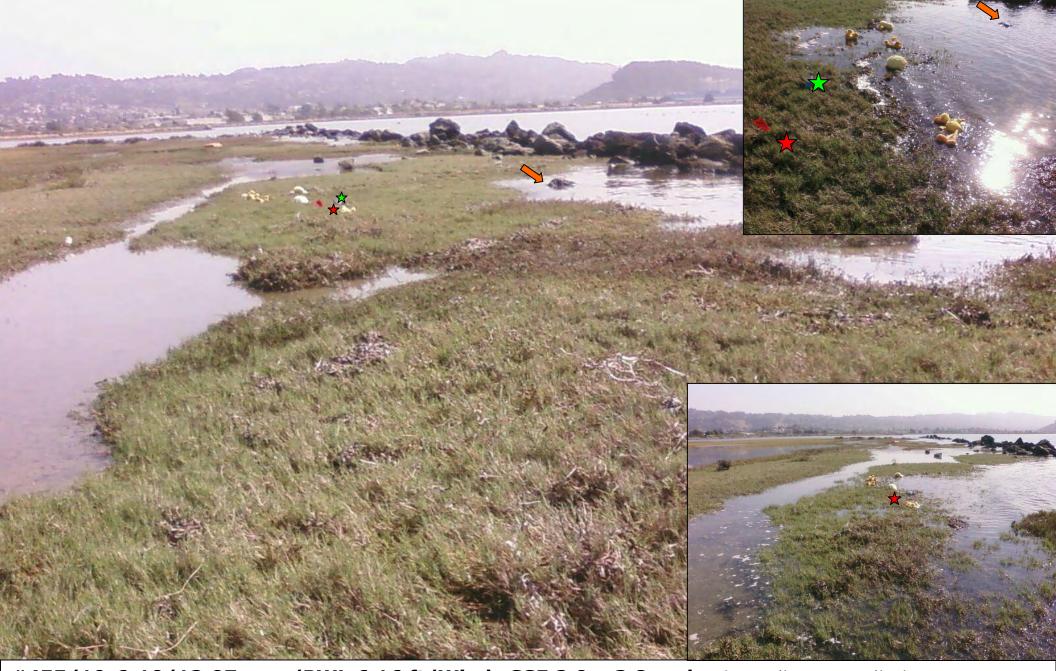
#454/10-6-10/12:05 p.m./PWL 6.17 ft/Winds SE 1.6-2.9 mph. Looking at the SW corner of the mudflat. A lot of water still standing in the dirt path and other dirt areas. Blue arrow, very large cargo ship.

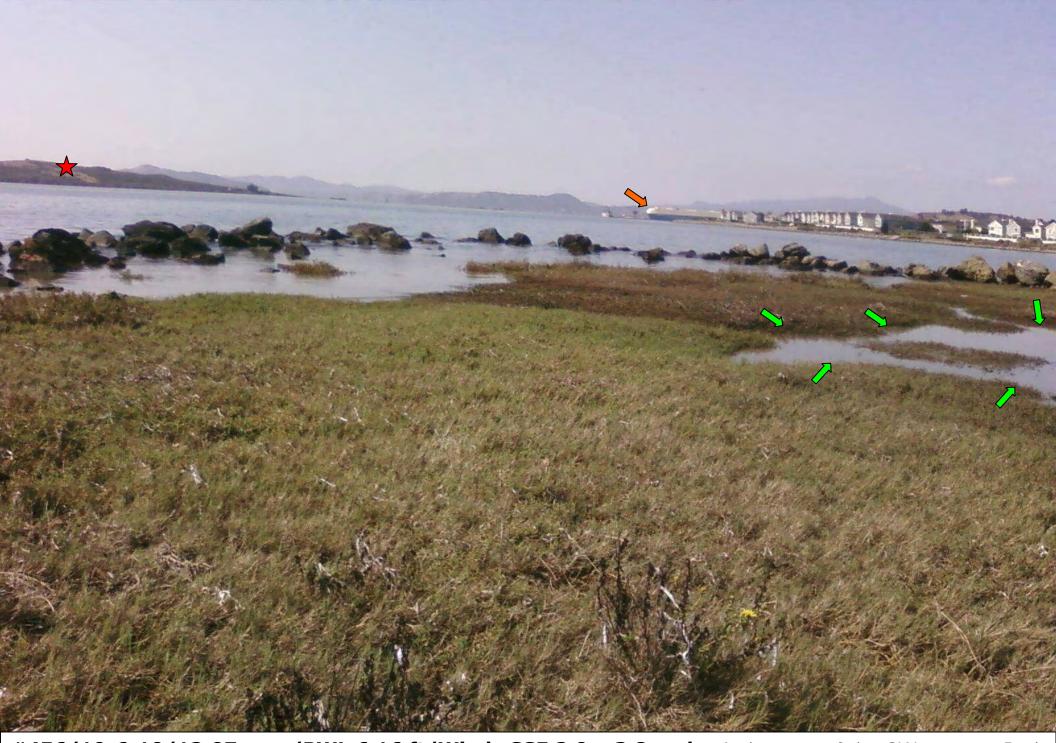
#455/10-6-10/12:07 p.m./PWL 6.16 ft/Winds SSE 2.9 – 3.8 mph. According to preliminary water levels, it's been more than an hour since the tide peaked at 6.35 ft, a drop of 2.16". Red star, most probable location for Conner's body; green star, alternate location; orange arrow, rock used to gauge water depth. Upper right inset is #354 taken at PWL 6.17 ft, winds SSW 1.3-2.2 mph. Notice the difference in water coverage at almost identical water levels—one a rising tide, and the other an ebb tide. The bottom right inset is #371 taken just before peak tide at PWL 6.33 ft., winds SSW 0.7-2.0 mph.

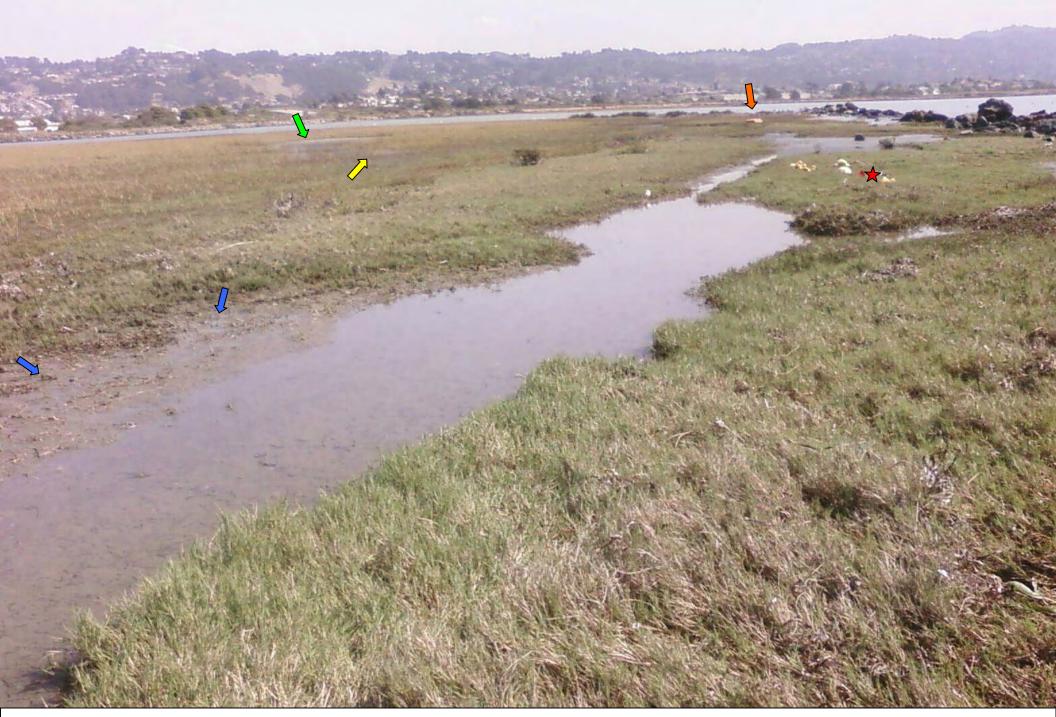
#456/10-6-10/12:07 p.m./PWL 6.16 ft/Winds SSE 2.9 – 3.8 mph. A close-up of the SW corner. Red star, Brooks Island; orange arrow, very large cargo ship; green arrows, standing water remaining from the high tide.

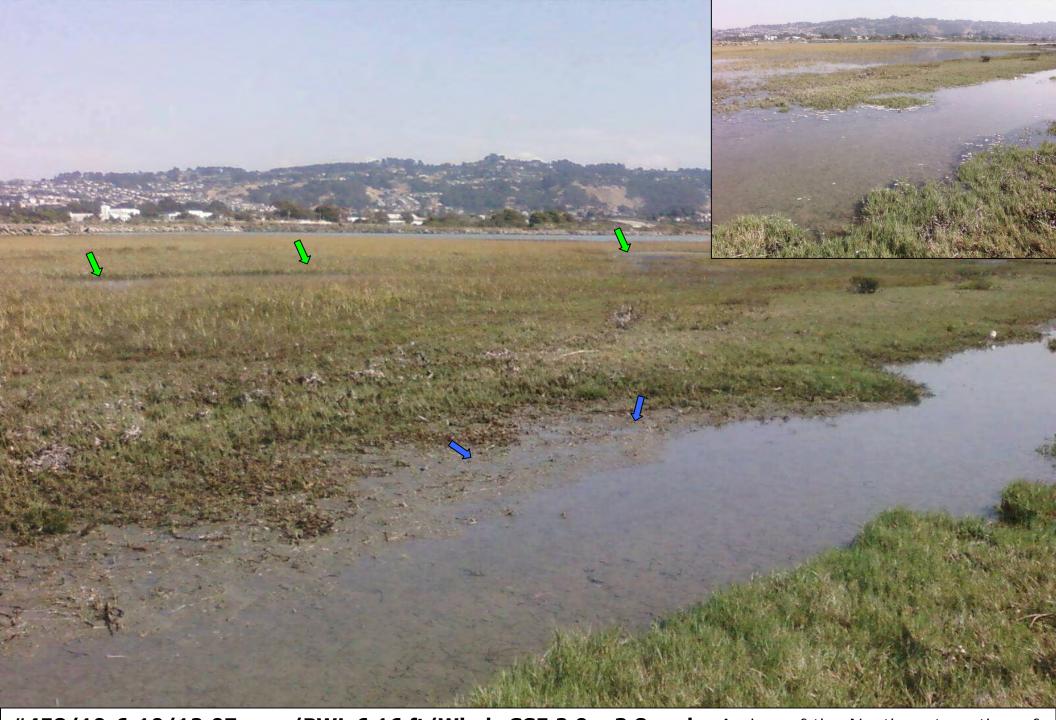
#457/10-6-10/12:07 p.m./PWL 6.16 ft/Winds SSE 2.9 – 3.8 mph. A view of the East section of the mudflat. Red star, probably location of Conner's body; Orange arrow, large Styrofoam object; green arrow, deeper water in one of the ponds; yellow arrow, standing overflow water; blue arrow, remaining puddles as water soaks into the ground.

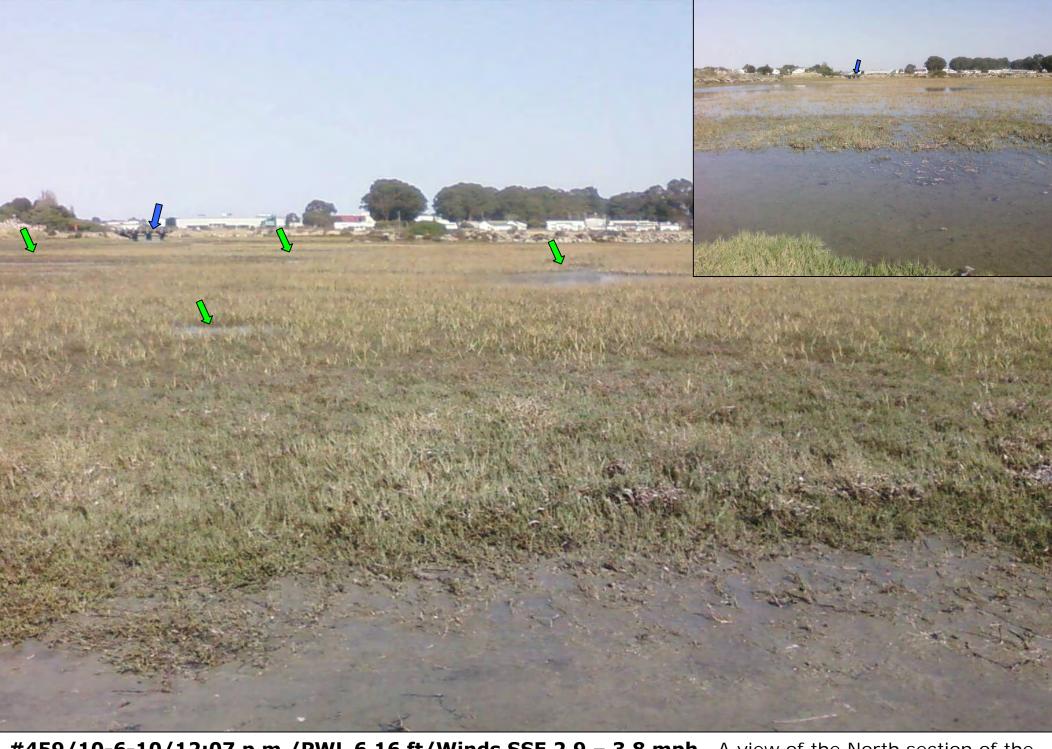
#458/10-6-10/12:07 p.m./PWL 6.16 ft/Winds SSE 2.9 – 3.8 mph. A view of the Northeast section of the mudflat. Dirt path still mostly filled with water. Green arrows, deeper water in a pond and creek; blue arrows, remaining puddles as water soaks into the ground. Inset is #377 at PWL 6.35 ft., peak high tide. Where does all the water go? Duh! It soaks into the ground.

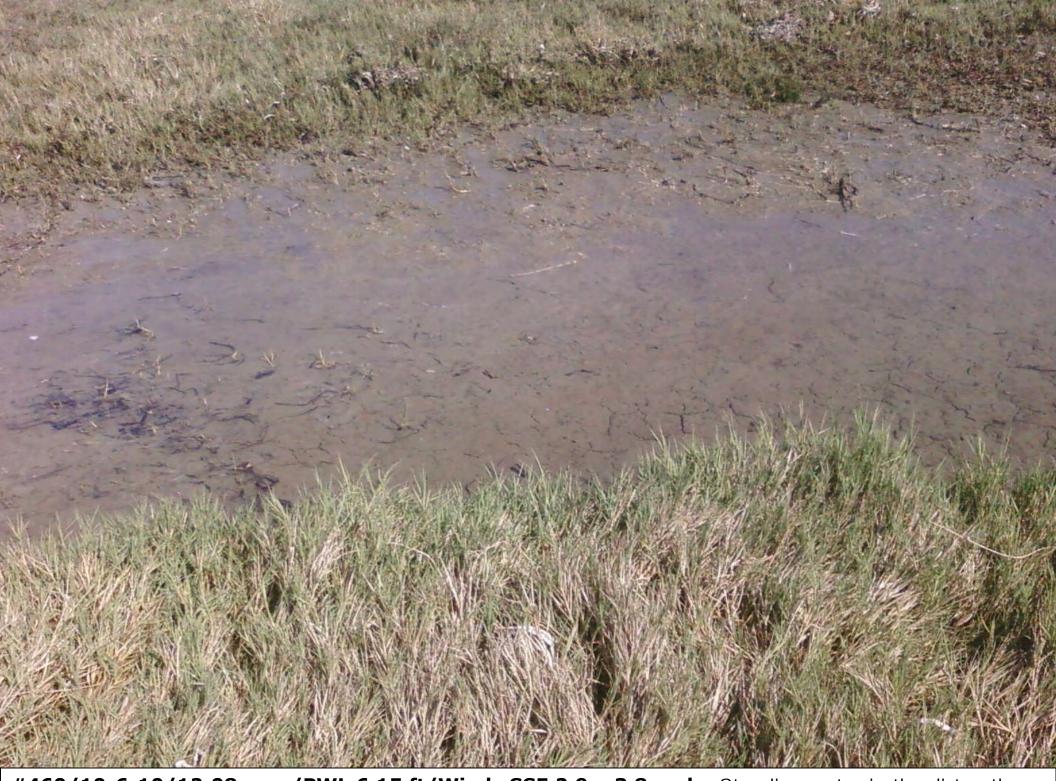
#460/10-6-10/12:08 p.m./PWL 6.15 ft/Winds SSE 2.9 - 3.8 mph. Standing water in the dirt path.

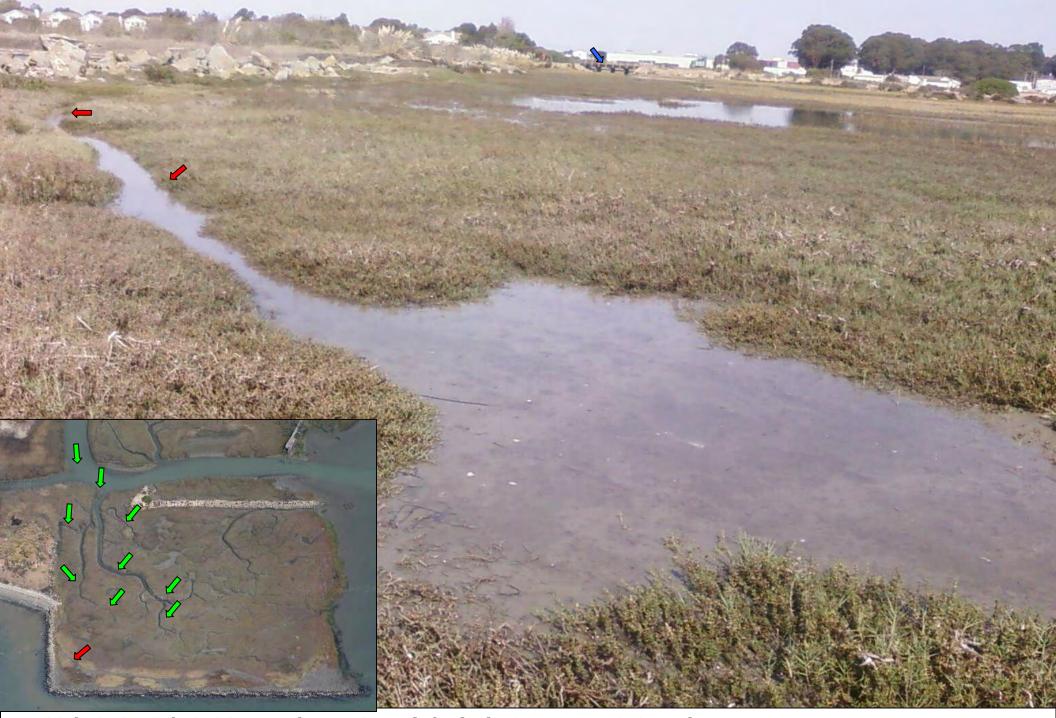
#461/10-6-10/12:09 p.m./PWL 6.15 ft/Winds SSE 2.9 – 3.8 mph. It's almost 1 hour since the high tide peaked at 6.35 at 11:12 a.m. (PWL), and I'm exiting the site. Orange arrow, large stryofoam object; green arrows, deep water pond and creek; yellow arrow, northernmost reach of debris line; blue arrow, rock used to gauge water depth.

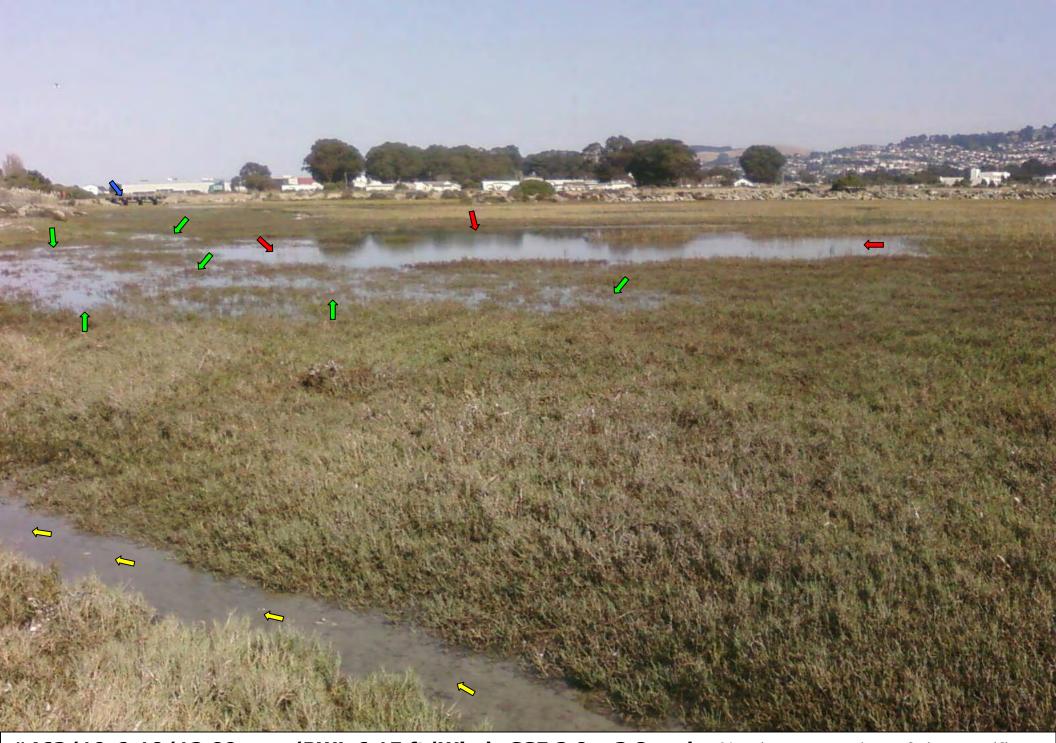
#462/10-6-10/12:09 p.m./PWL 6.15 ft/Winds SSE 2.9 – 3.8 mph. Northwest section of the mudflat. Much more standing water than on the Northeast section because of the large creek system that flows from Meeker's Slough (Inset picture, green arrows). Blue arrow, Bay Trail bridge; red arrows, dirt path, which is still filled with water.

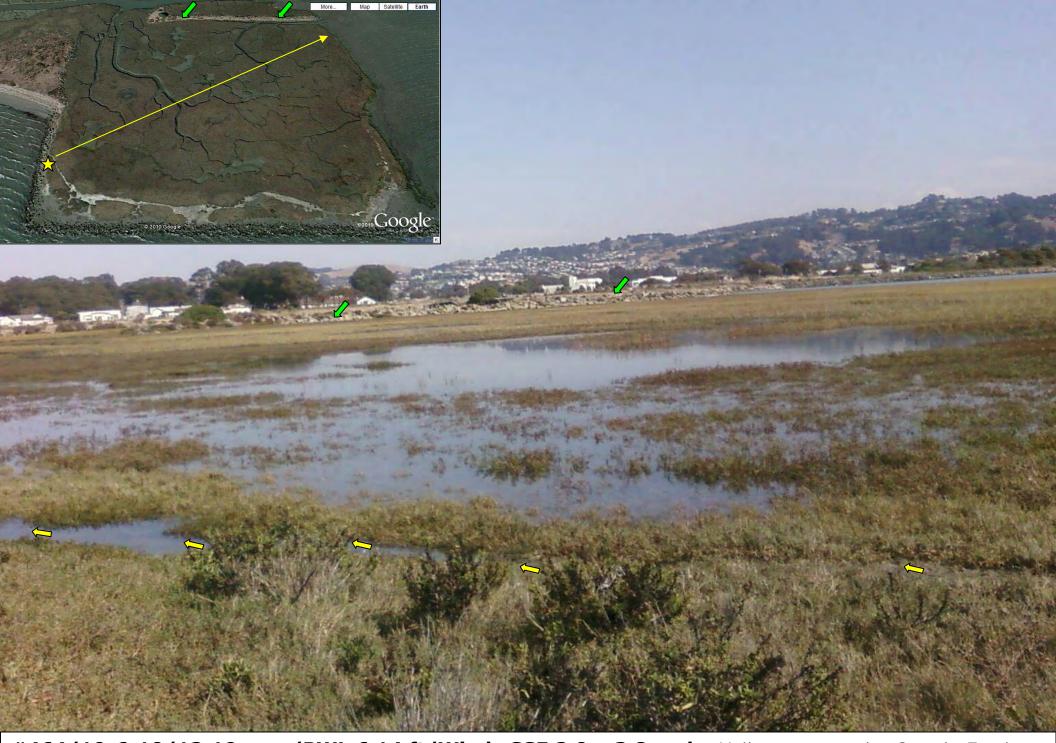
#463/10-6-10/12:09 p.m./PWL 6.15 ft/Winds SSE 2.9 – 3.8 mph. Northwest section of the mudflat. A closer look at the large pond (red arrows) and the standing overflow water (green arrows); yellow arrows, dirt path; blue arrow, Bay Trail bridge.

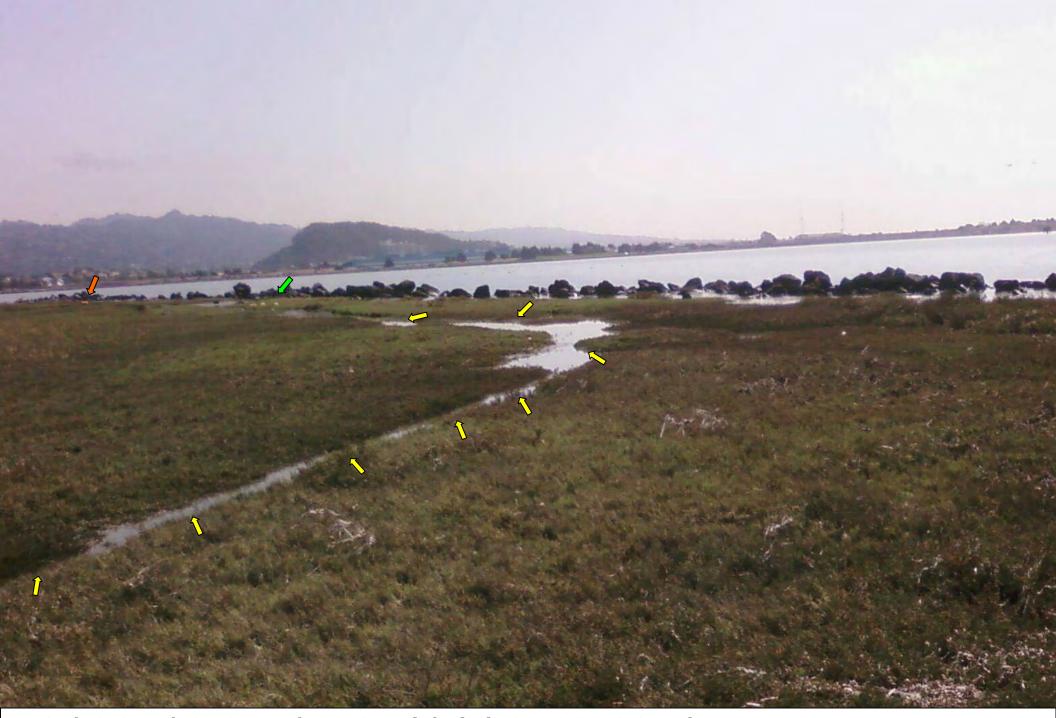
#464/10-6-10/12:10 p.m./PWL 6.14 ft/Winds SSE 2.9 – 3.8 mph. Yellow star on the Google Earth inset shows my standing location, yellow line indicates angle to the NE; yellow arrows mark dirt path. Green arrows, north breakwater.

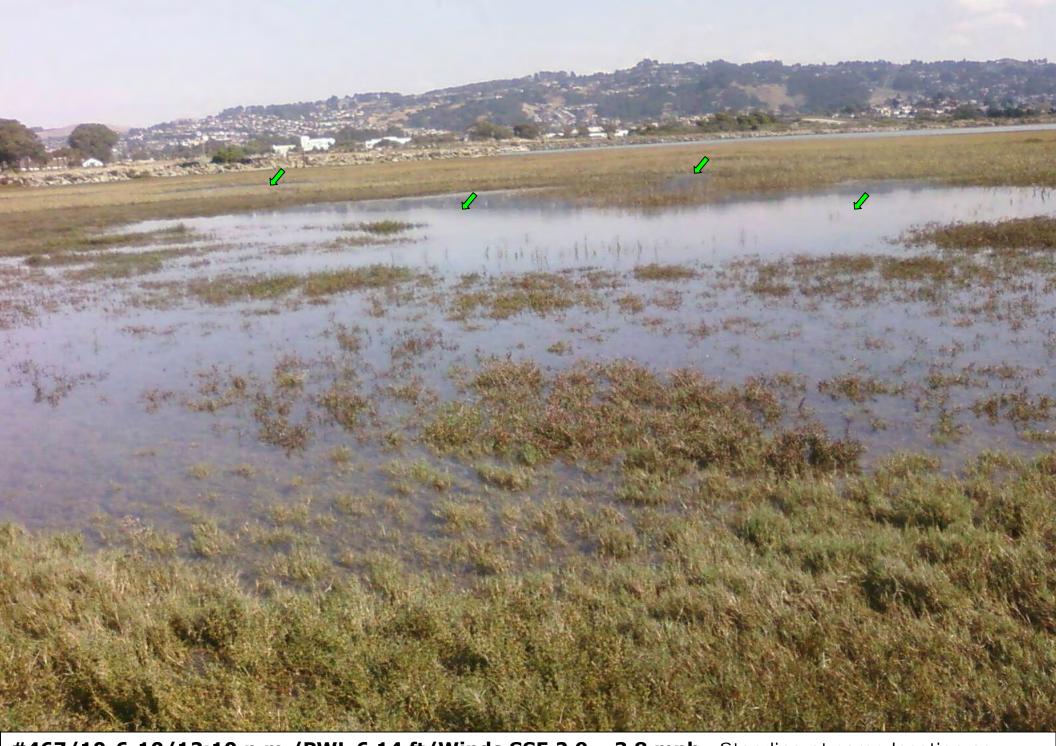
#466/10-6-10/12:10 p.m./PWL 6.14 ft/Winds SSE 2.9 – 3.8 mph. Standing at same location as #464, looking towards the ESE. Yellow arrows mark the dirt path; green arrow points to the deeper water in the pond and creek in contrast to the shallower, over-flow water that will soak into the ground; orange arrow, large Styrofoam object.

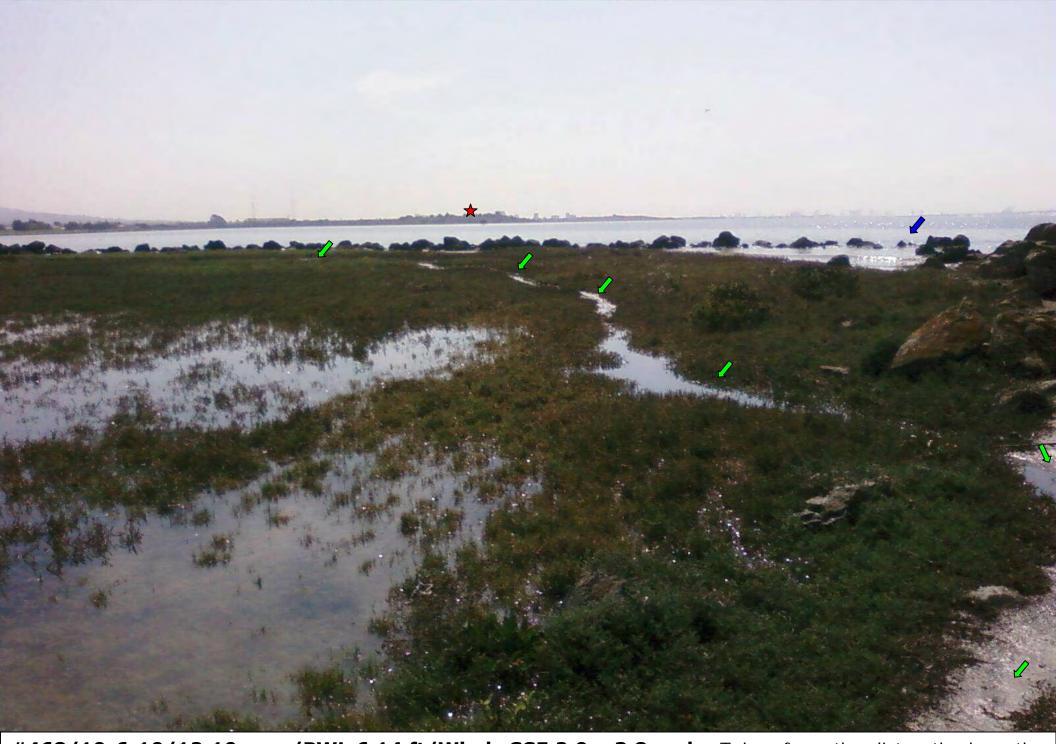
#467/10-6-10/12:10 p.m./PWL 6.14 ft/Winds SSE 2.9 – 3.8 mph. Standing at same location as #464, looking towards the NE corner of the mudflat. Green arrow points to the deeper water in the pond and creeks in contrast to the shallower, over-flow water that will soak into the ground

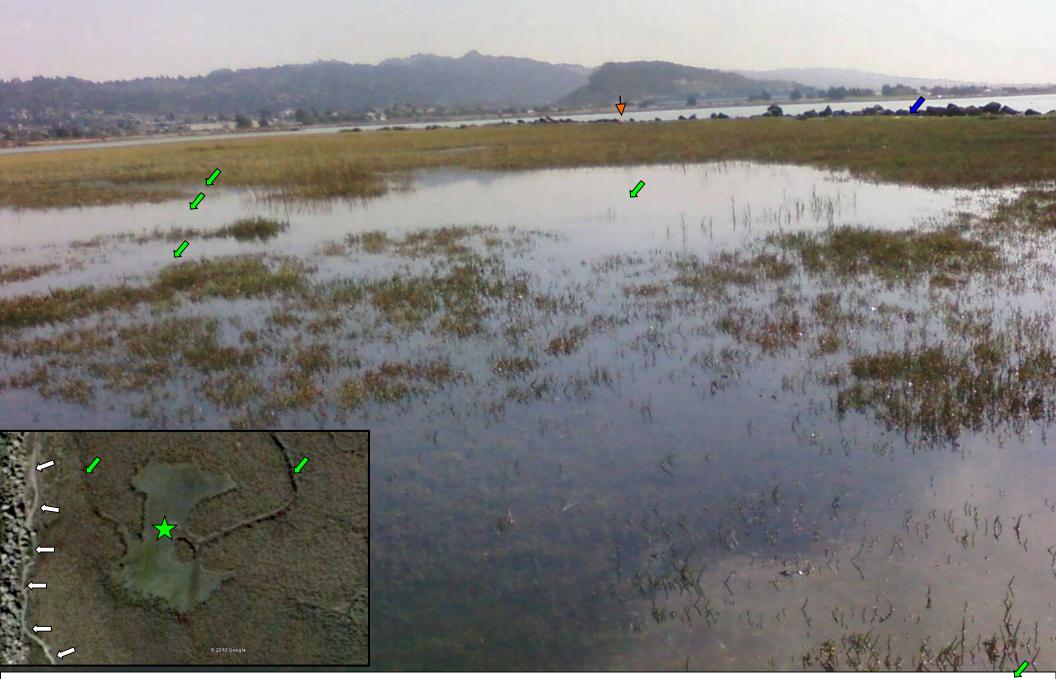
#468/10-6-10/12:10 p.m./PWL 6.14 ft/Winds SSE 2.9 – 3.8 mph. Taken from the dirt path along the west breakwater, a little further north than #464-467. Red star, Albany Bulb; blue arrow, SW corner; green arrows, dirt path.

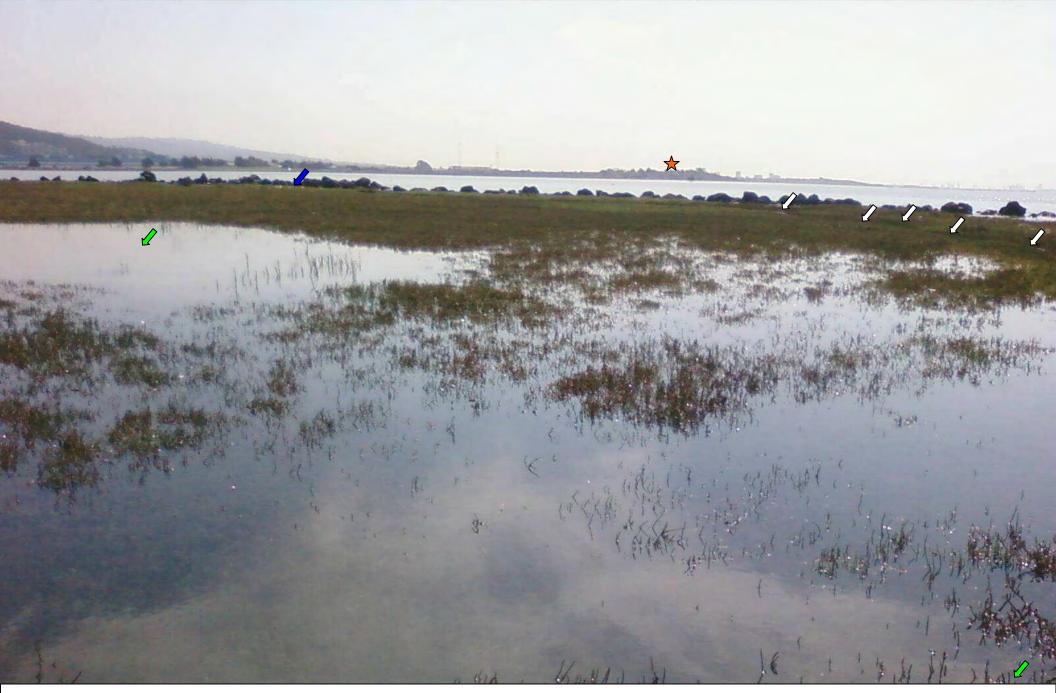
#469/10-6-10/12:12 p.m./PWL 6.13 ft/Winds SSE 3.6 – 4.2 mph. Taken from the dirt path along the west breakwater, a little further north than #468, looking SE. Orange arrow, large styrofoam object barely shows; blue arrow, stuffed animals in debris line barely show; green arrows, deeper water in the pond. Inset is a Google Earth close-up of this pond at low tide (green star). Creeks feed into it from Meeker's Slough on both sides (green arrows). White line (white arrows) marks the path along the west breakwater.

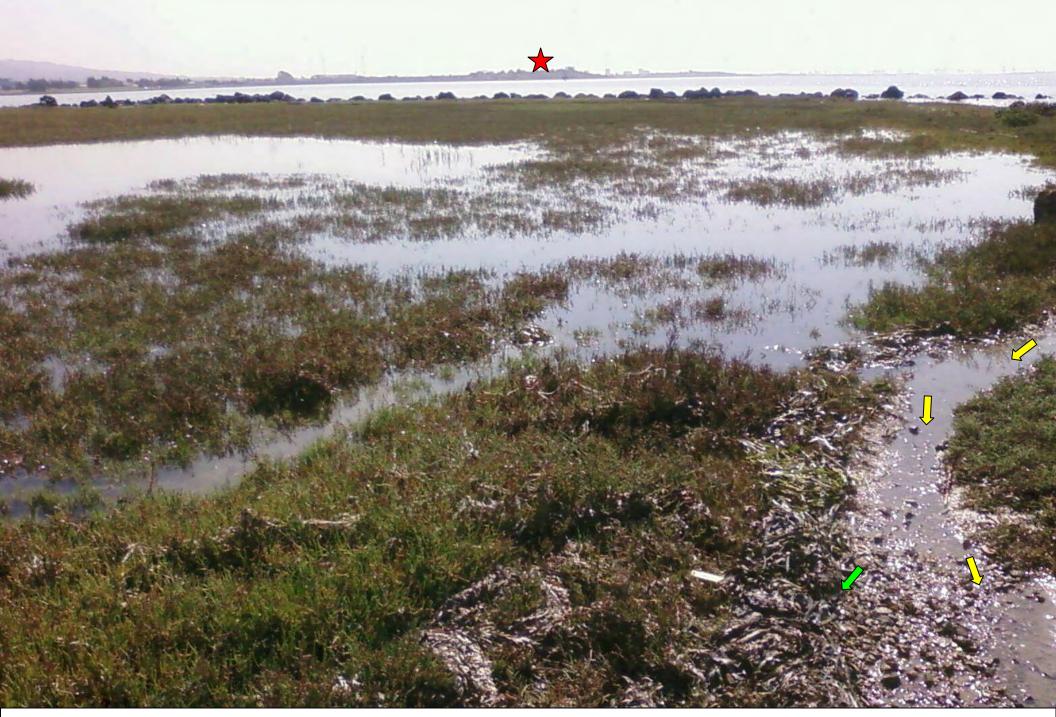
#471/10-6-10/12:12 p.m./PWL 6.13 ft/Winds SSE 3.6 – 4.2 mph. Taken from the dirt path along the west breakwater, showing wet debris that washed ashore through the west breakwater.

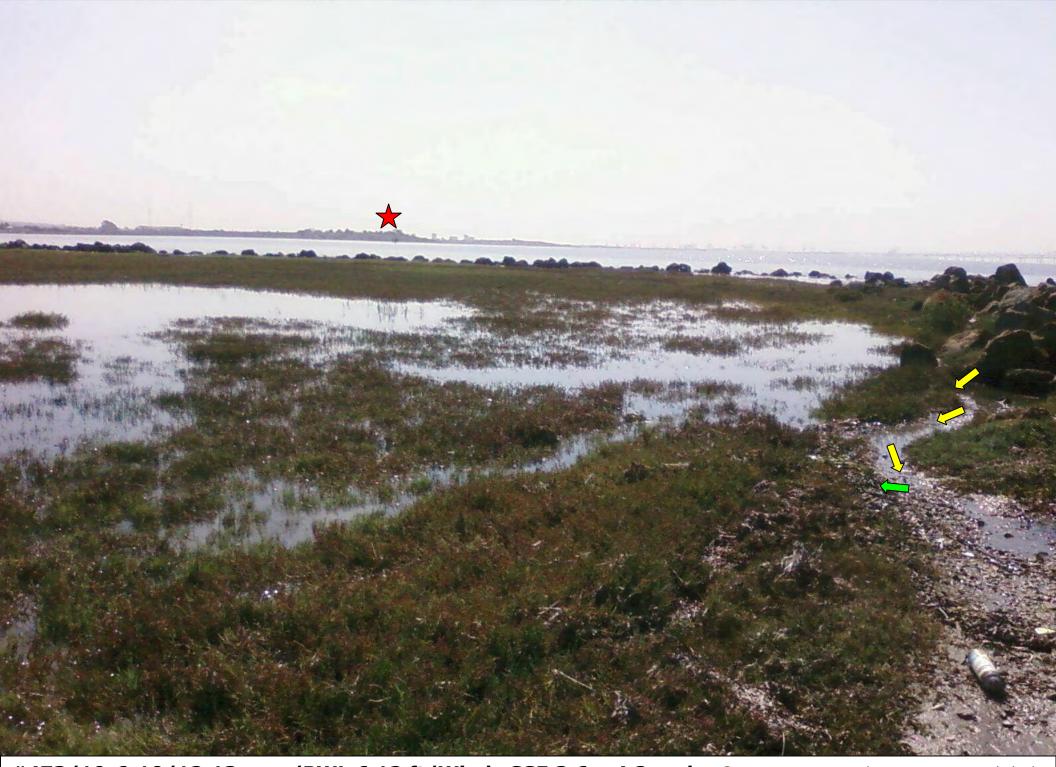
#472/10-6-10/12:12 p.m./PWL 6.13 ft/Winds SSE 3.6 – 4.2 mph. Green arrow points to same debris in #471; red star is Albany Bulb; yellow arrows, dirt path along west breakwater. Shows how much more water is retained in the northern section of the mudflat compared to the southern section, contrary to Distaso's theory.

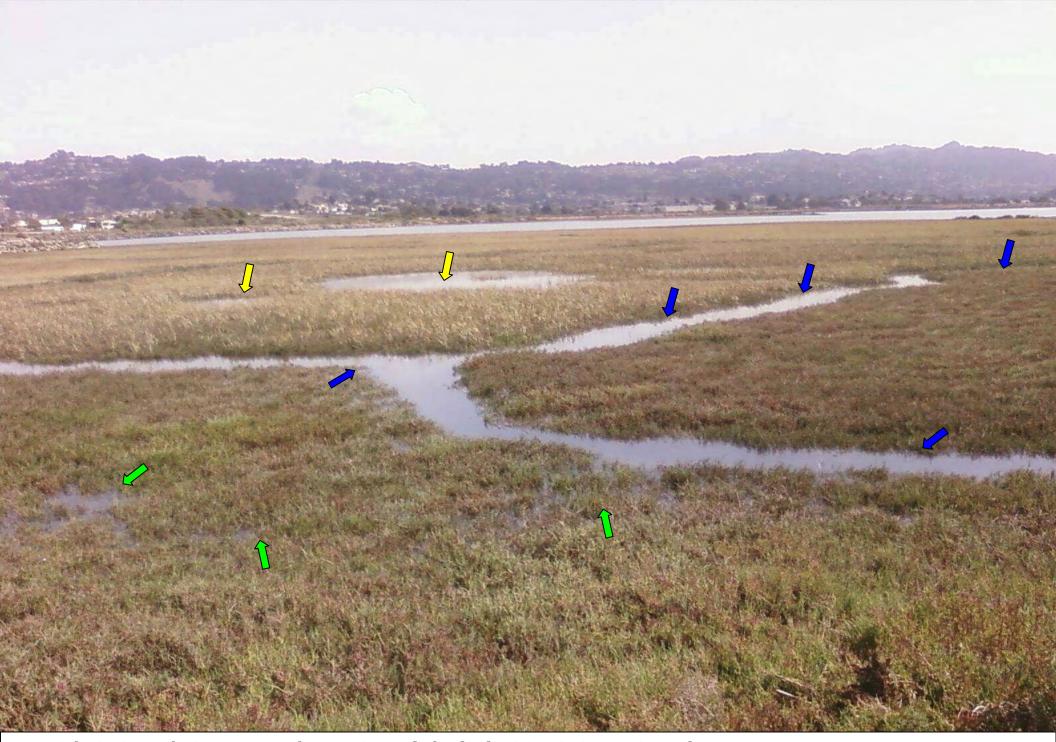
#475/10-6-10/12:14 p.m./PWL 6.11 ft/Winds SSE 3.6 – 4.2 mph. Standing at the entrance to the mudflat from the beach, looking towards the NE corner. Yellow arrows, north breakwater; blue arrows, major creeks that flow from Meeker's Slough. Not that much visible standing water at the back north of the mudflat. 6.11 ft is less than an inch (6/10 of an inch to be exact) higher than the MHHW of 6.05.

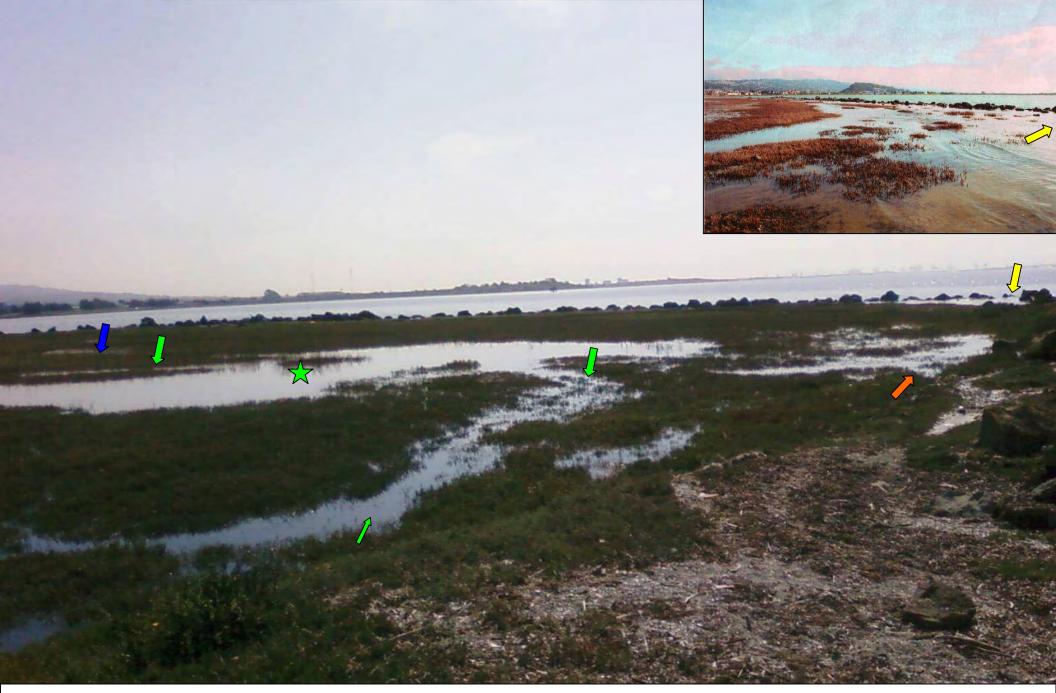
#478/10-6-10/12:15 p.m./PWL 6.11 ft/Winds SSE 3.6 – 4.2 mph. Standing at the entrance to the mudflat from the beach, looking South, showing the west side of the pond. Inset is from Google Satellite. Green stars, pond that remains on the mudflat; green arrows, creeks from Meeker's Slough that empty into the pond; blue arrow, another pond; orange arrow, standing overflow water between the large pond and the west breakwater; white arrows, dirt path along west breakwater. MHHW is 6.05 ft.

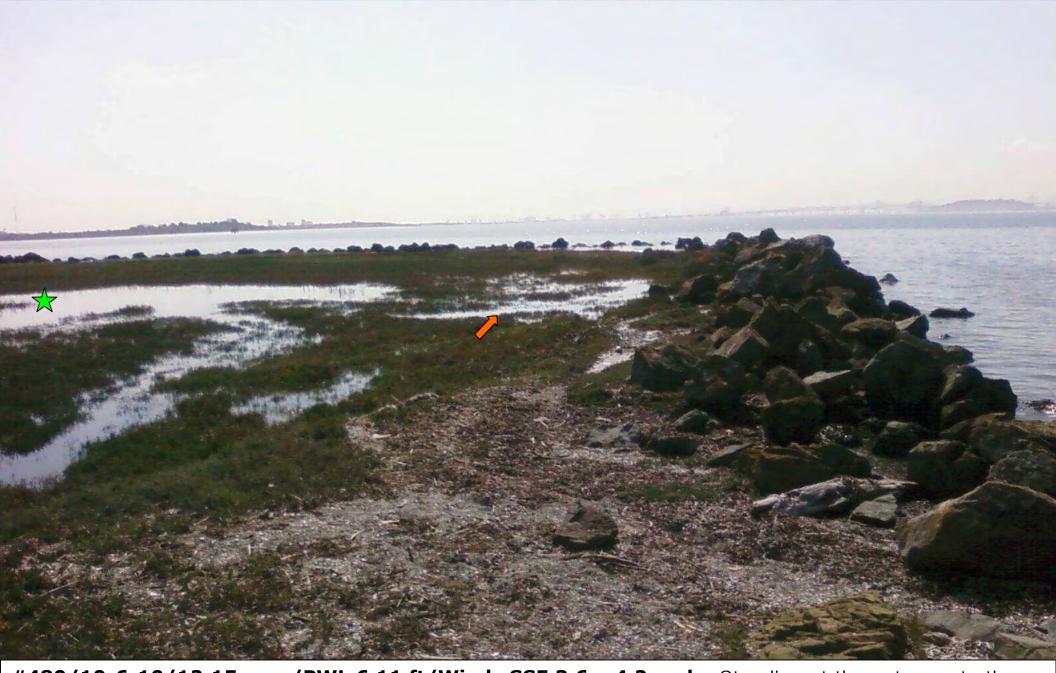
#479/10-6-10/12:15 p.m./PWL 6.11 ft/Winds SSE 3.6 – 4.2 mph. Standing at the entrance to the mudflat from the beach, looking at the Southwest corner, showing full extent of the standing water (orange arrow) between the pond (green star) and the west breakwater. Blue arrow, another small pond. Green arrows, the two creeks flowing from Meeker's Slough that flow into the large pond. Inset is People's 100 at 6.39 verified water level. MHHW (average of all higher high tides) is 6.05 ft.
