DEFENDANT'S  
EXHIBIT NO.

D8K

PEOPLE v. SCOTT PETERSON

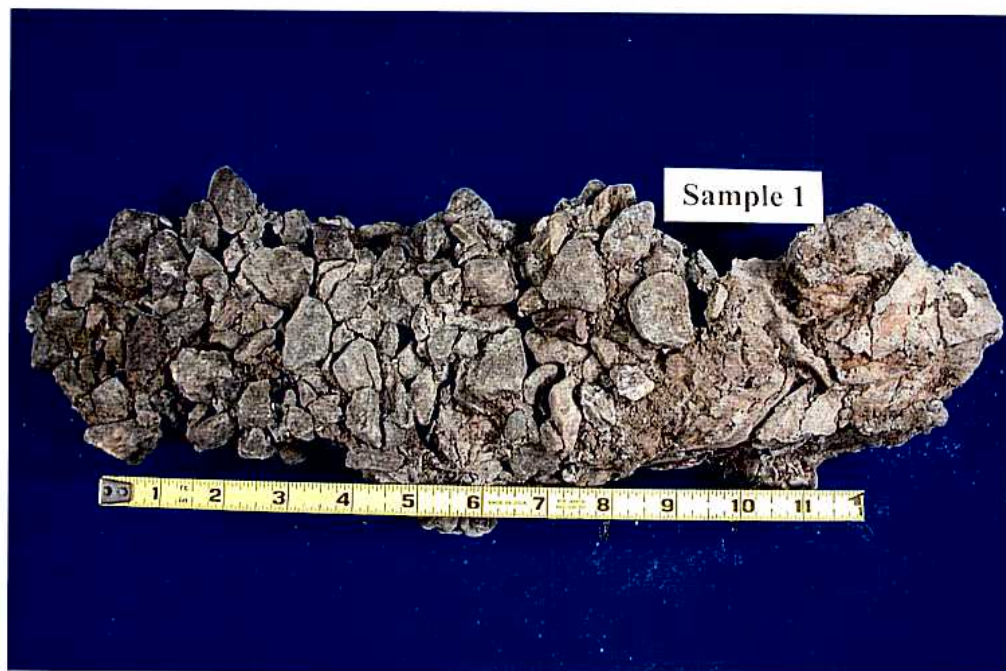
**Fig. 2** Bottom surface of Sample 1, as received.

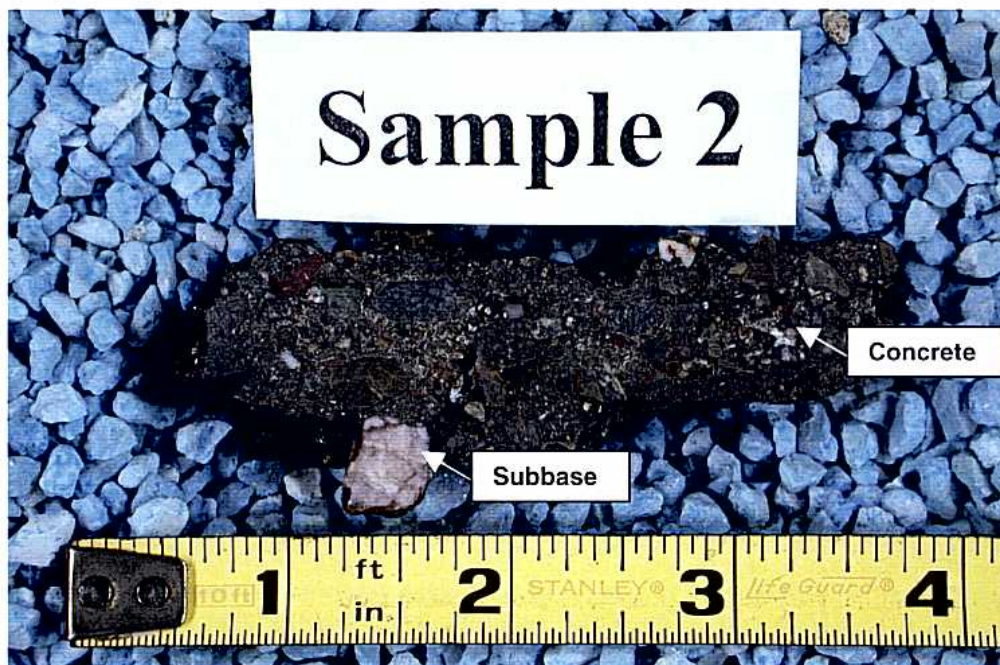
**Fig. 40** Cut and lapped cross section of a representative portion of Sample 2 showing the general appearance and location of the concrete, and the rock subbase.
